May & June 2020  
Environmental Update  
for SLEMA Board  
July 07, 2020

### 3. GNWT Inspector's Report

#### ➤ June 4 Inspection Report

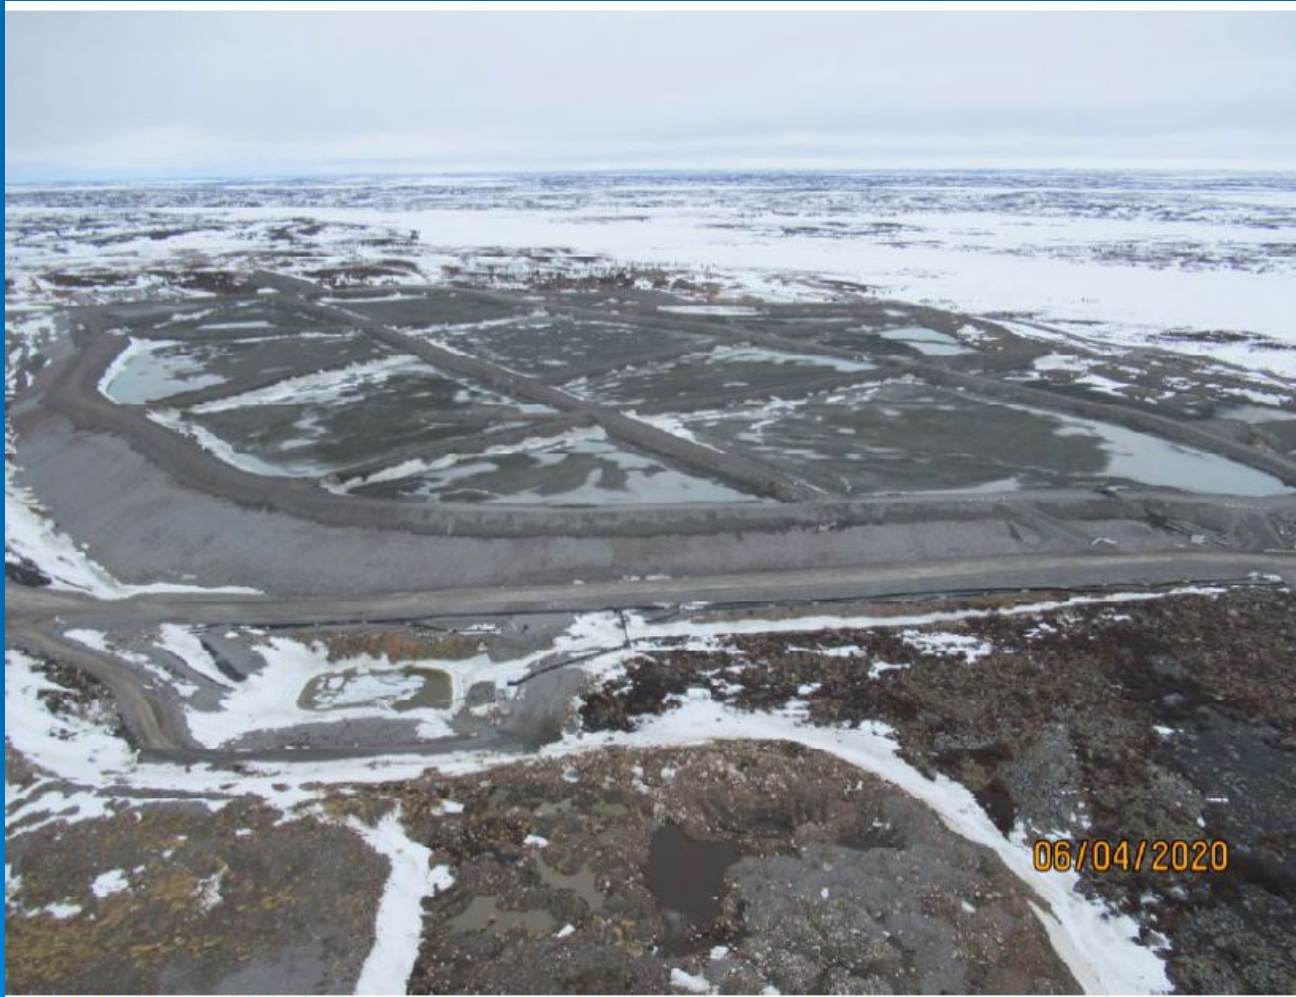
**Photo 1:** Looking west at the Snap Lake Mine North Pile. The North Pile perimeter Sump #2 can be seen in the foreground.

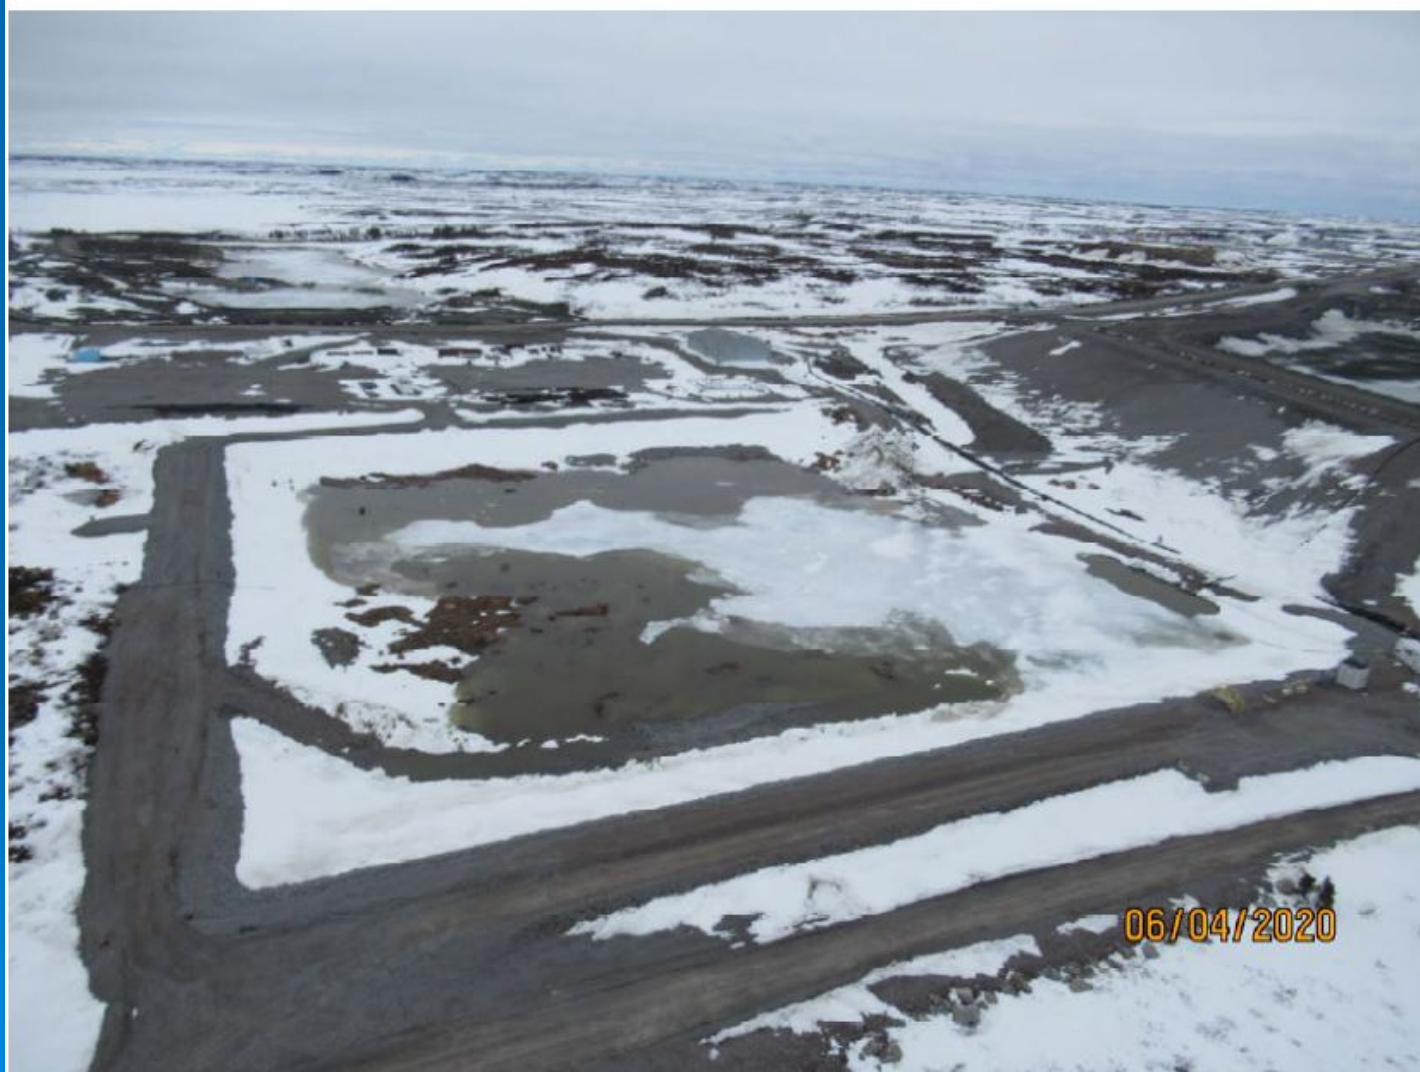
Photo 2: Looking south at perimeter Sump #3. The eastern edge of the North Pile can be seen on the right.

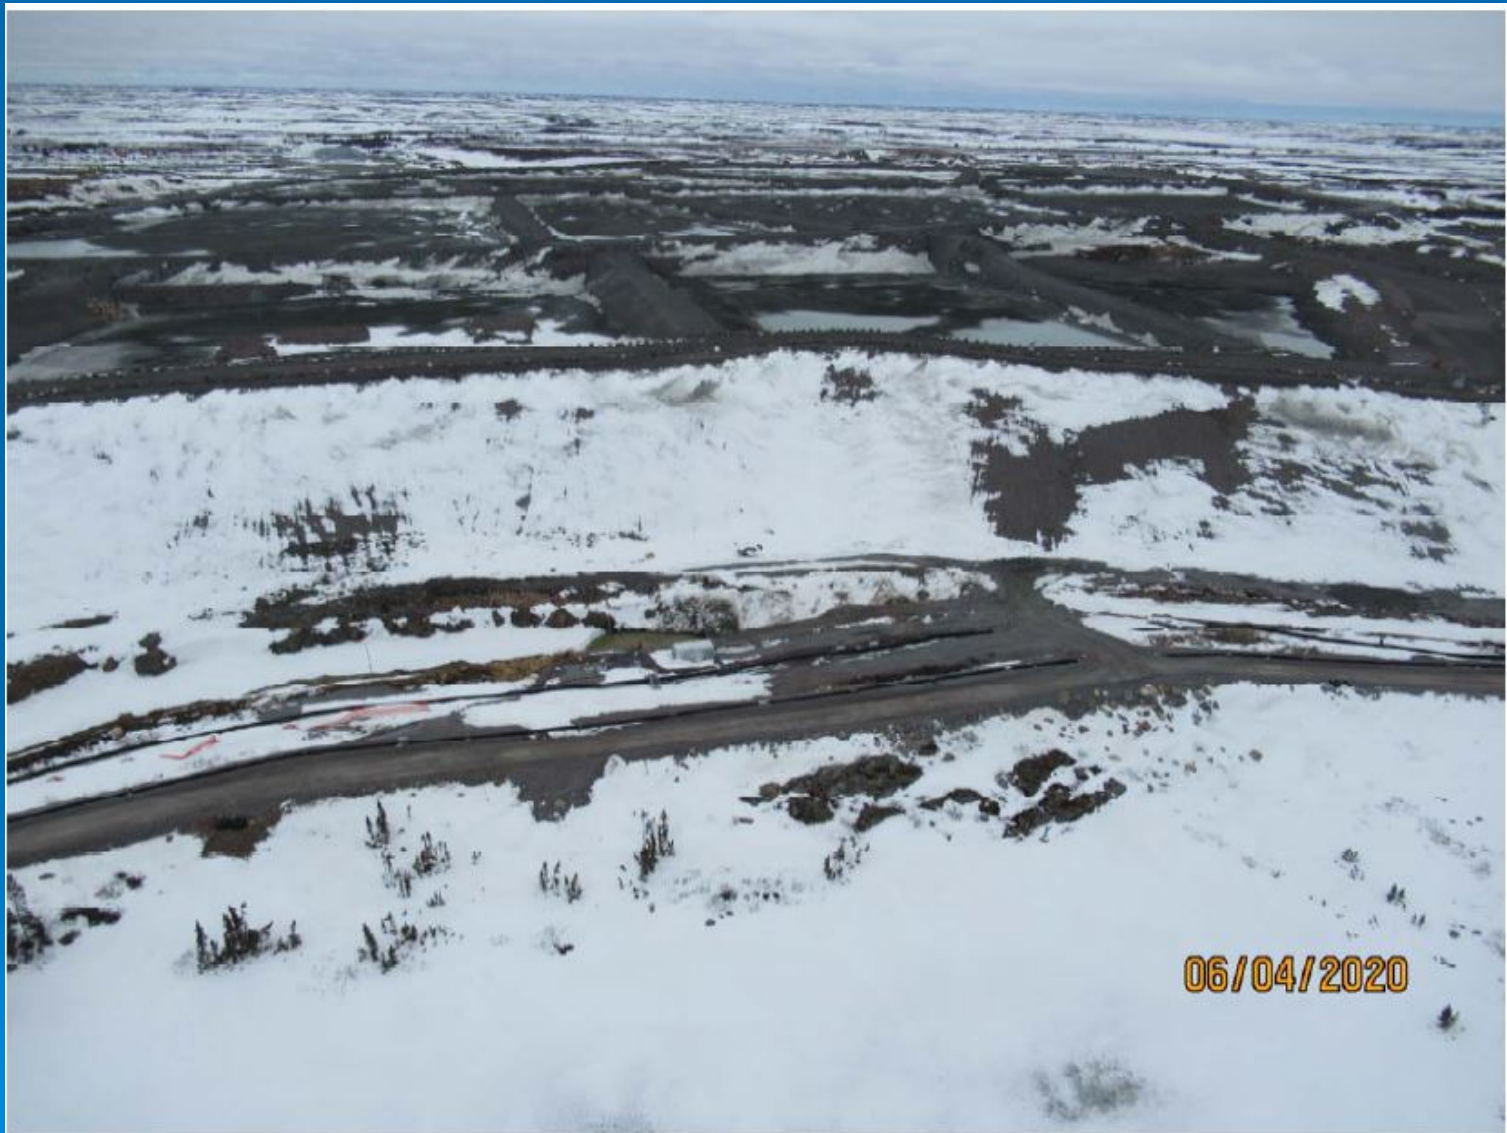
Photo 3: Looking south at the North Pile perimeter Sump #4.

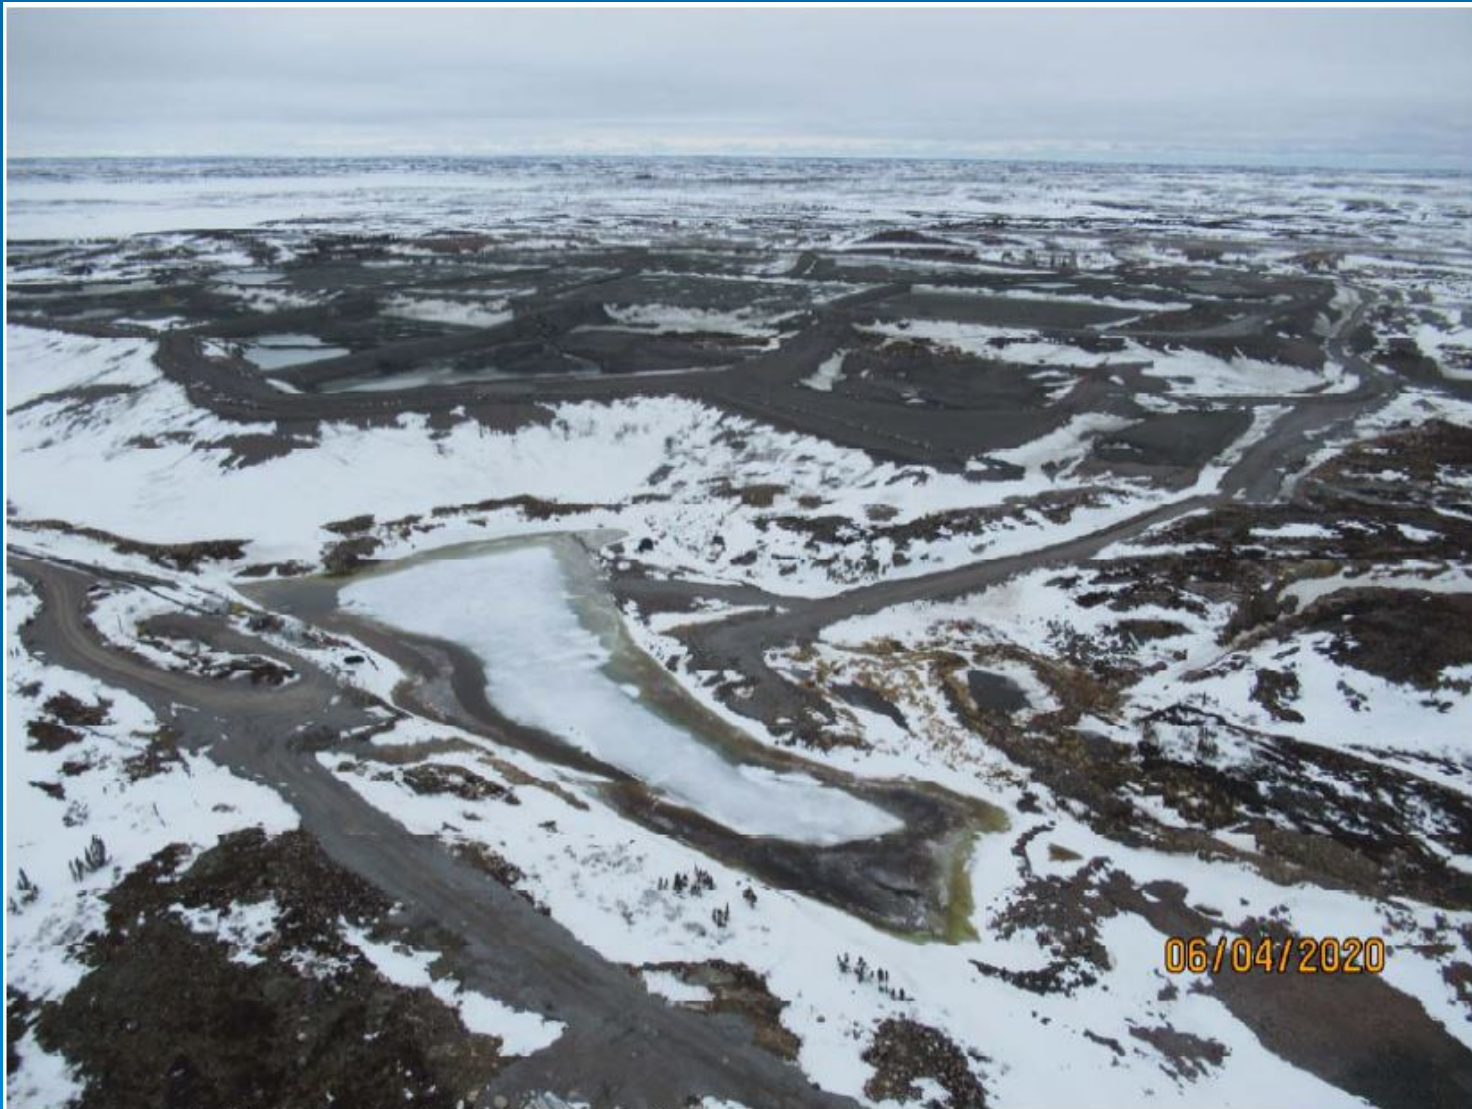
Photo 4: Sump #5 is located north and west of the North Pile.

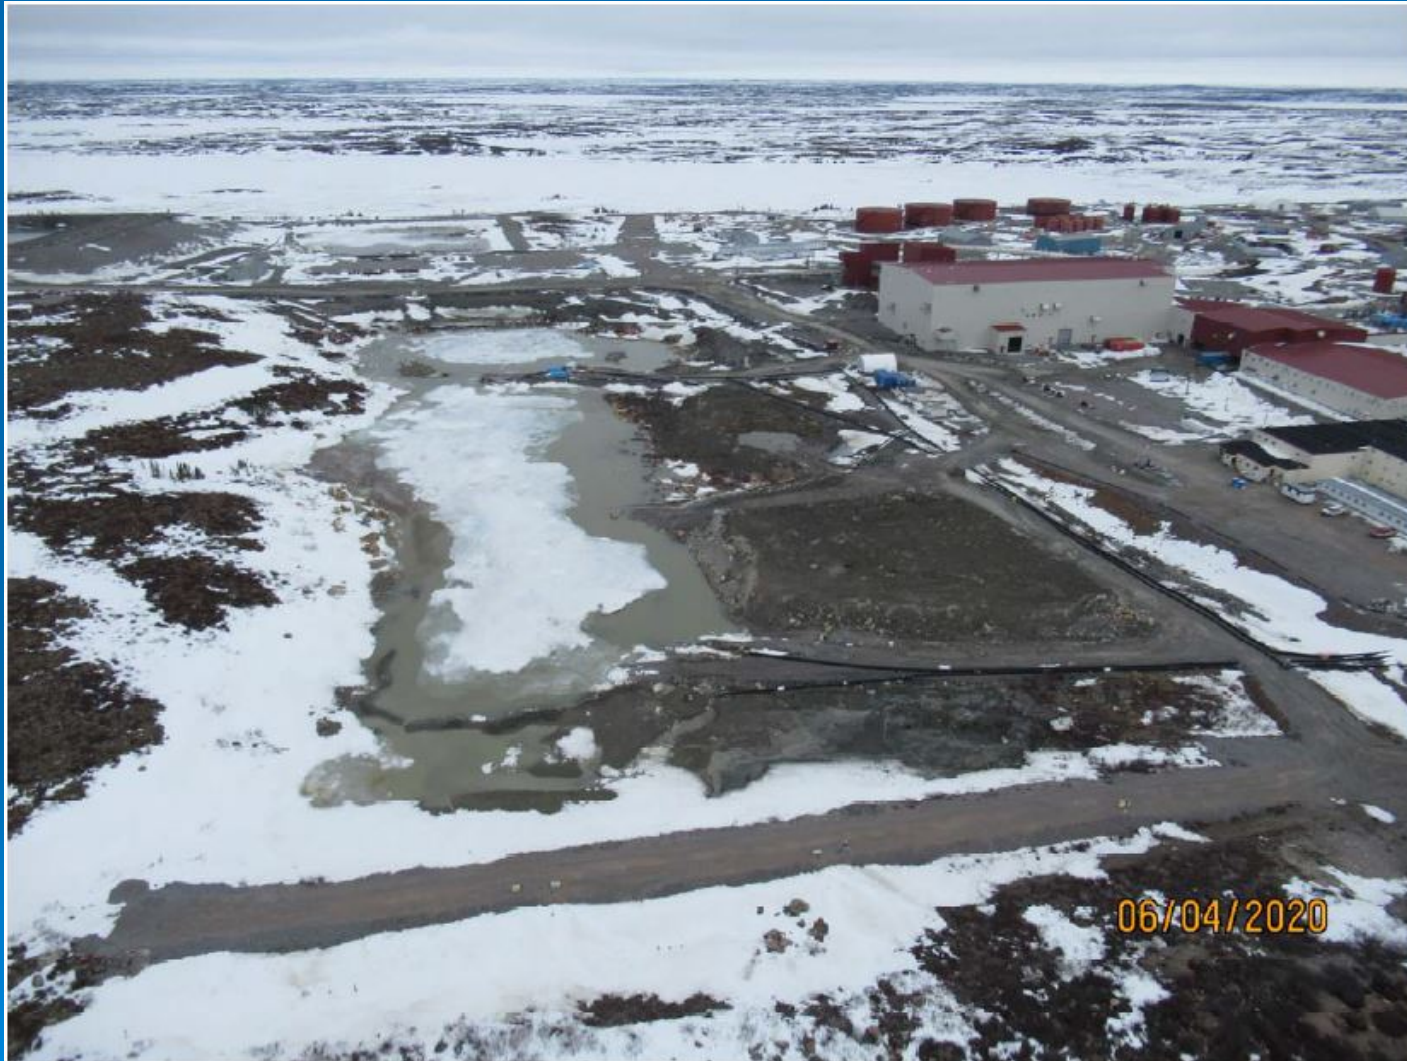
Photo 5: Looking north at the Water Management Pond. Sump #3 can be seen in the top of the photo.

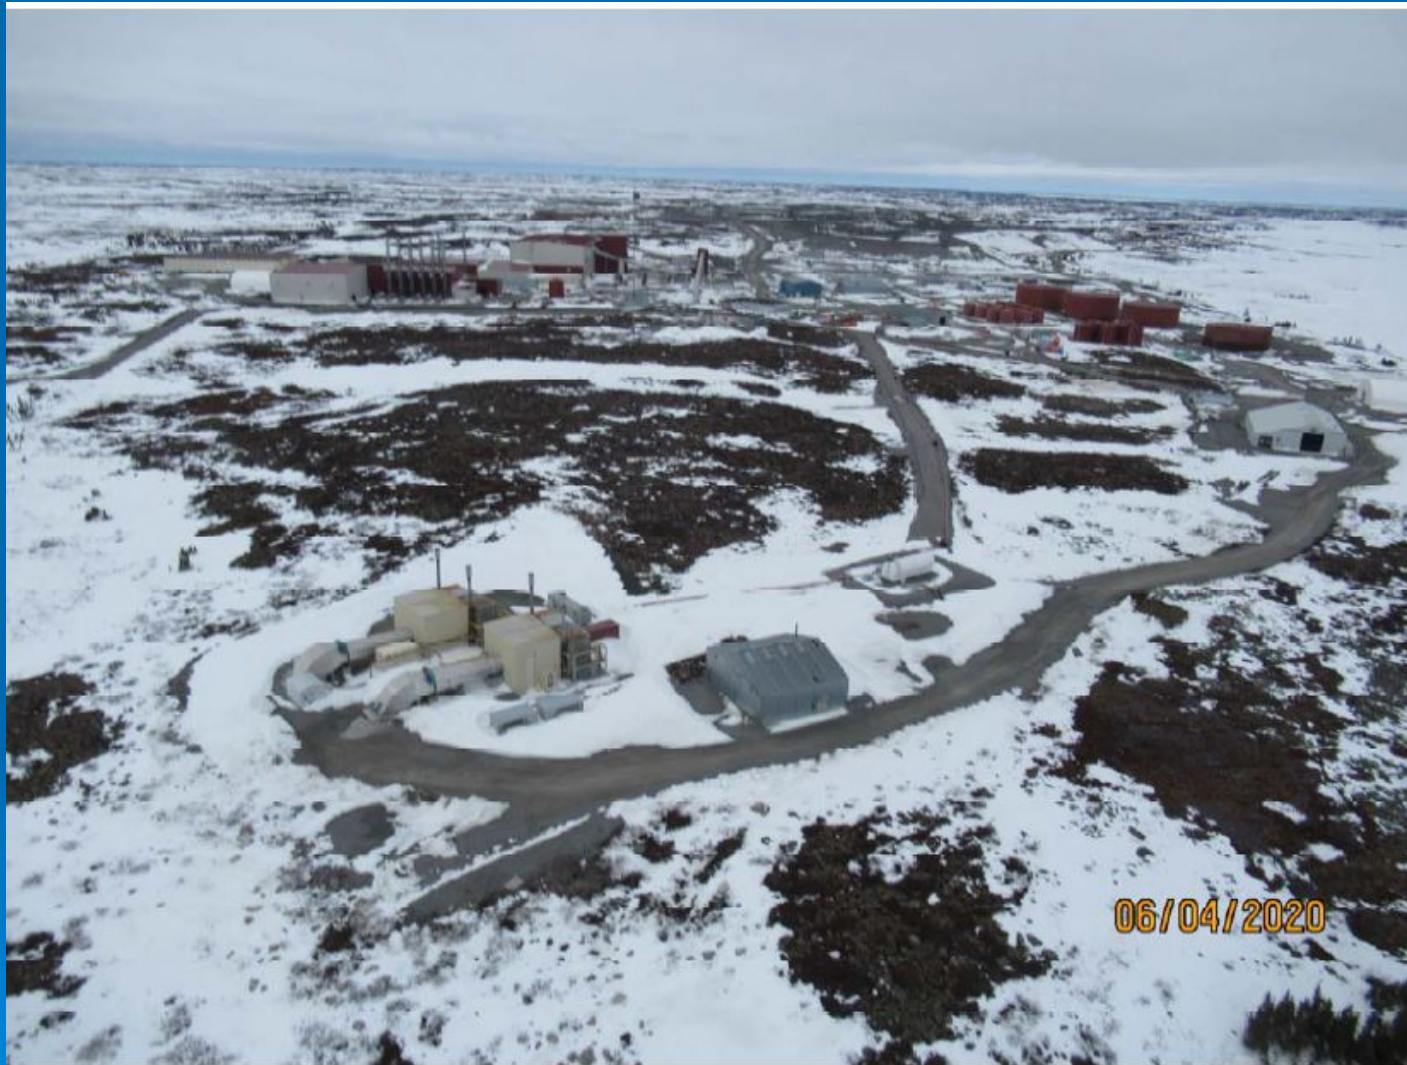
**Photo 6:** Looking west at the main site. Water levels at the underground are monitored at the buildings on the bottom-left and at the mine underground access portal.

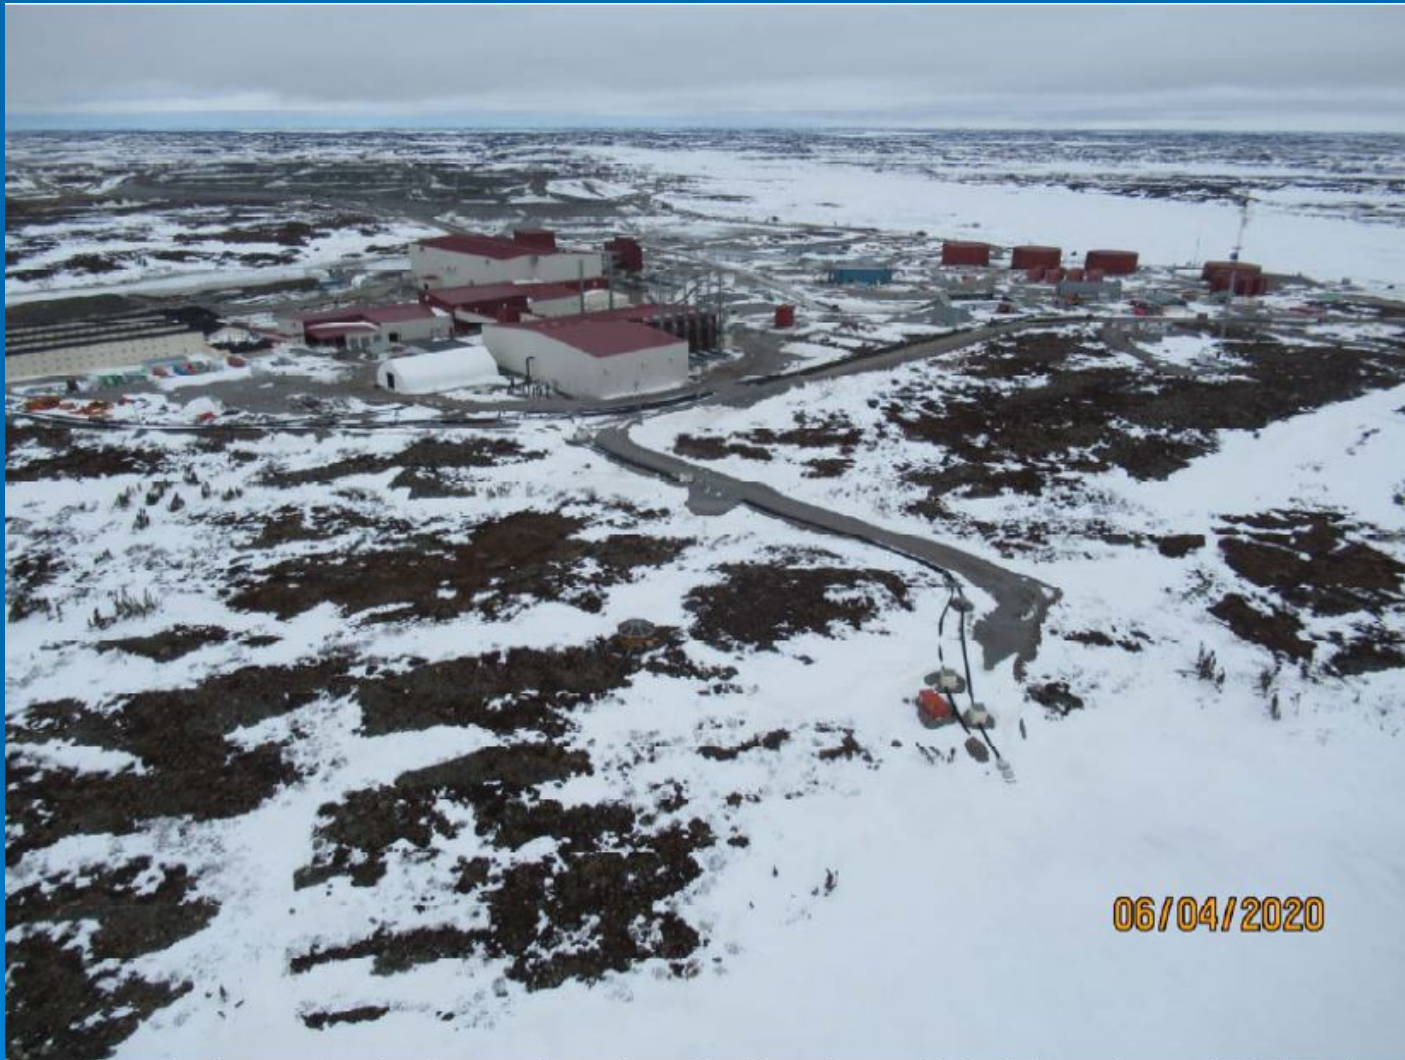
Photo 7: Once the site water from the mine WMP is treated, tested and deemed acceptable for discharge, the water is discharged through the mine diffuser seen in the bottom-right.

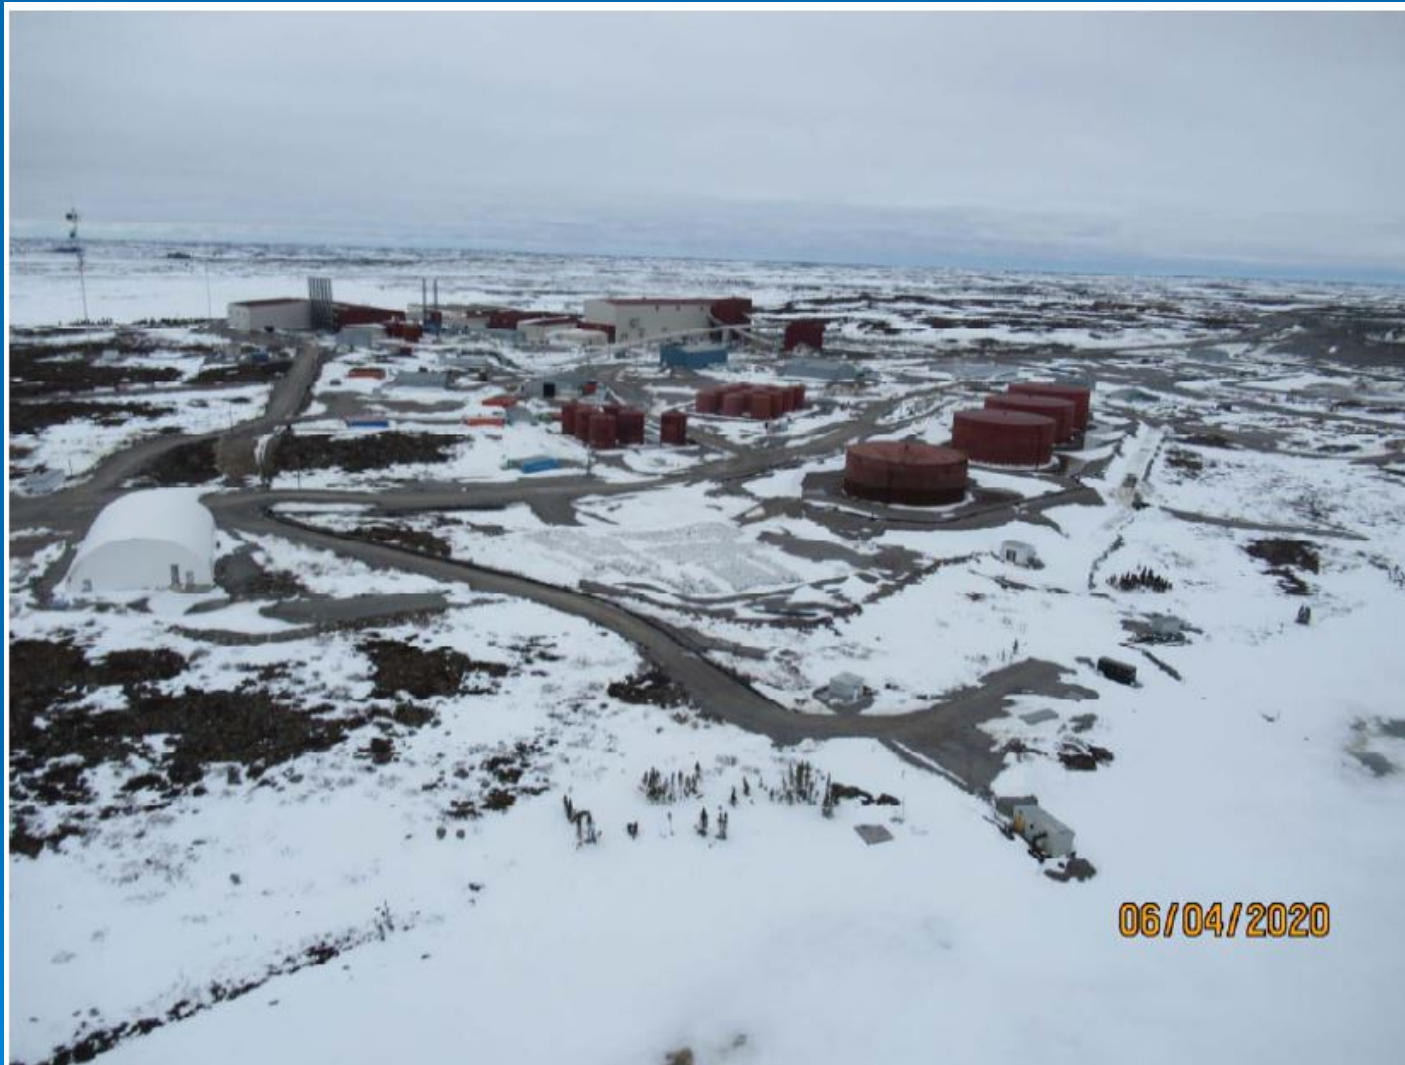
**Photo 8:** Freshwater required for camp use is drawn from Snap Lake at the fresh water intake in the bottom right. Near the centre of the photo are the site bulk fuel storage & distribution facilities.

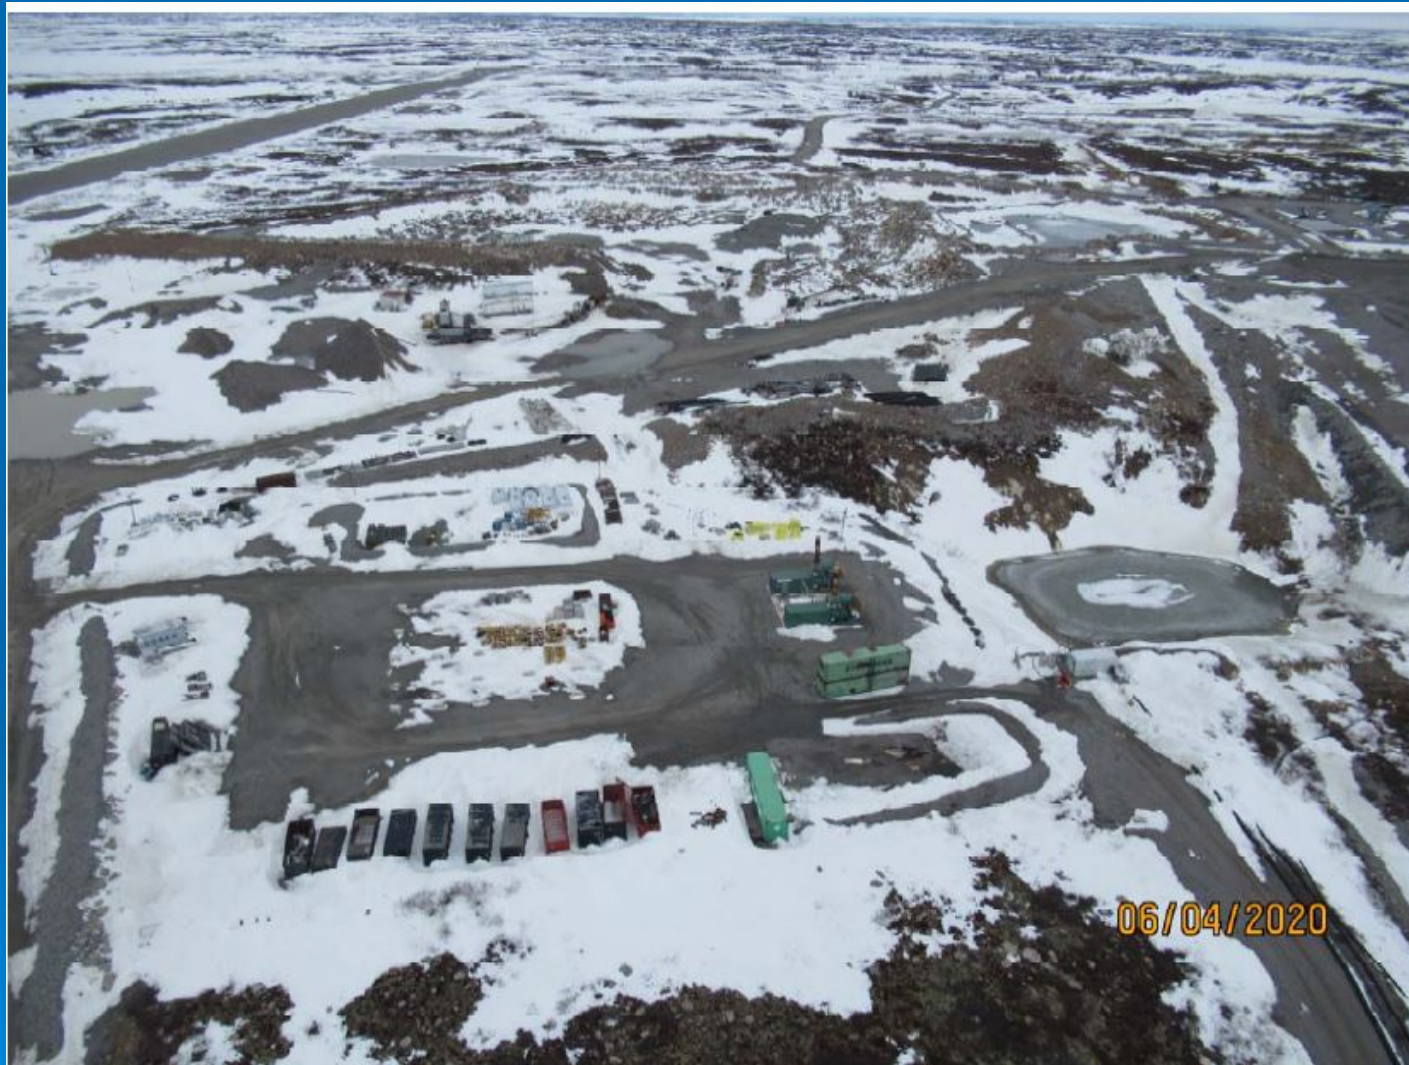
**Photo 9:** Looking west at the camp Waste Transfer Area, camp incinerators and the burn pit. The North Pile perimeter Sump #1 can be seen in the right of the photo.

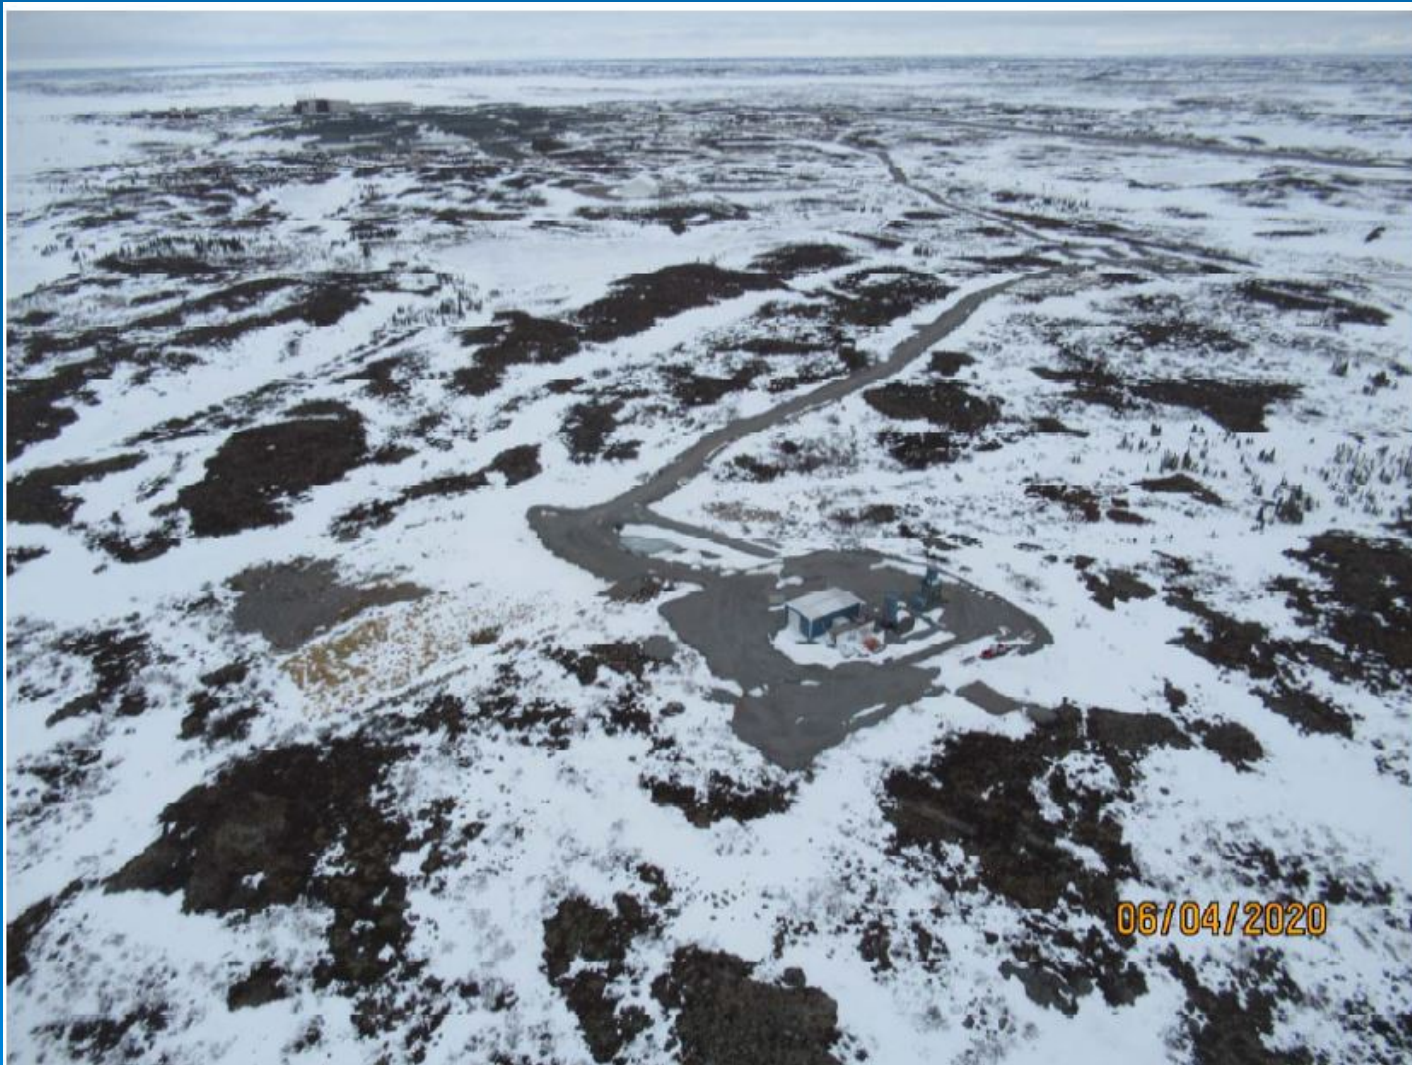
**Photo 10:** Looking west at the decommissioned AN facility Emulsion Plant. The site vegetation test plots can be seen in the centre-left of the photo.

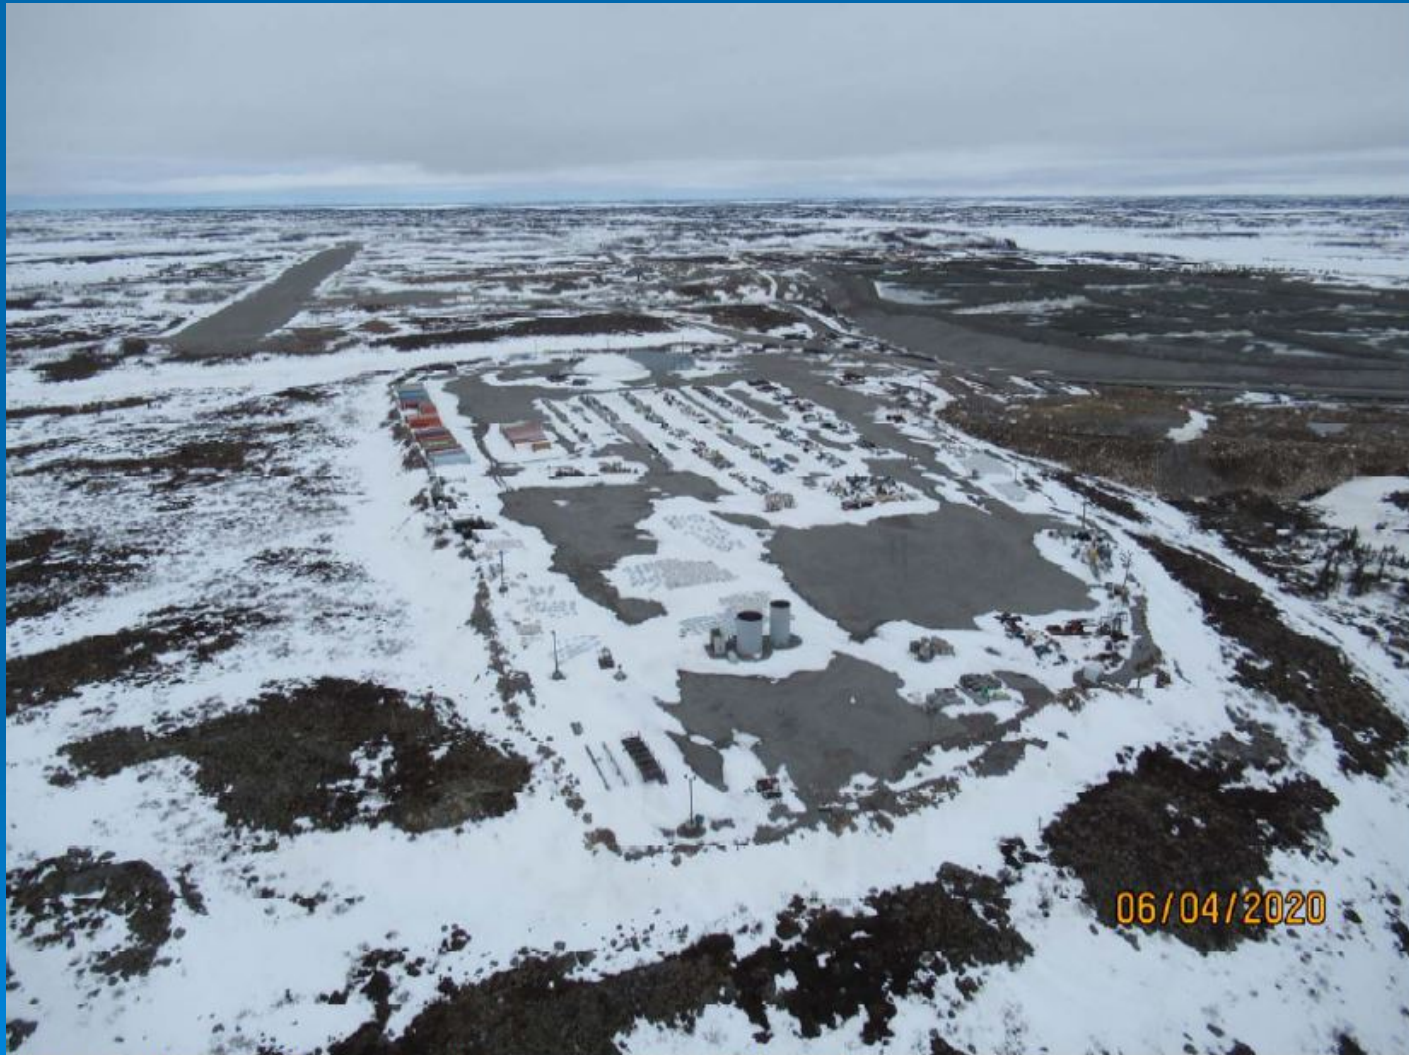
Photo 11: Looking west at Laydown #1 with the mine airstrip in the background.

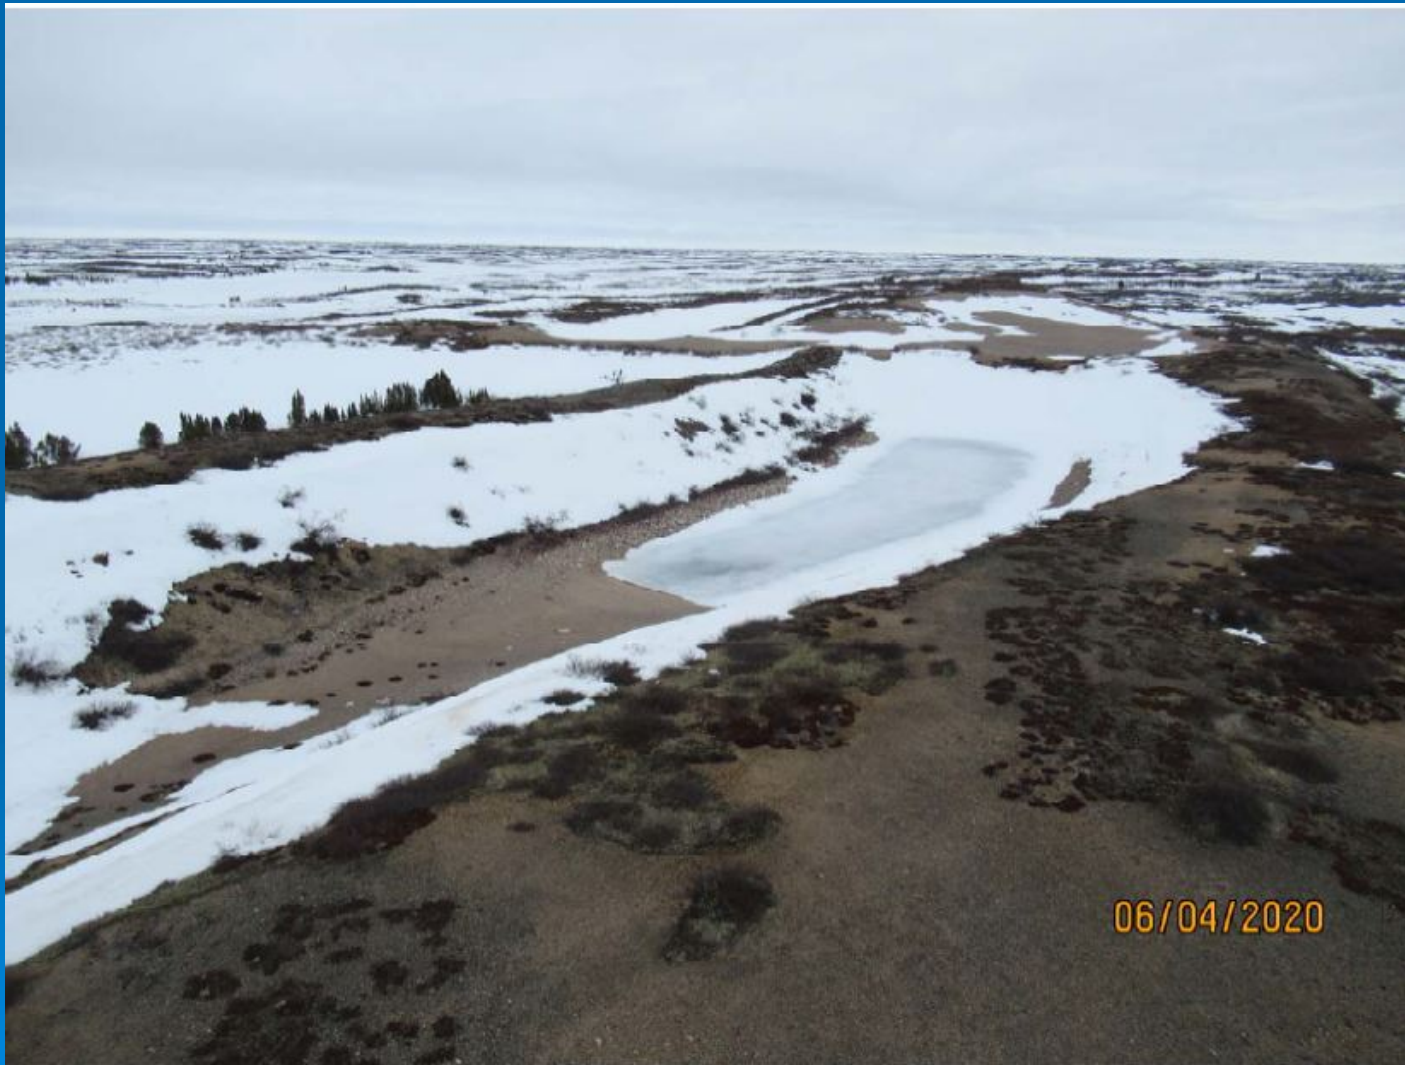
Photo 12: Looking east at the site quarry located south of the main mine facility.

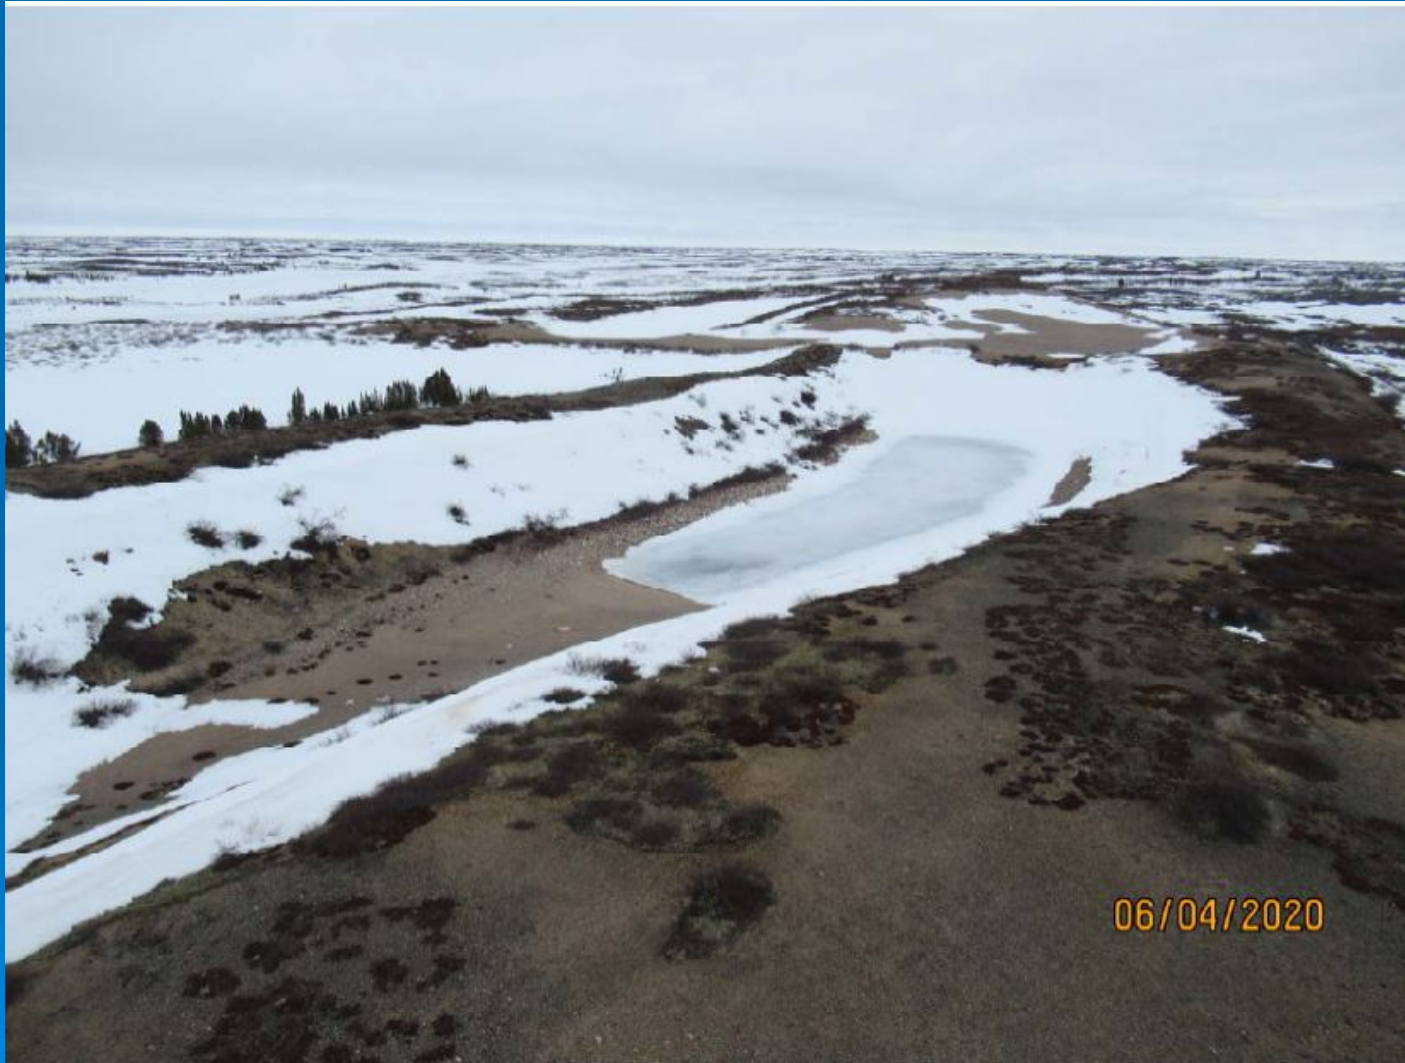
Photo 12: Looking east at the site quarry located south of the main mine facility.
