# July & August 2020 Environmental Update for SLEMA Board

September 1, 2020

### ➤ **August 18 GNWT Inspection Report**

An Inspection of the Snap Lake Diamond Mine Project was conducted by Inspector Joe Heron on August 18, 2020;

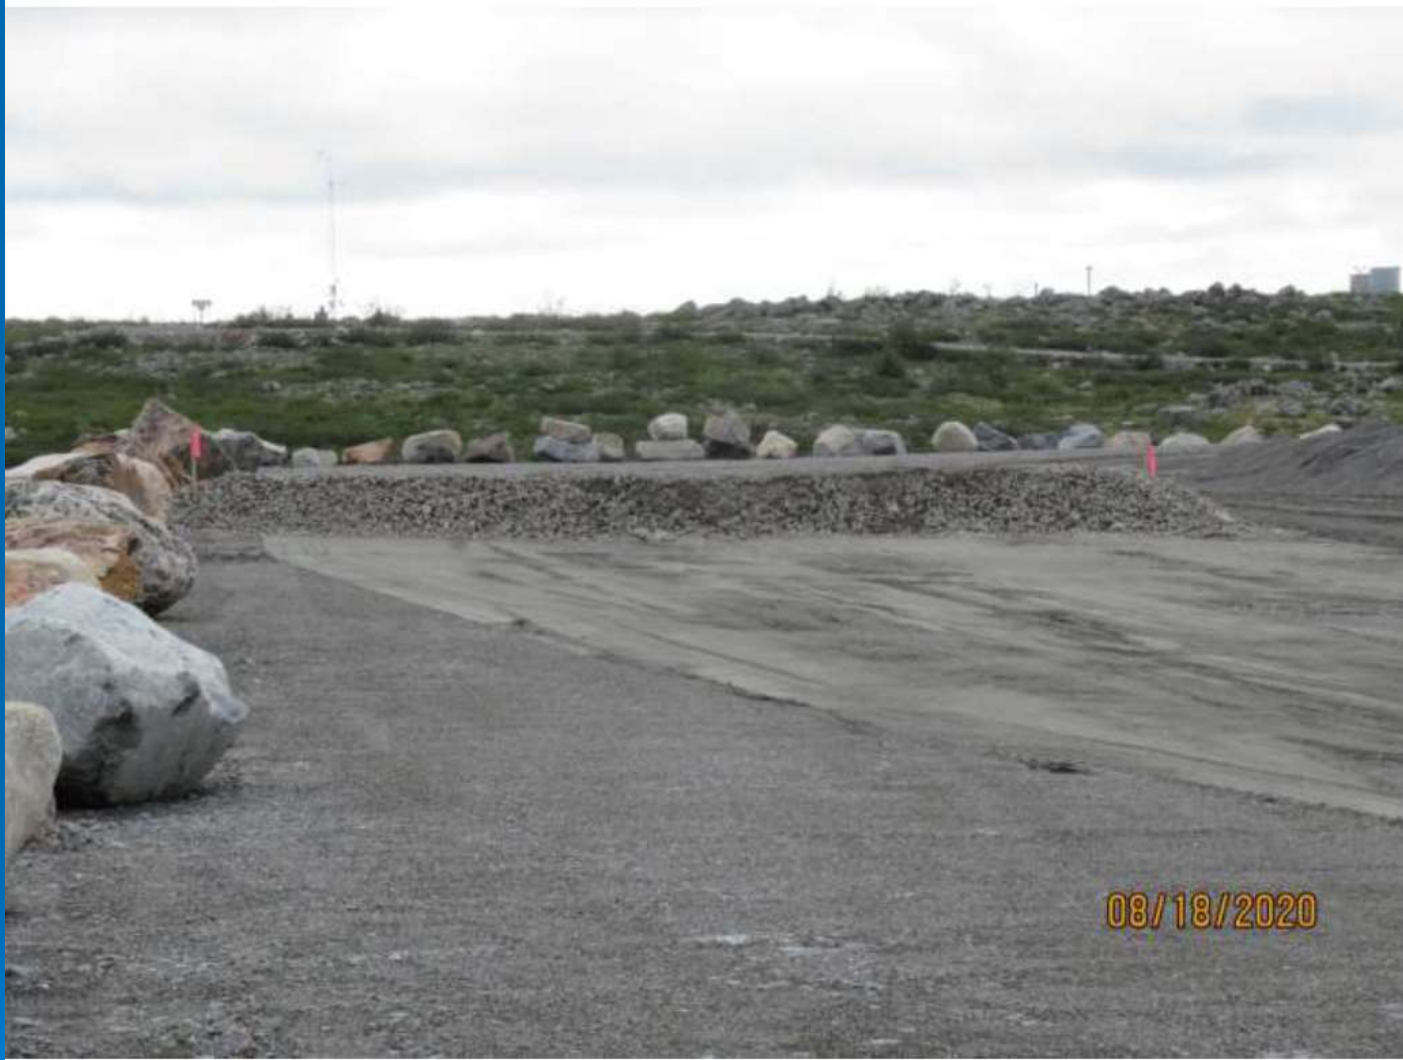
- North Pile Inspection:
  - On the North Pile, thermistors were installed in two locations to monitor ground temperatures and covered over with rock to protect them from the elements (Photos #1 & #2).
  - In addition to the installation of the thermistors, the Starter Cell perimeter embankments on the North Pile were buttressed with rock to ensure their stability (Photo#3).

Photo 1: Thermistors used to measure ground temperatures have been installed and covered over with rock on the North Pile to protect from the weather elements.

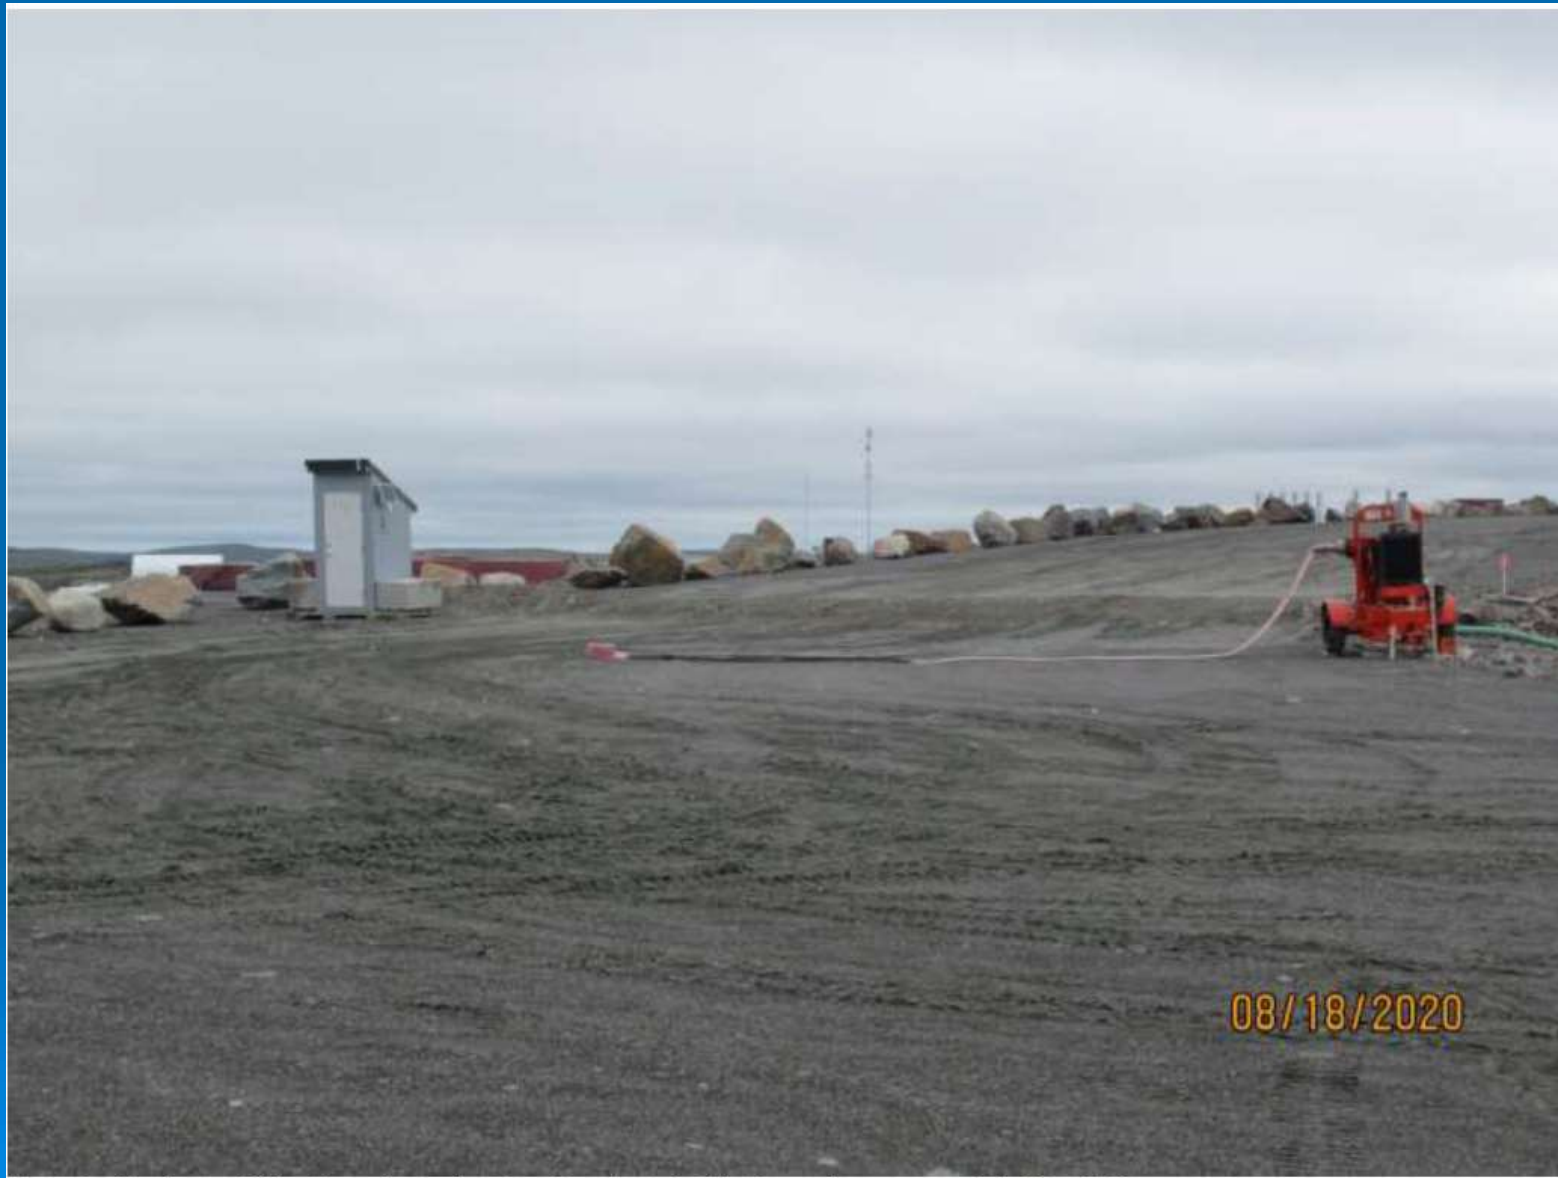
Photo 2: A look at addition thermistors that have been installed in the northwest area of the North Pile.

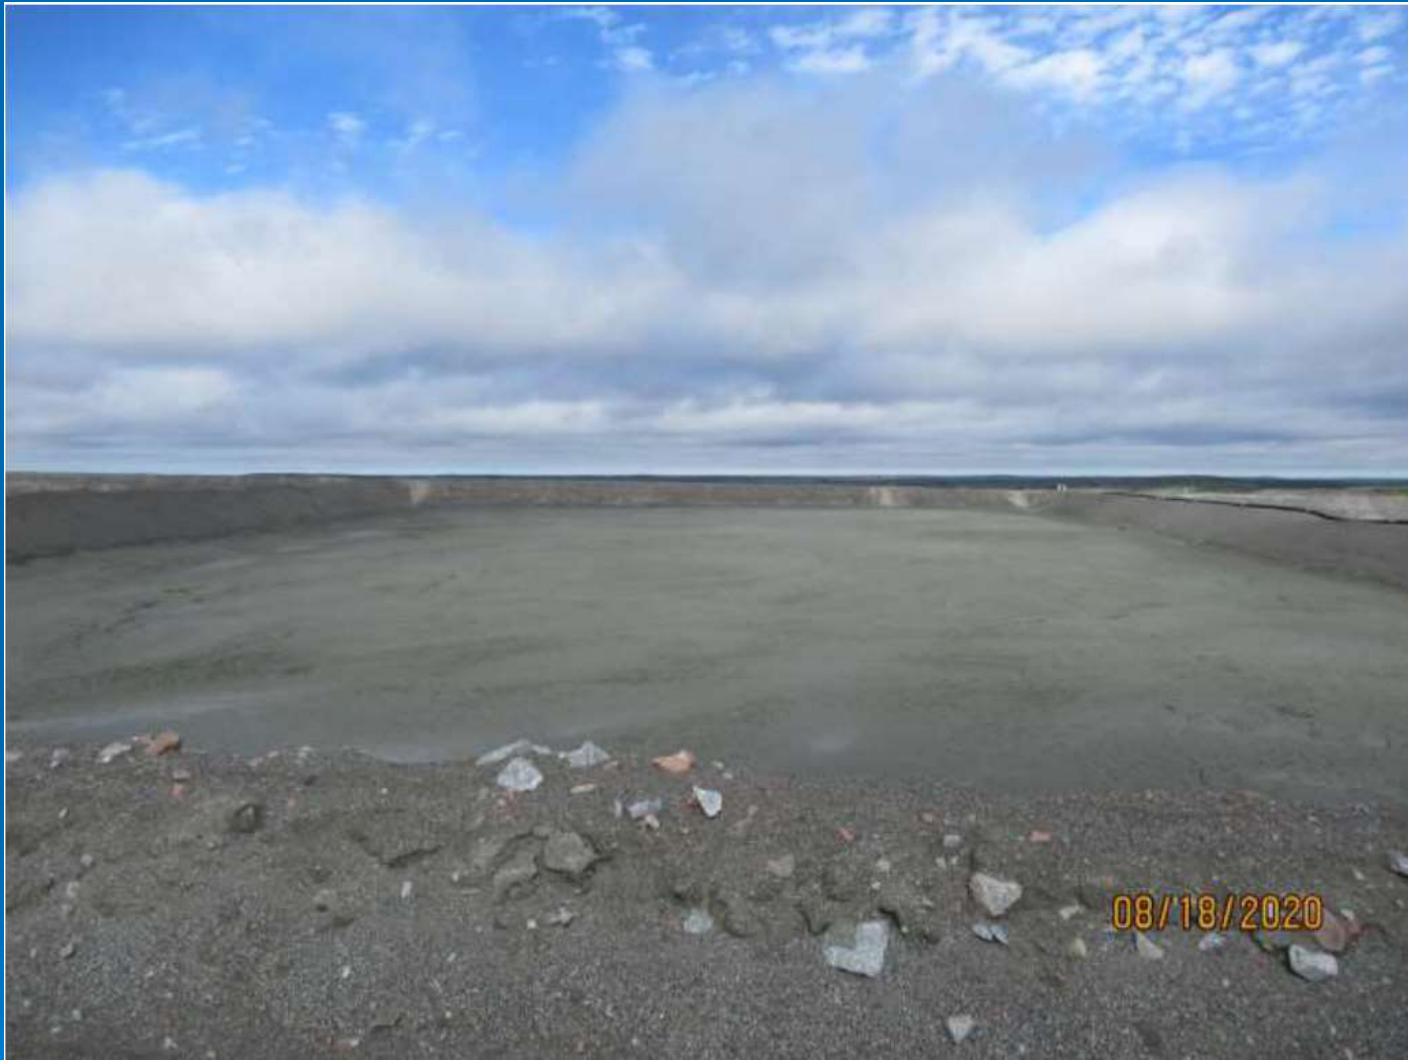
Photo 3: An example of reinforced embankments on the North Pile cells.

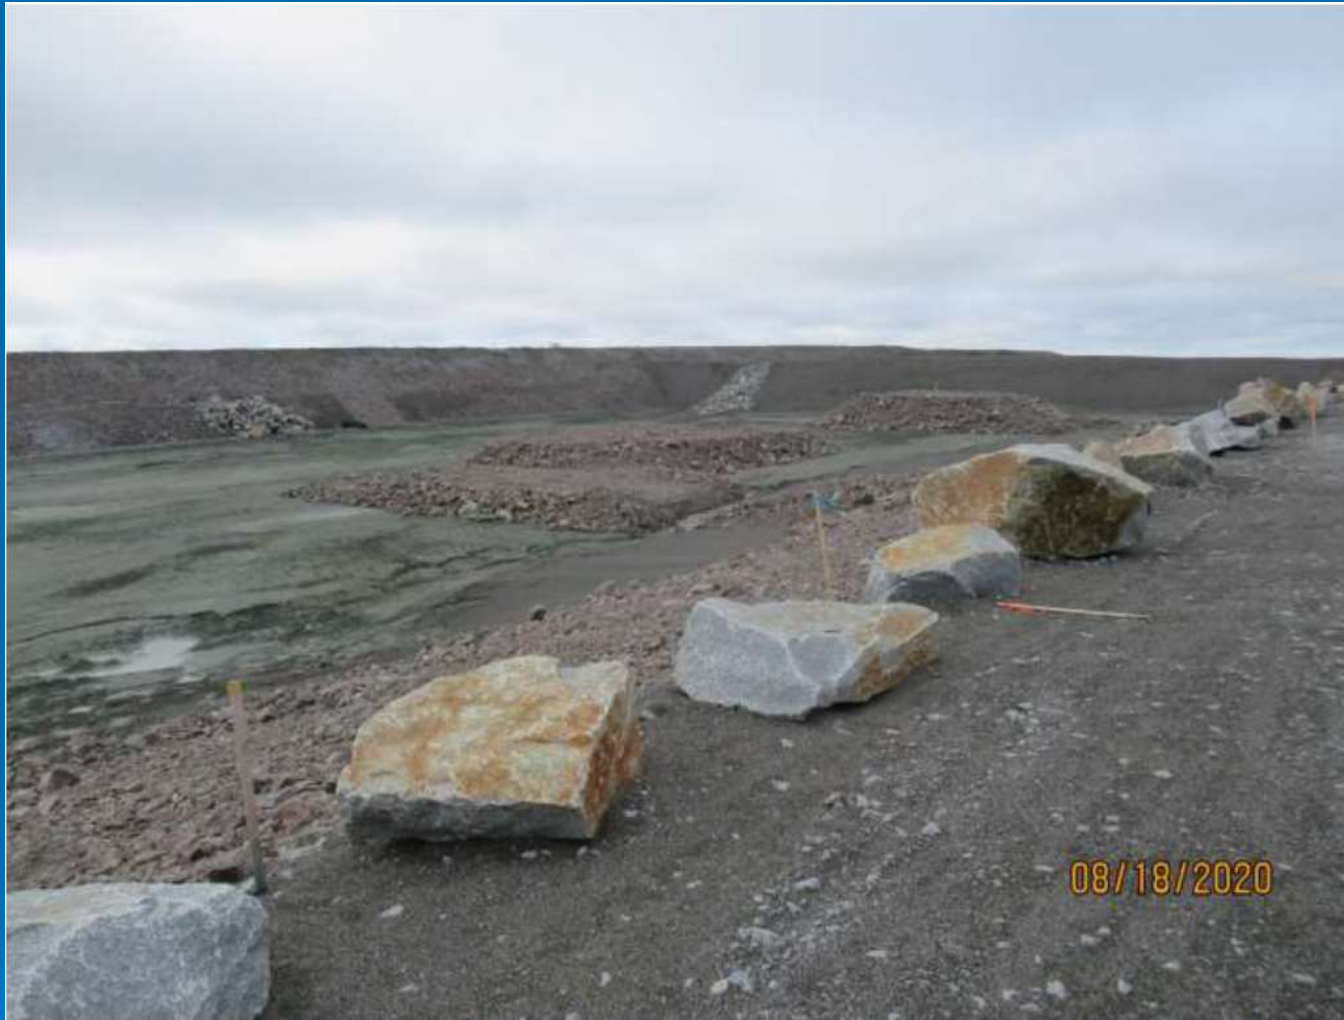
- Areas on the North Pile, such as roadways, were re-sloped to ensure proper drainage and to prevent the pooling of water.
- Other additional drainage structures were re-established such as the drainage culverts into the cells as seen in Photo #4.

Photo 4: Survey points within a cell on the North Pile. As seen, the majority of the water has been pumped out of the cells and culverts have been re-established to promote proper drainage.

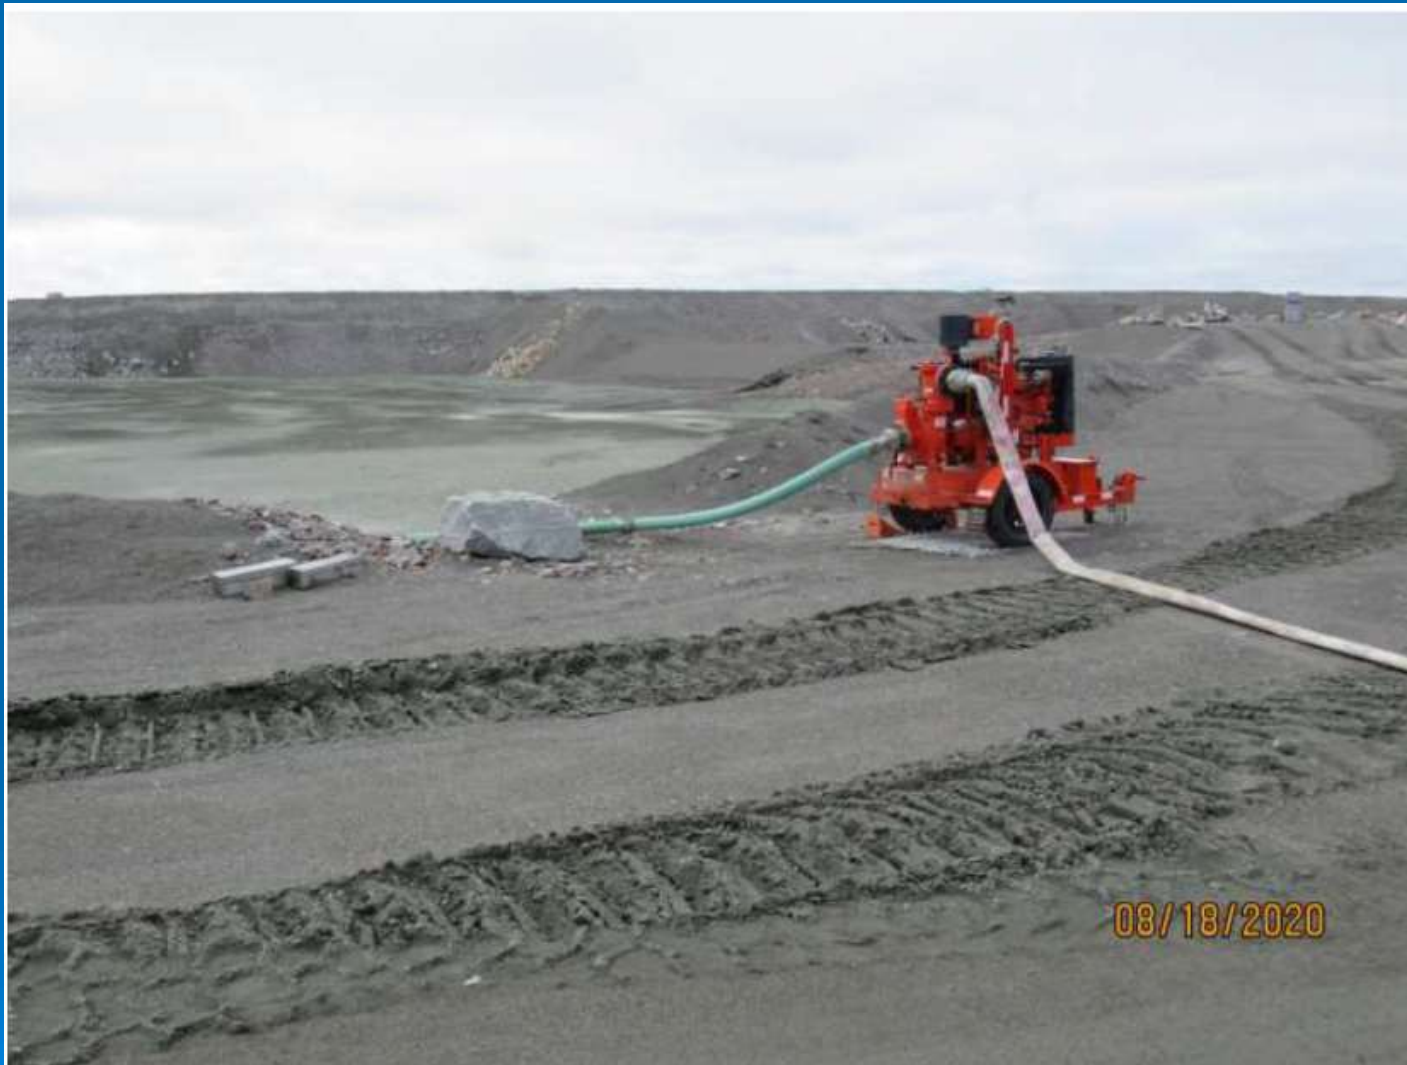
- North Pile Inspection:
  - As seen in Photo #5, the majority of water within the containment cells on the North Pile was pumped out and down into the North Pile sumps.
  - The pumping of water from the North Pile sump system to the Water Management Pond was ongoing and continued until the seasonal closure of the mine.
  - No concerns were noted regarding the pumping of water from the cells or the structural work that was completed during the Summer Season 2020 at the Snap Lake Mine North Pile

Photo 5: Pumps were set up along the North Pile perimeter and were pumping water down into the North Pile sump system.

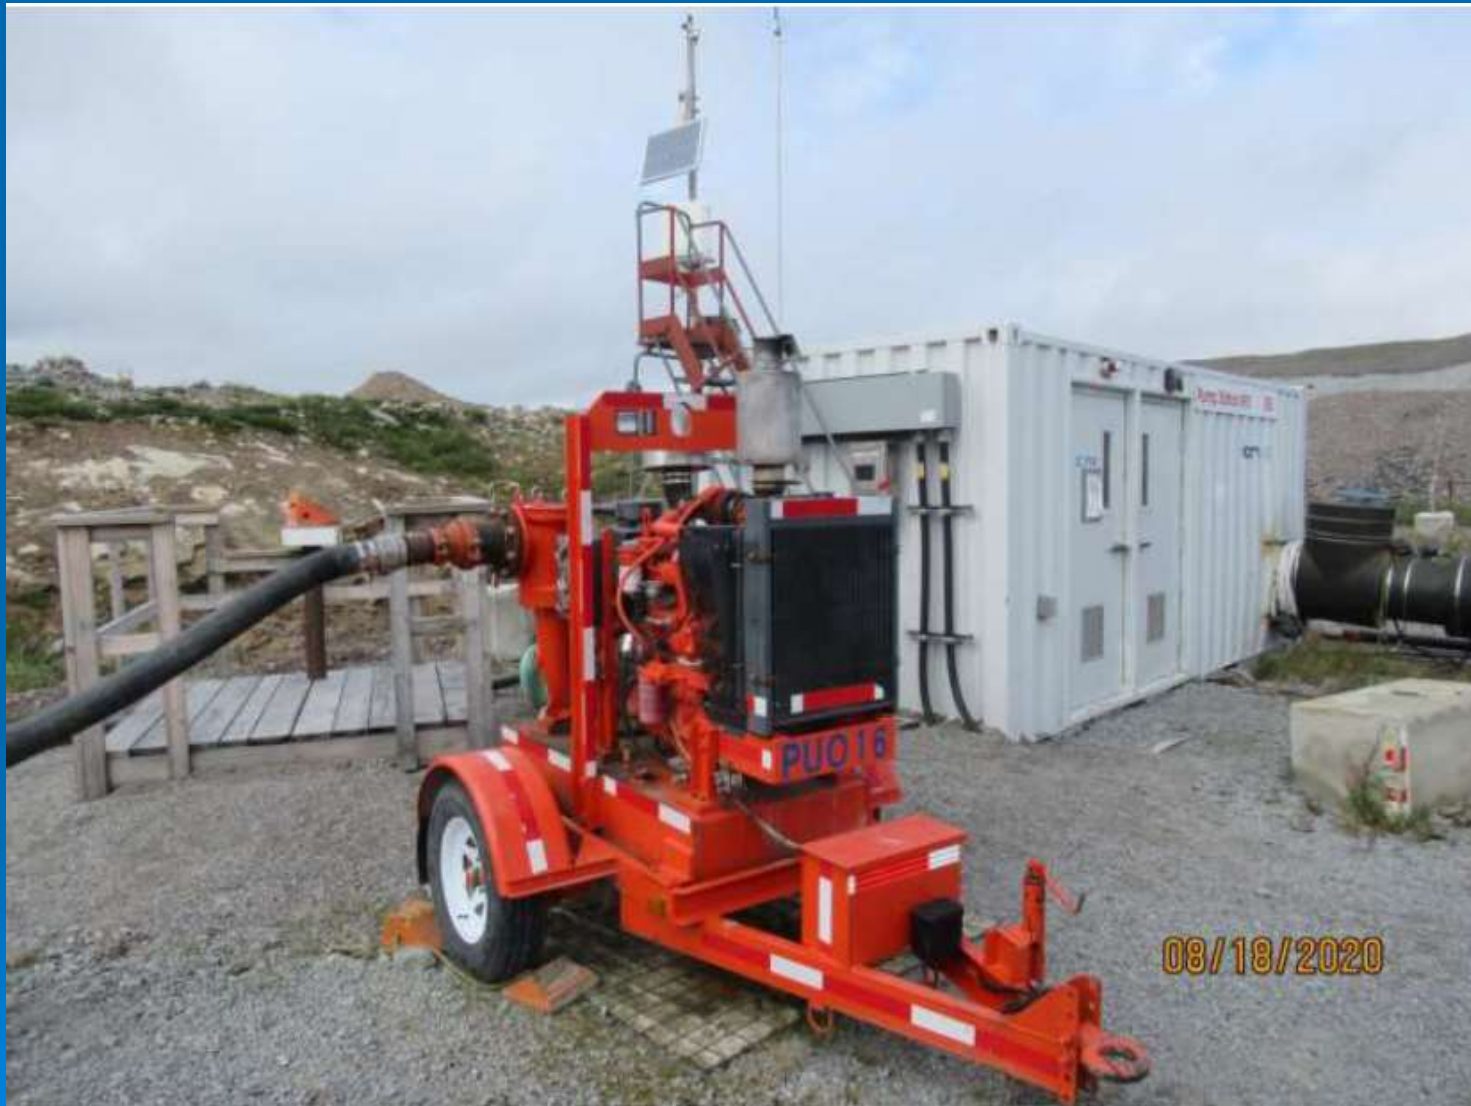
Photo 6: A mobile pump was set-up at the North Pile Sump #1 and was pumping water clear of the sump to ensure over-winter capacities.

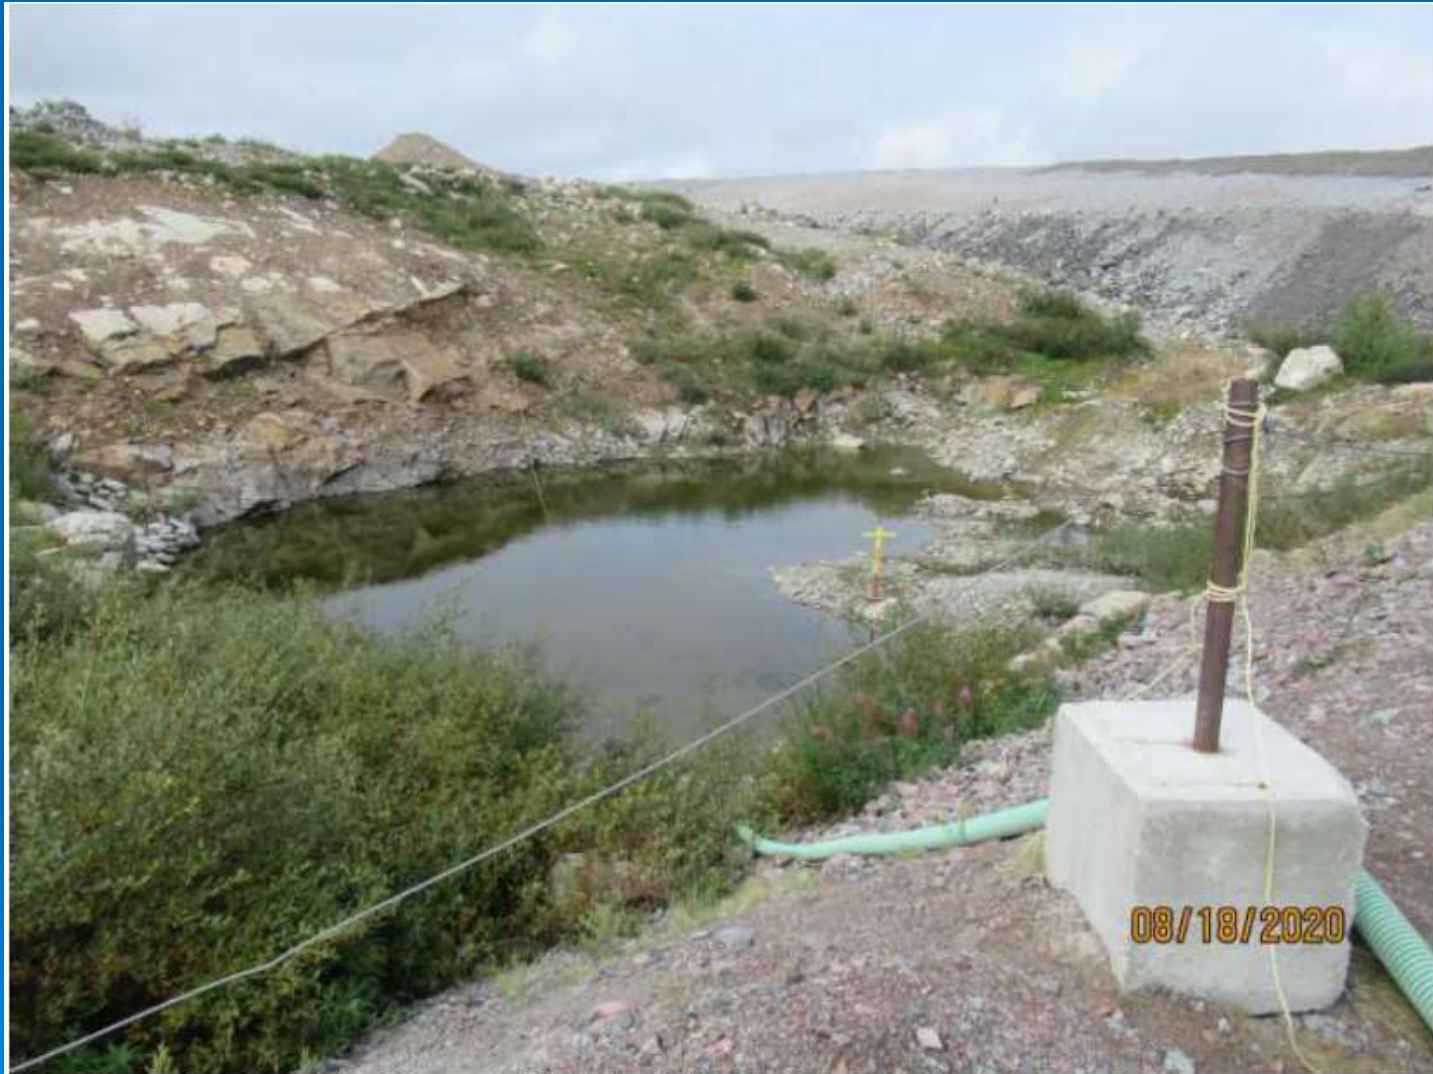
Photo 7: As seen here, the majority of the water within the North Pile Sump #1 was pumped out.

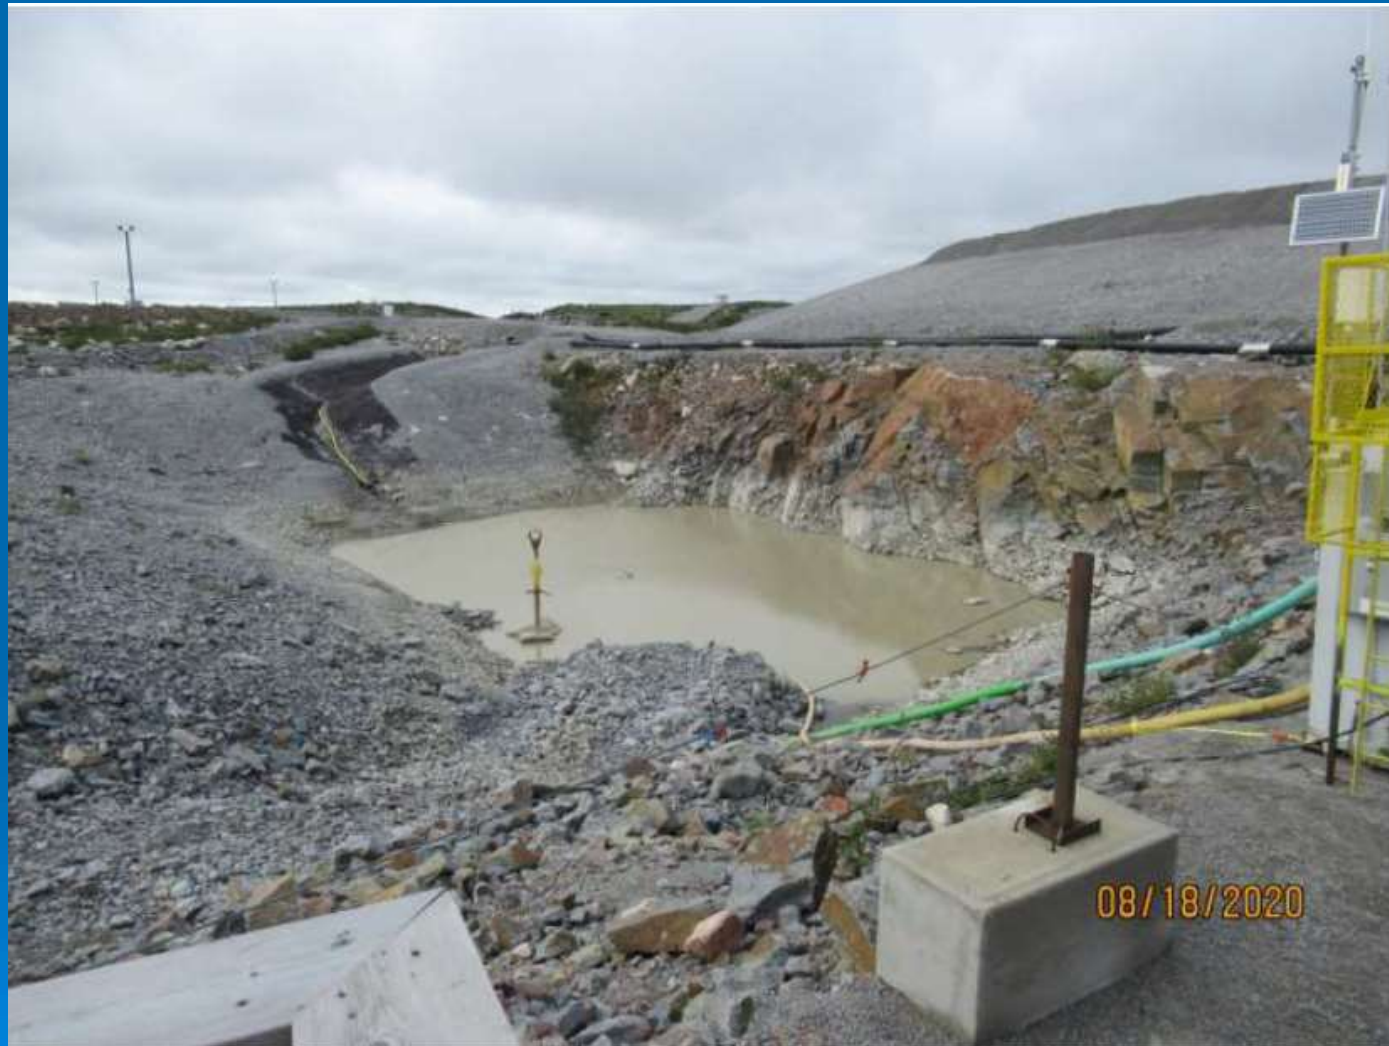
Photo 8: Water levels within Sump #2 were minimal and capacity was made available for the Winter & Spring freshet 2021.

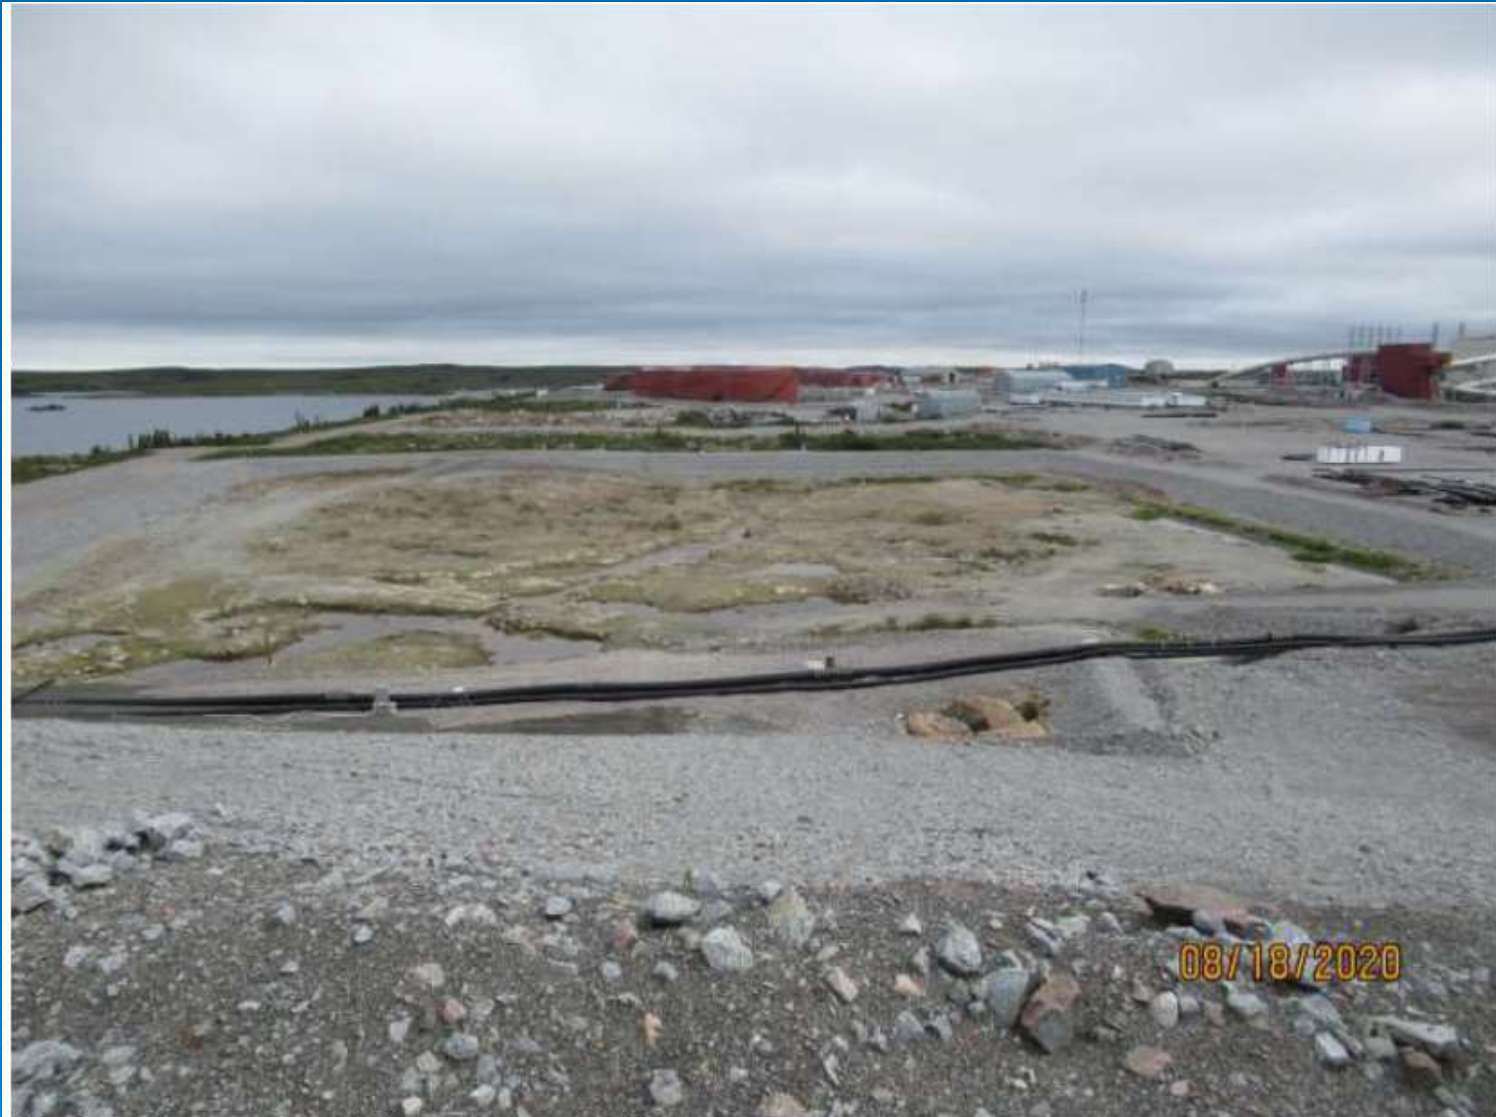
Photo 9: Looking east at Sump #3. The sump was pumped clear of water.

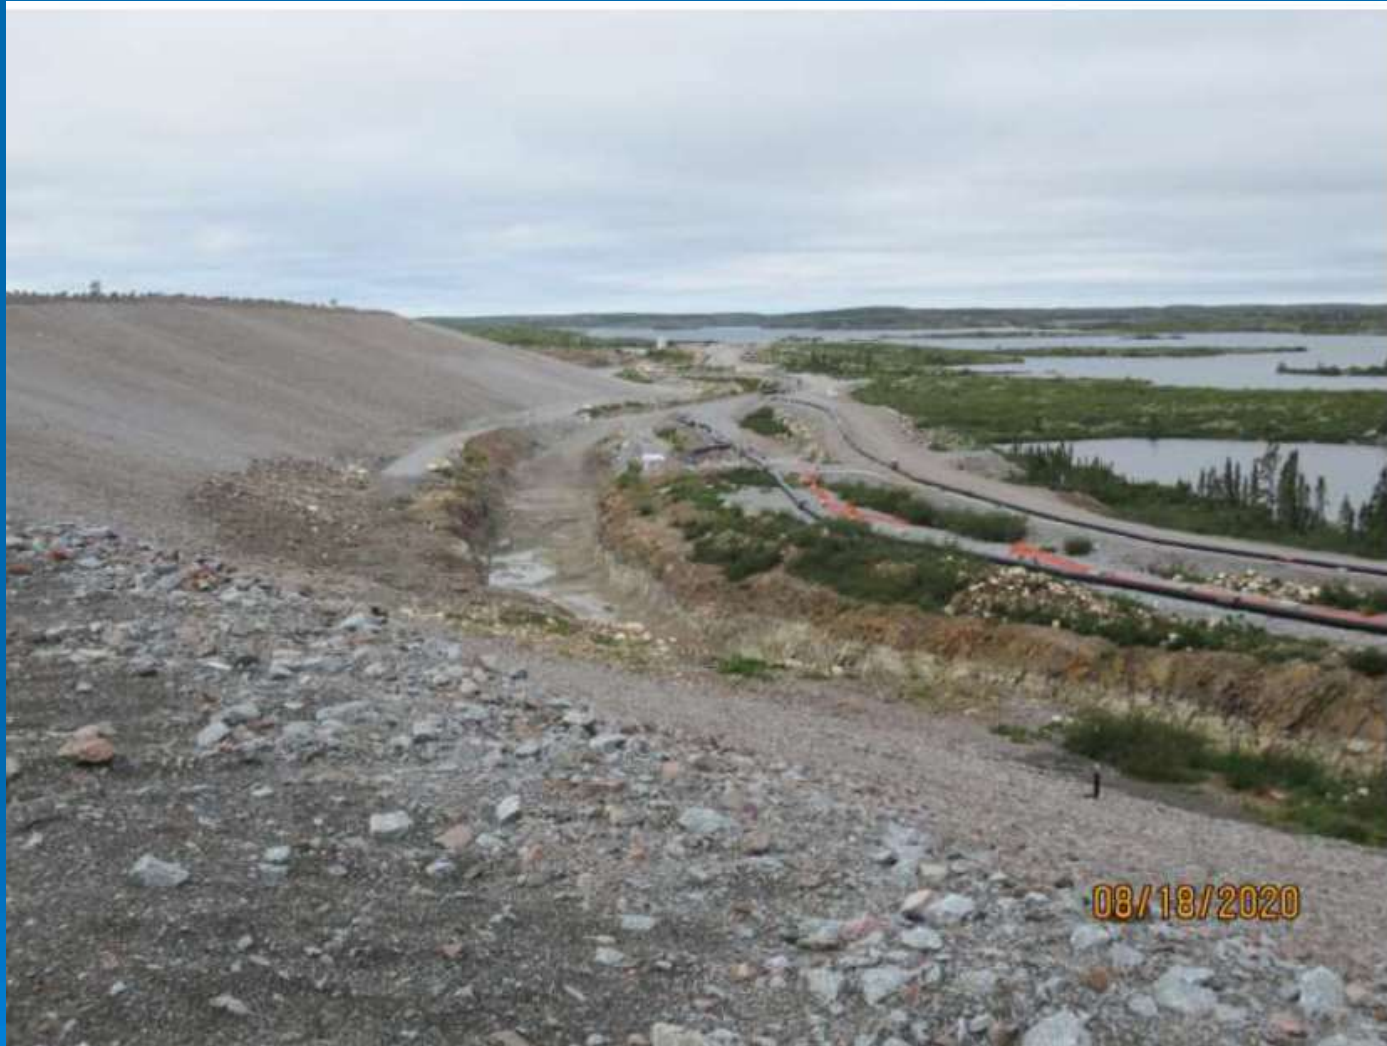
Photo 10: Looking west at the Sump #4 pumphouse and sump.

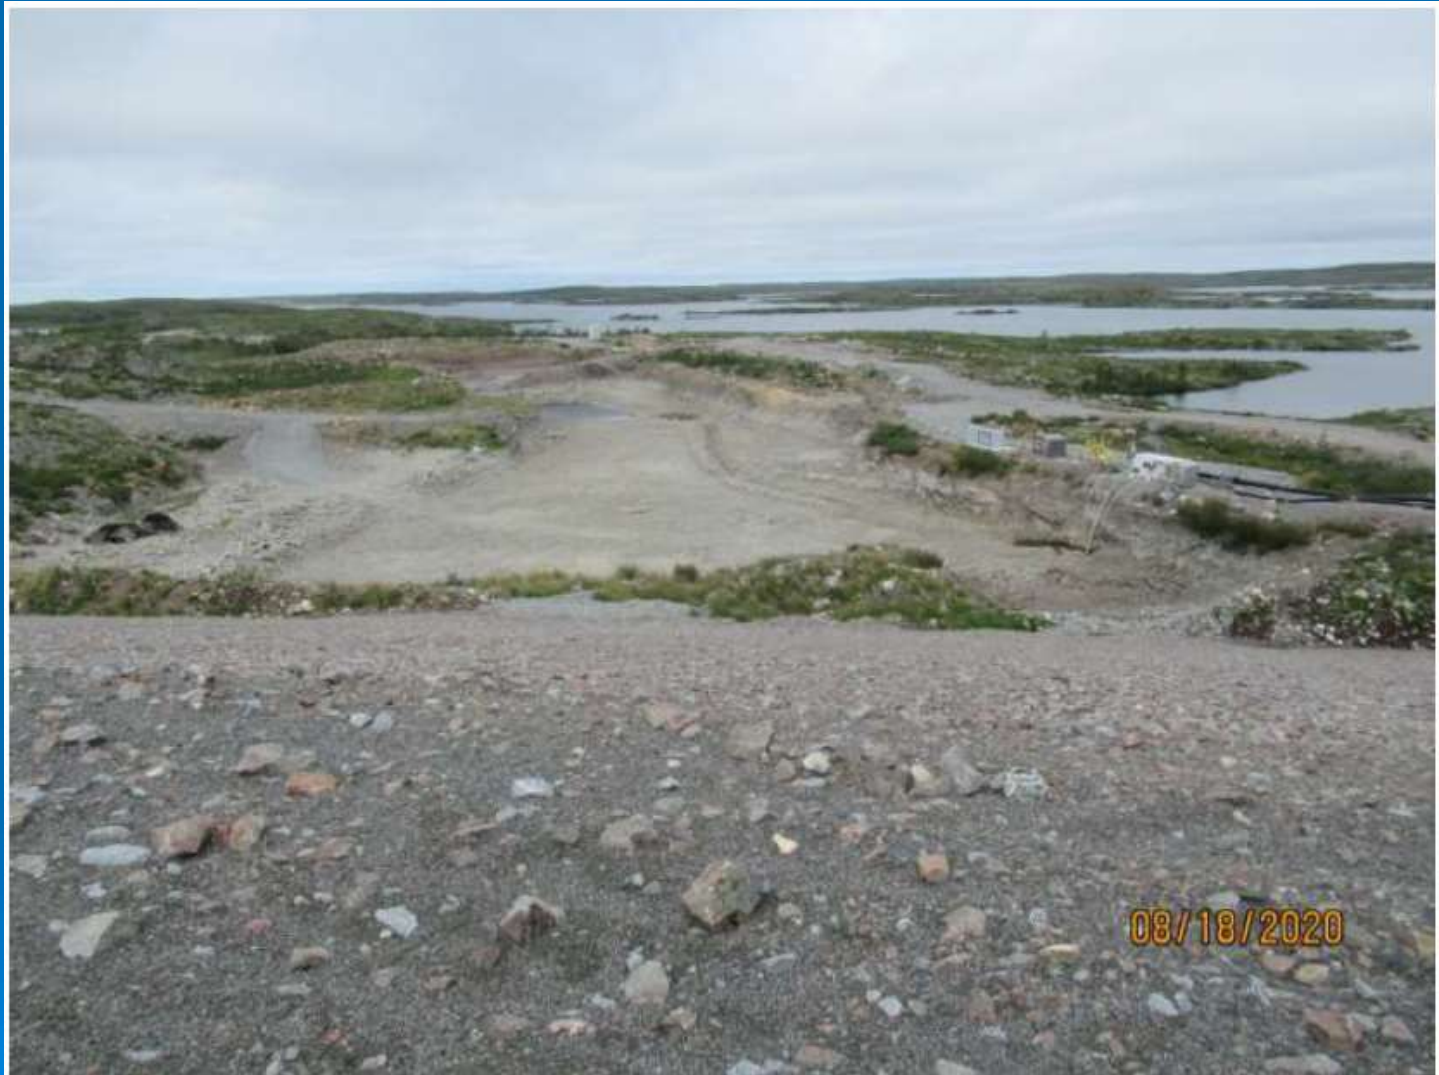
Photo 11: Looking west at Sump #5.

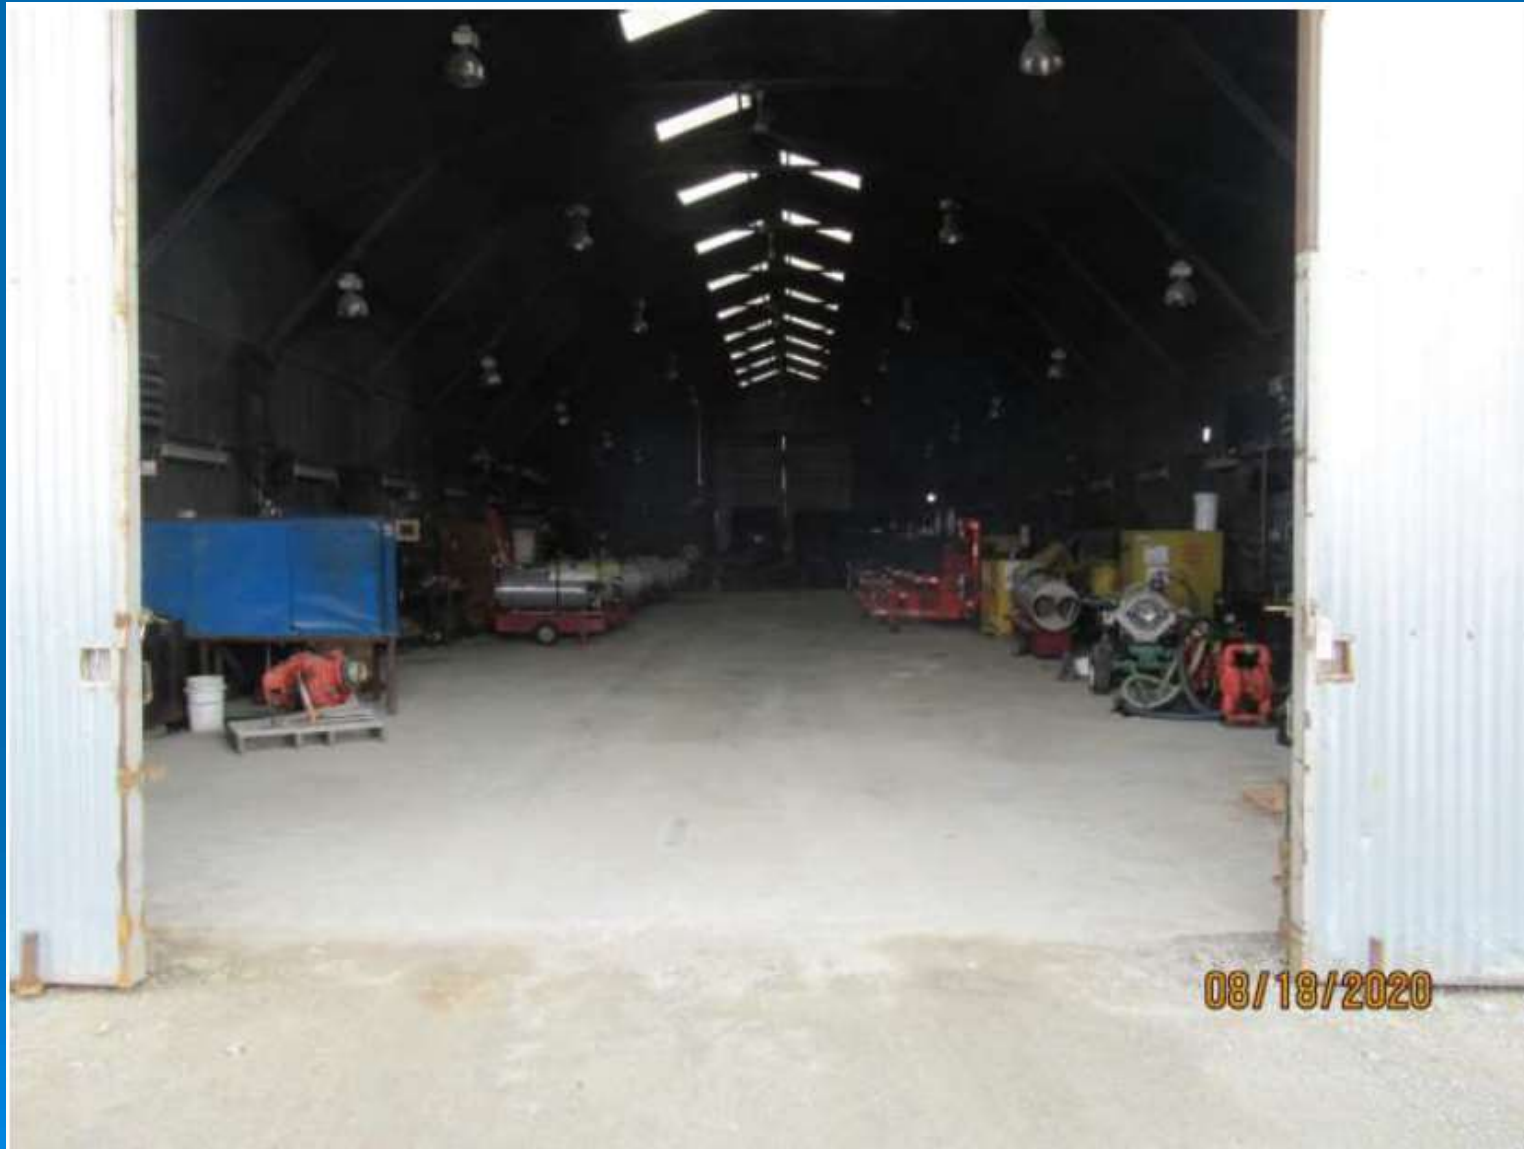
Photo 12: Equipment such as frost fighters and pumps were being staged indoors at the Mechanical Shop #2.

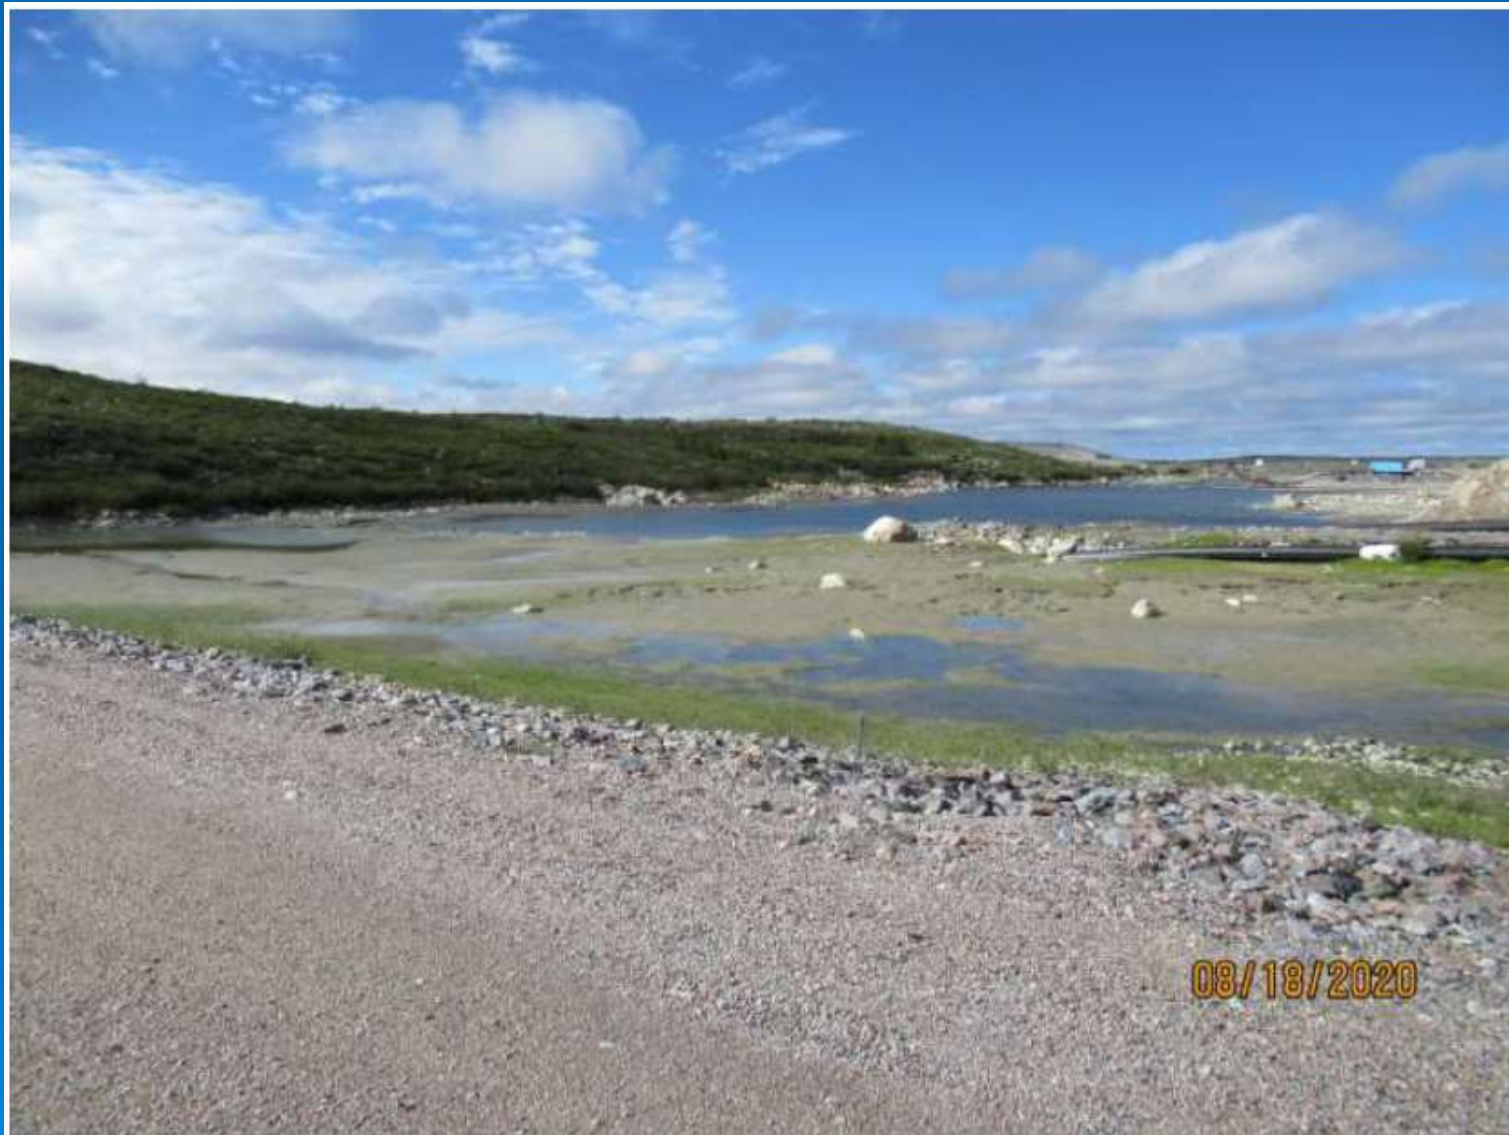
Photo 13: Looking north at the mine Water Management Pond. The pond was being pumped clear to ensure capacity over-winter.

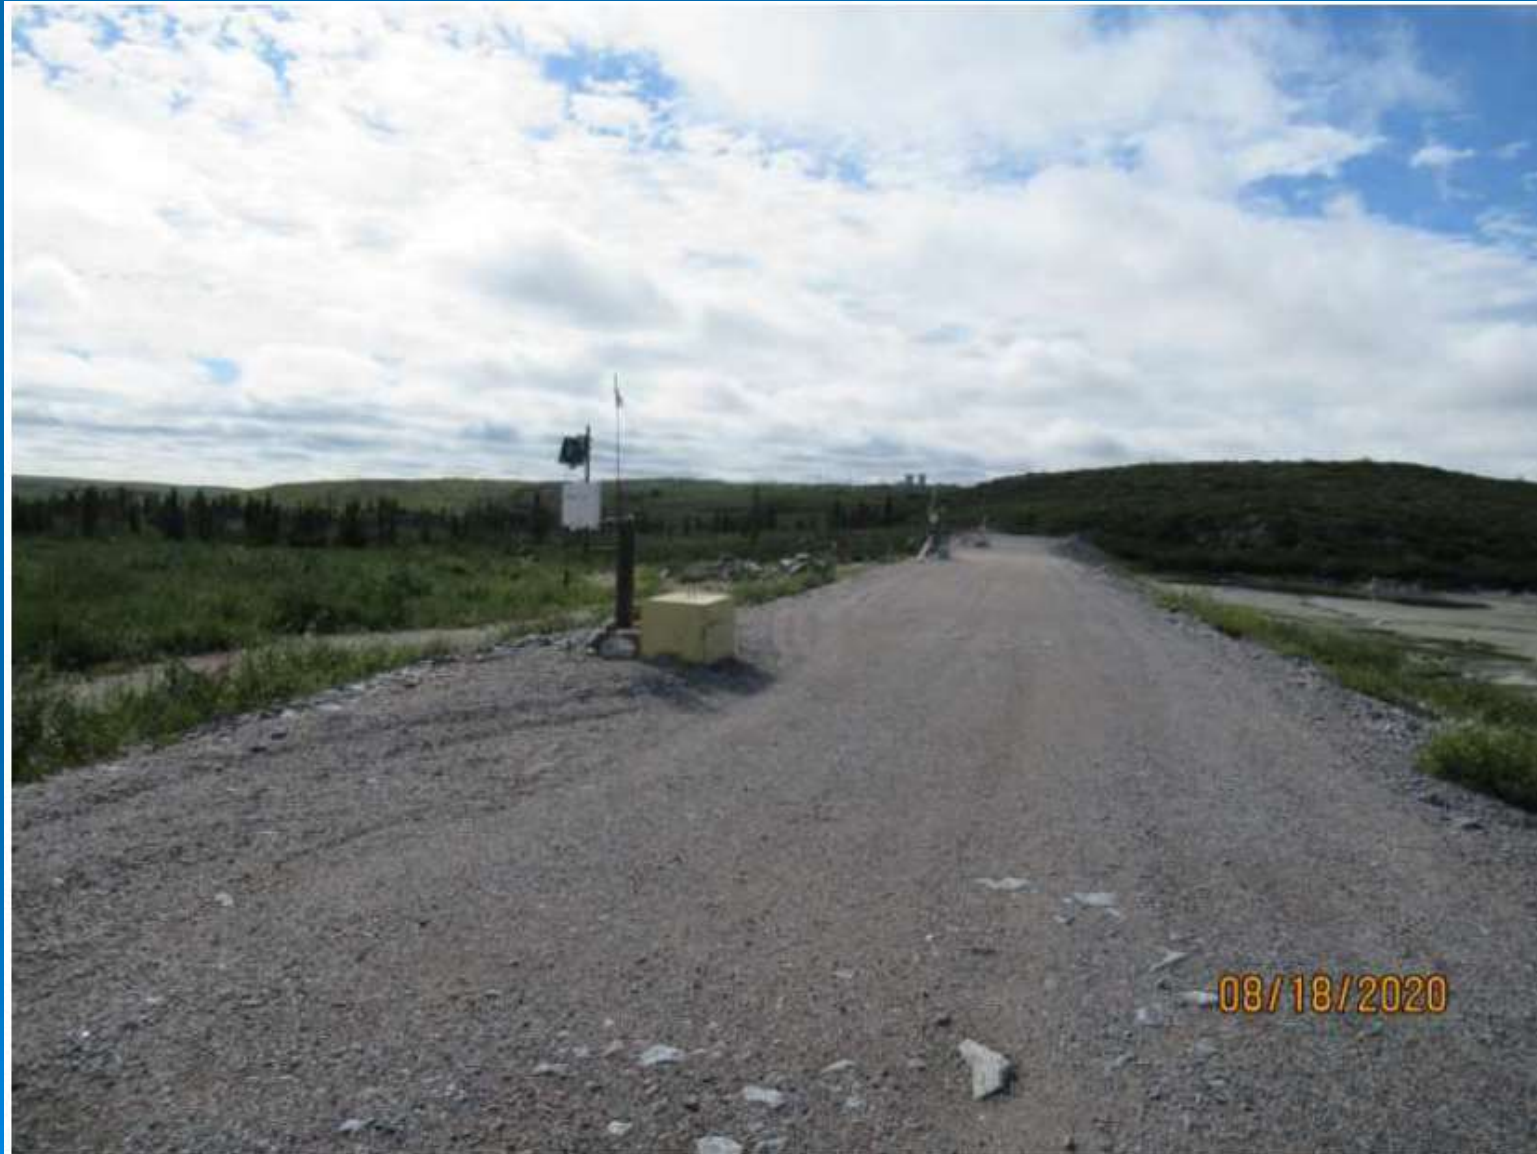
Photo 14: Looking west along the WMP containment dyke and cameras that will be used for the winter monitoring program.
