# July & August 2020 Environmental Update for SLEMA Board

September 1, 2020

### ➤ **August 18 GNWT Inspection Report**

An Inspection of the Snap Lake Diamond Mine Project was conducted by Inspector Joe Heron on August 18, 2020;

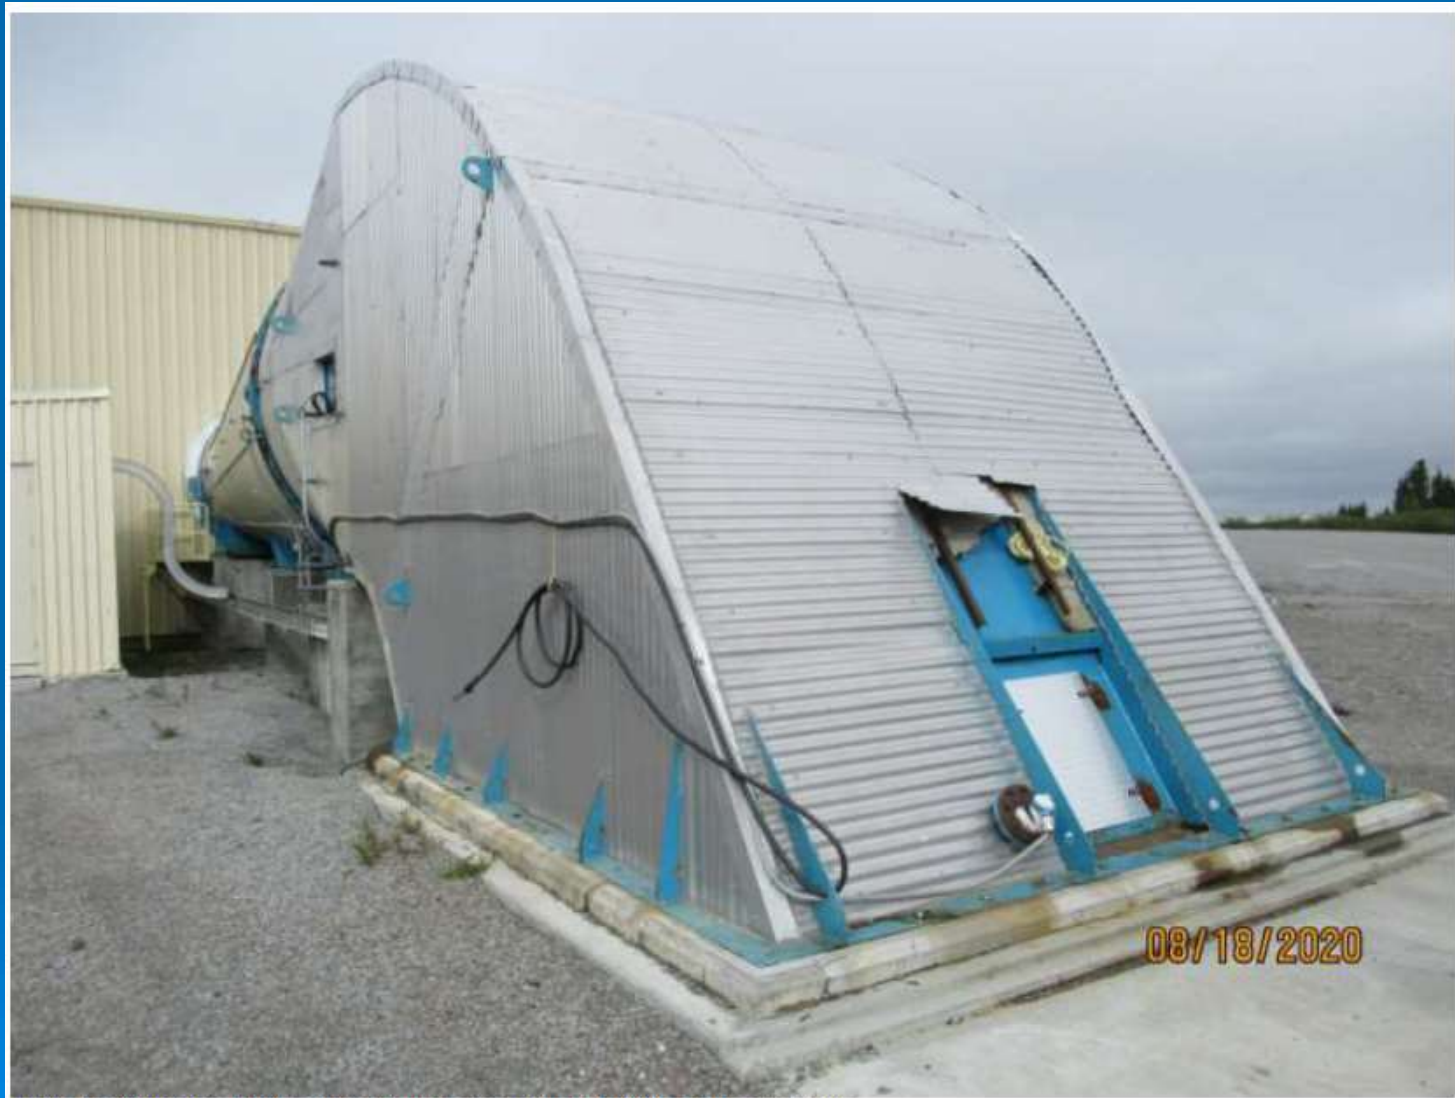
Photo 15: Water levels in the underground are monitored at this FAR access vent.

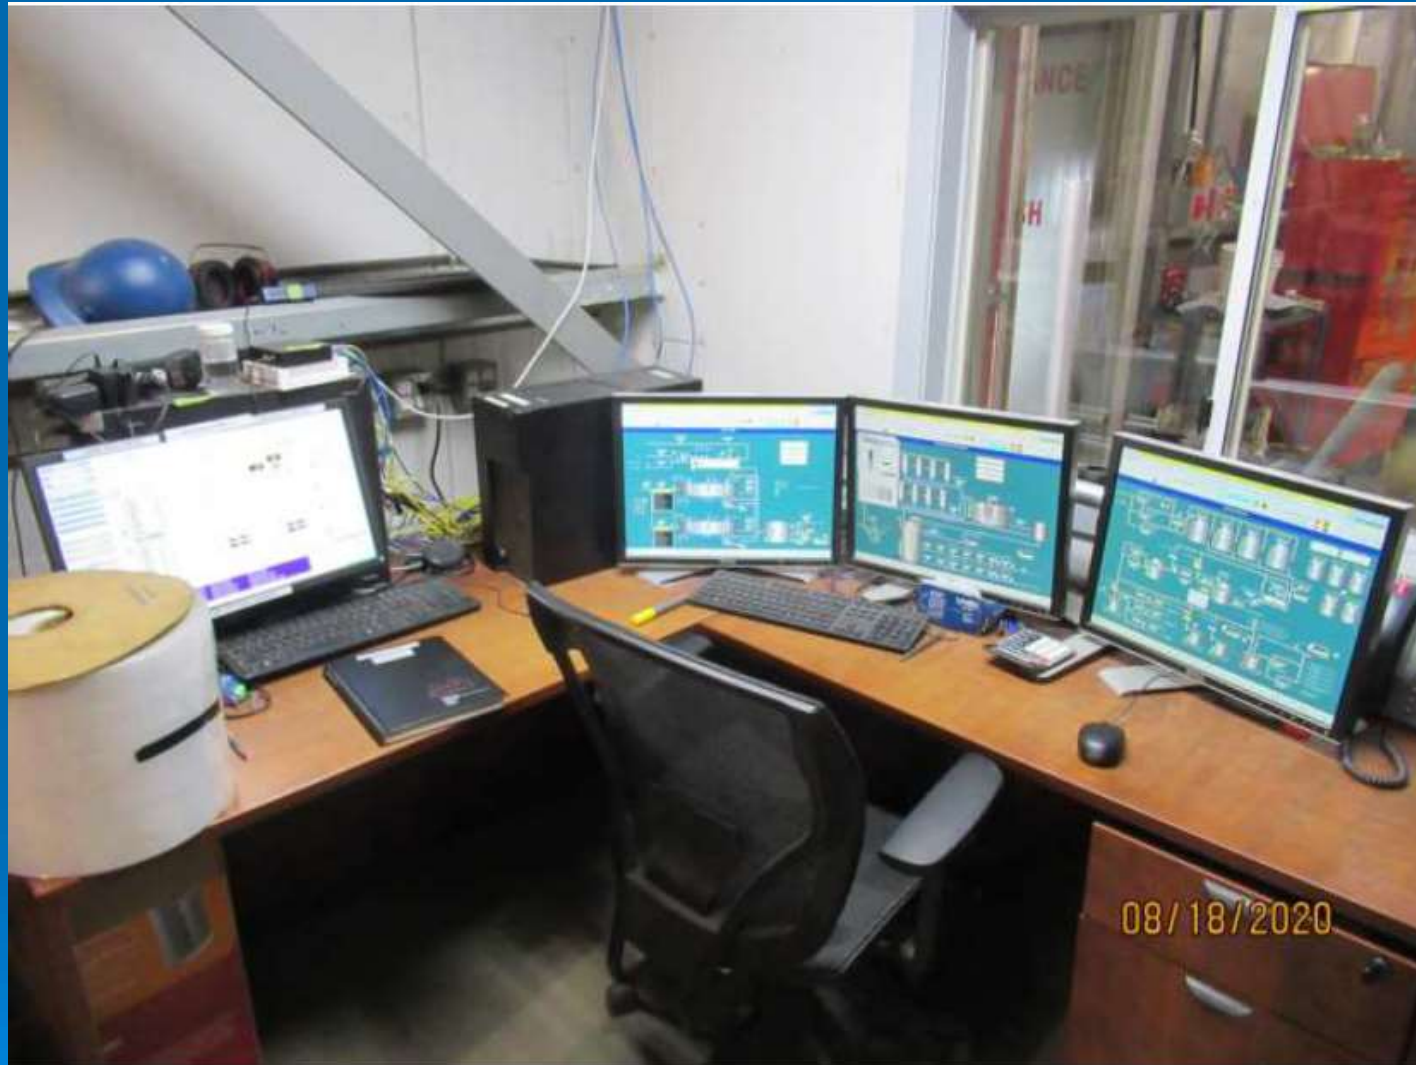
Photo 16: The mine Water Treatment Plant control area.

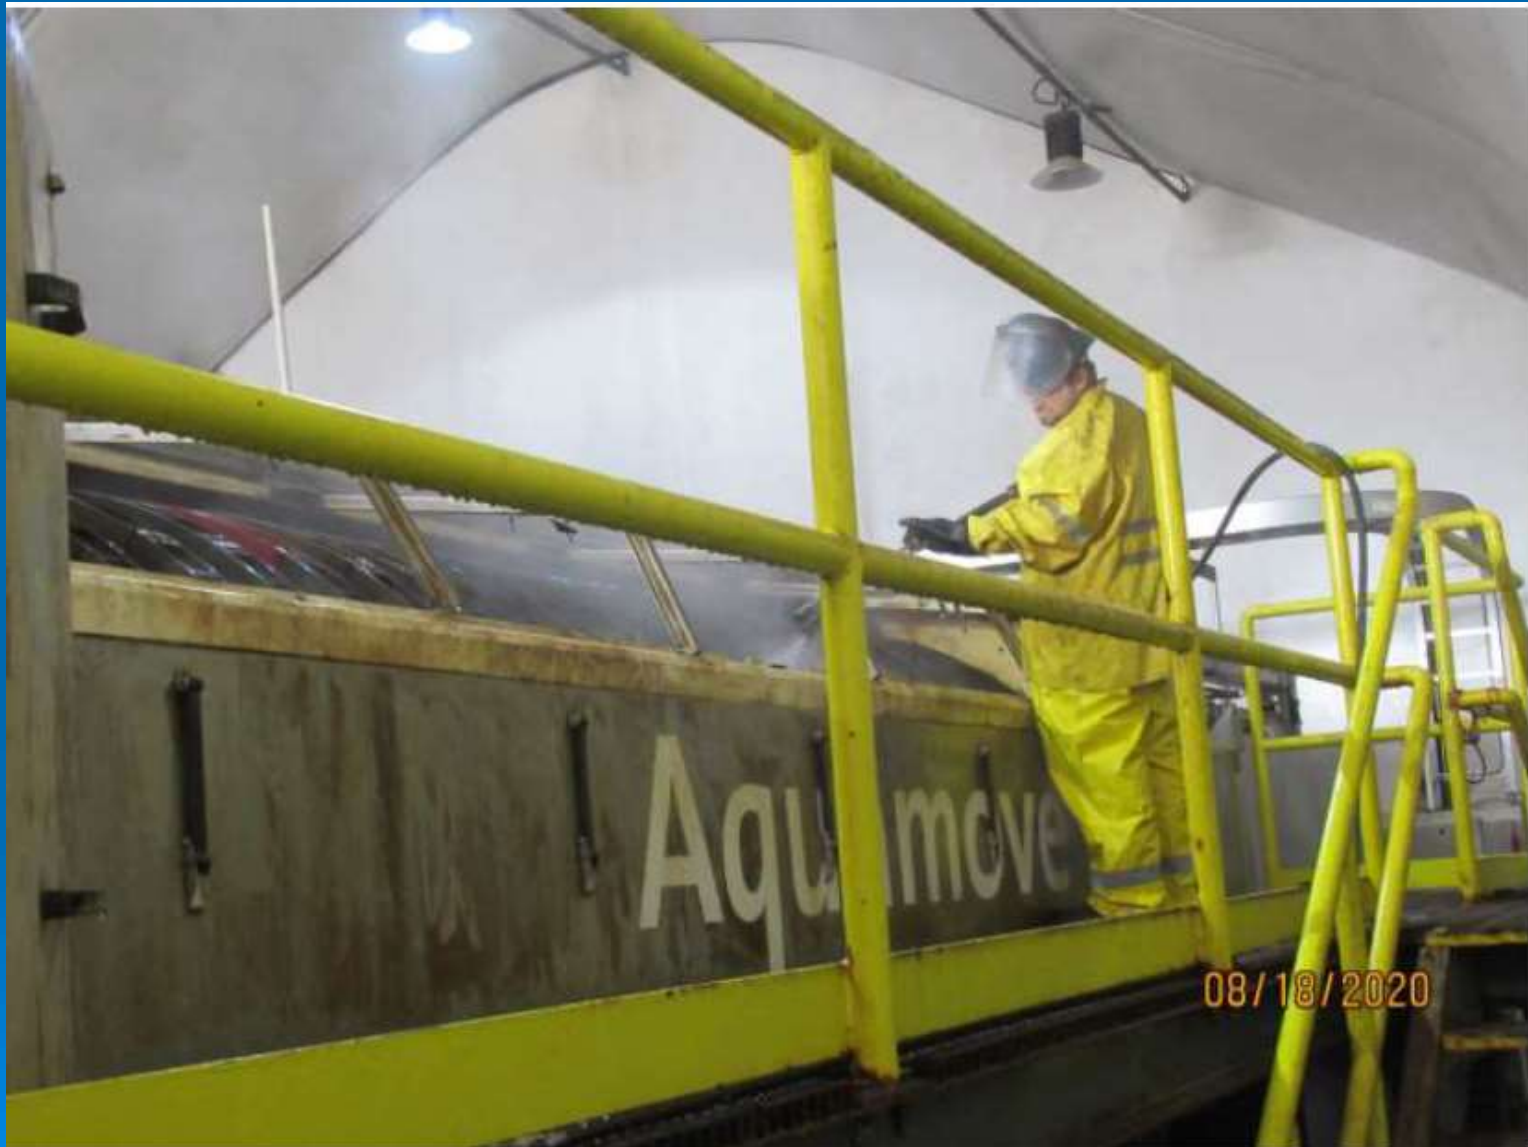
Photo 17: Crews were pressure washing the WTP disc filters prior to disassembly.

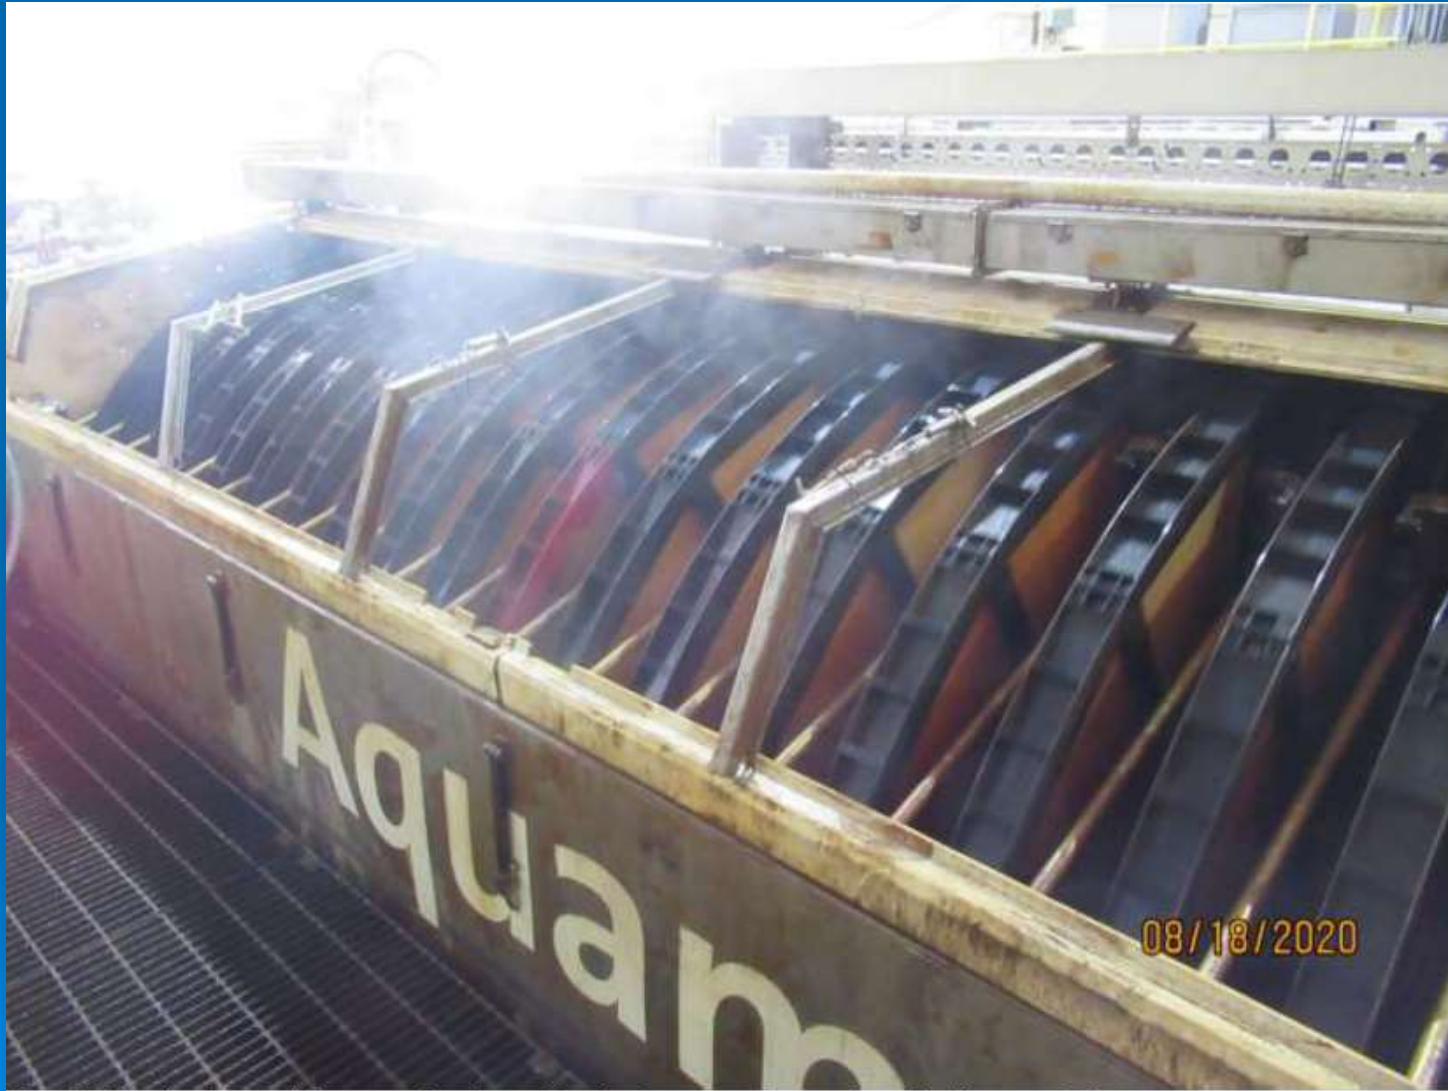
Photo 18: The disc filters will be removed and staged for the winter once they are cleaned with pressurized water.

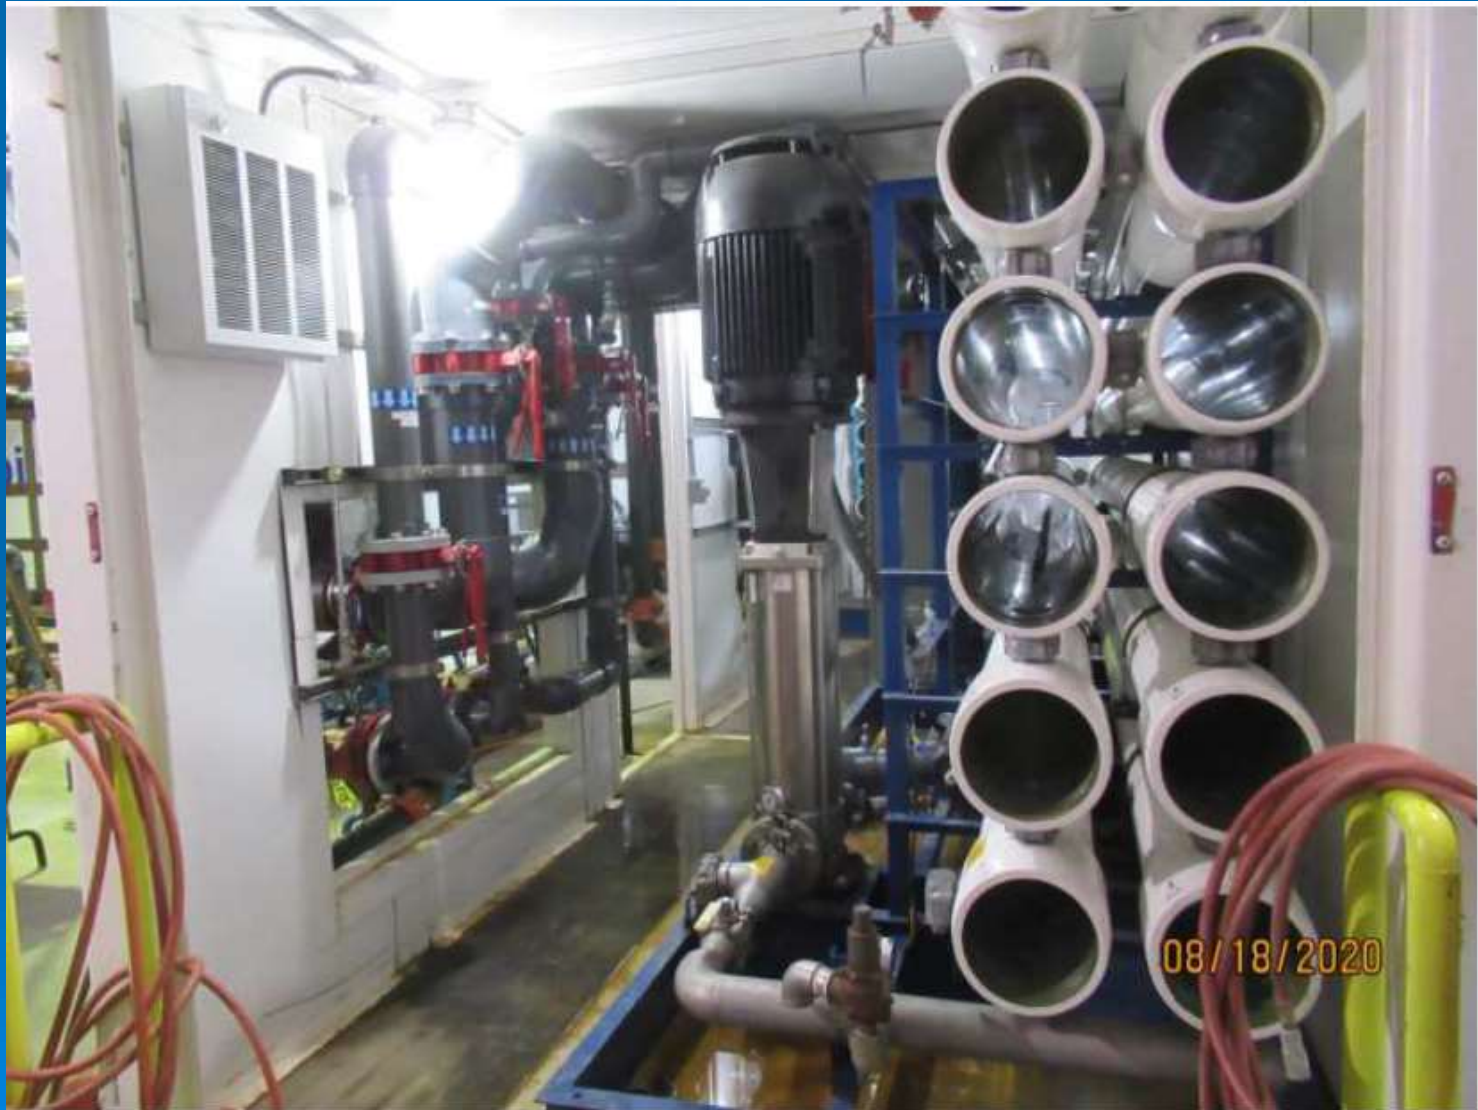
Photo 19: The filters have been removed from the reverse osmosis filtration unit as part of the seasonal shutdown.

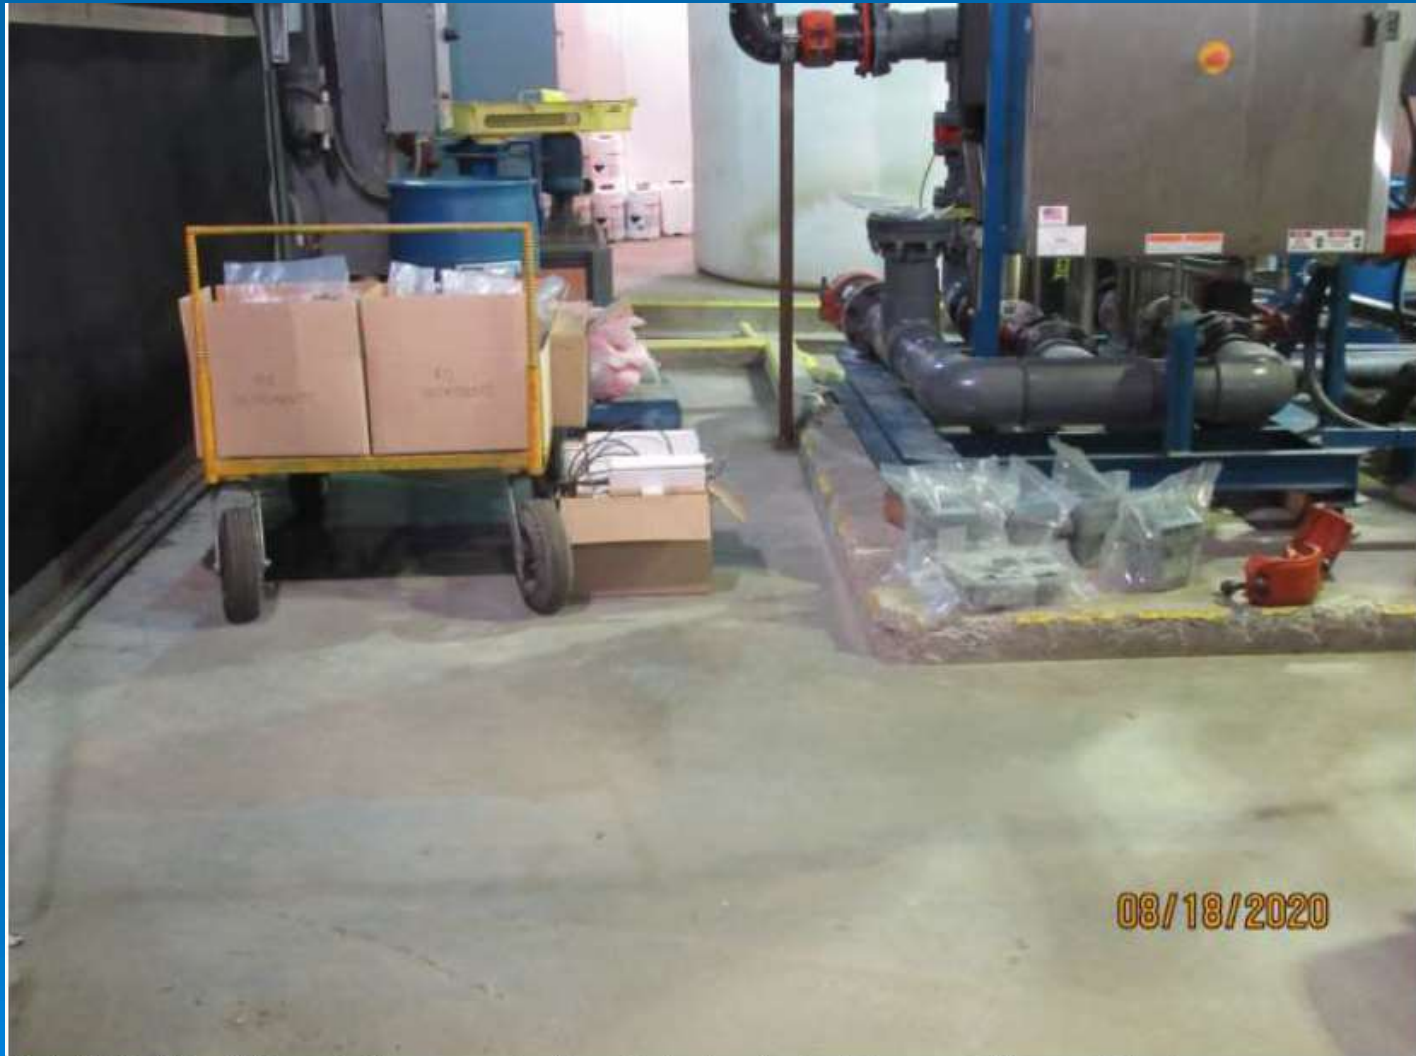
Photo 20: The RO unit filters and other components of the water treatment system being prepared for over-winter storage.

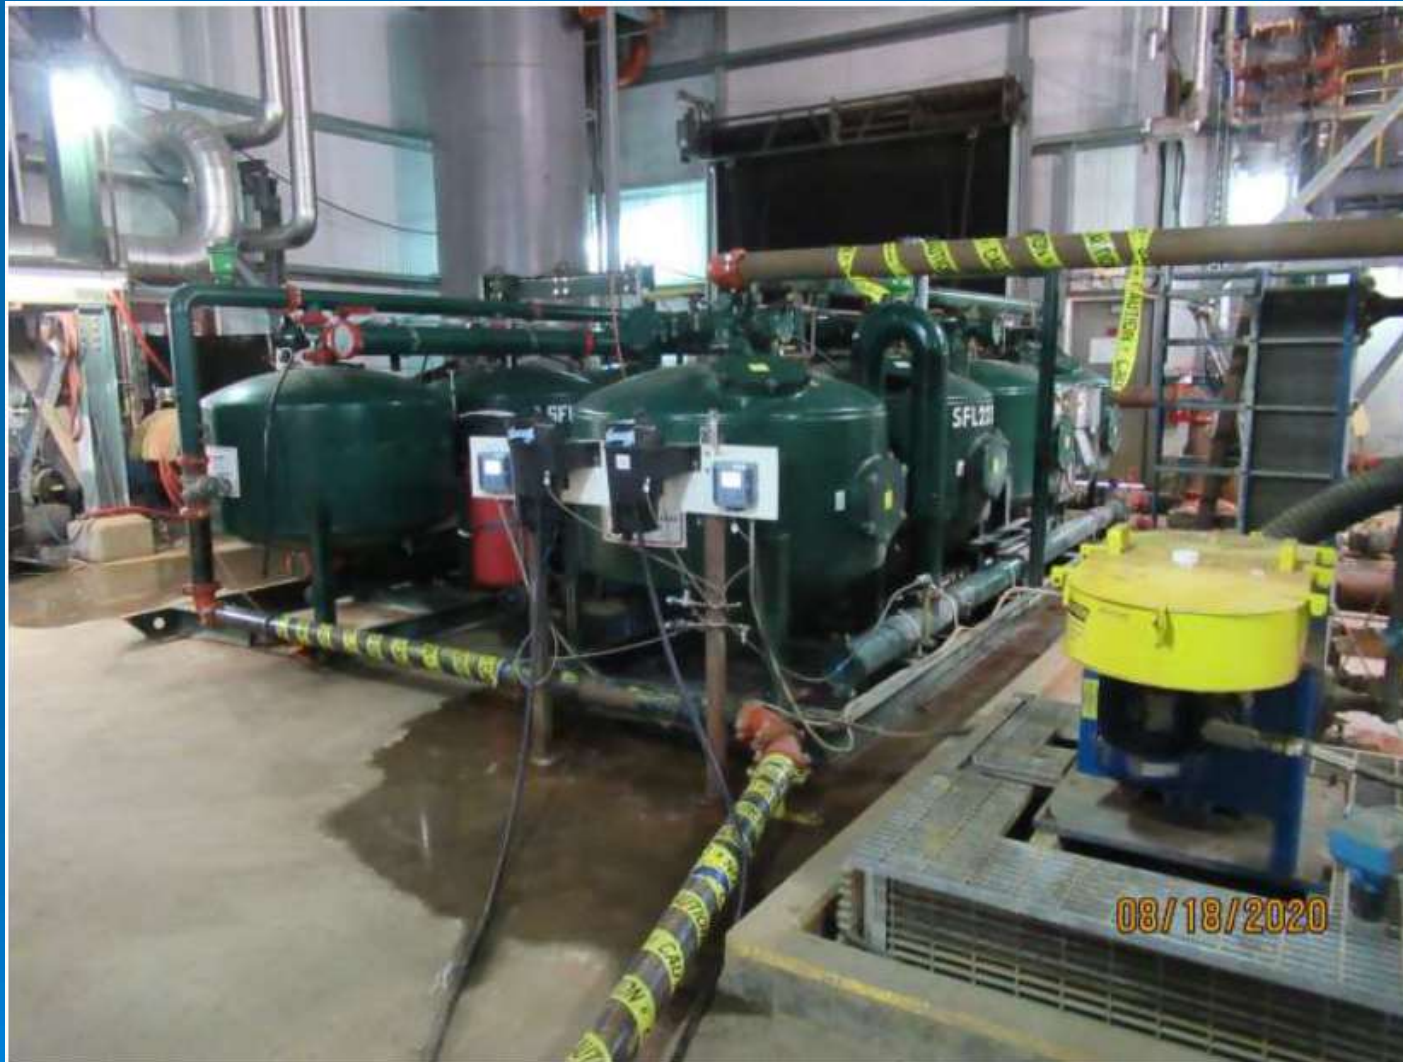
Photo 21: Water reports to these pressure filters, then to the pH tank and is eventually is discharged into Snap Lake.

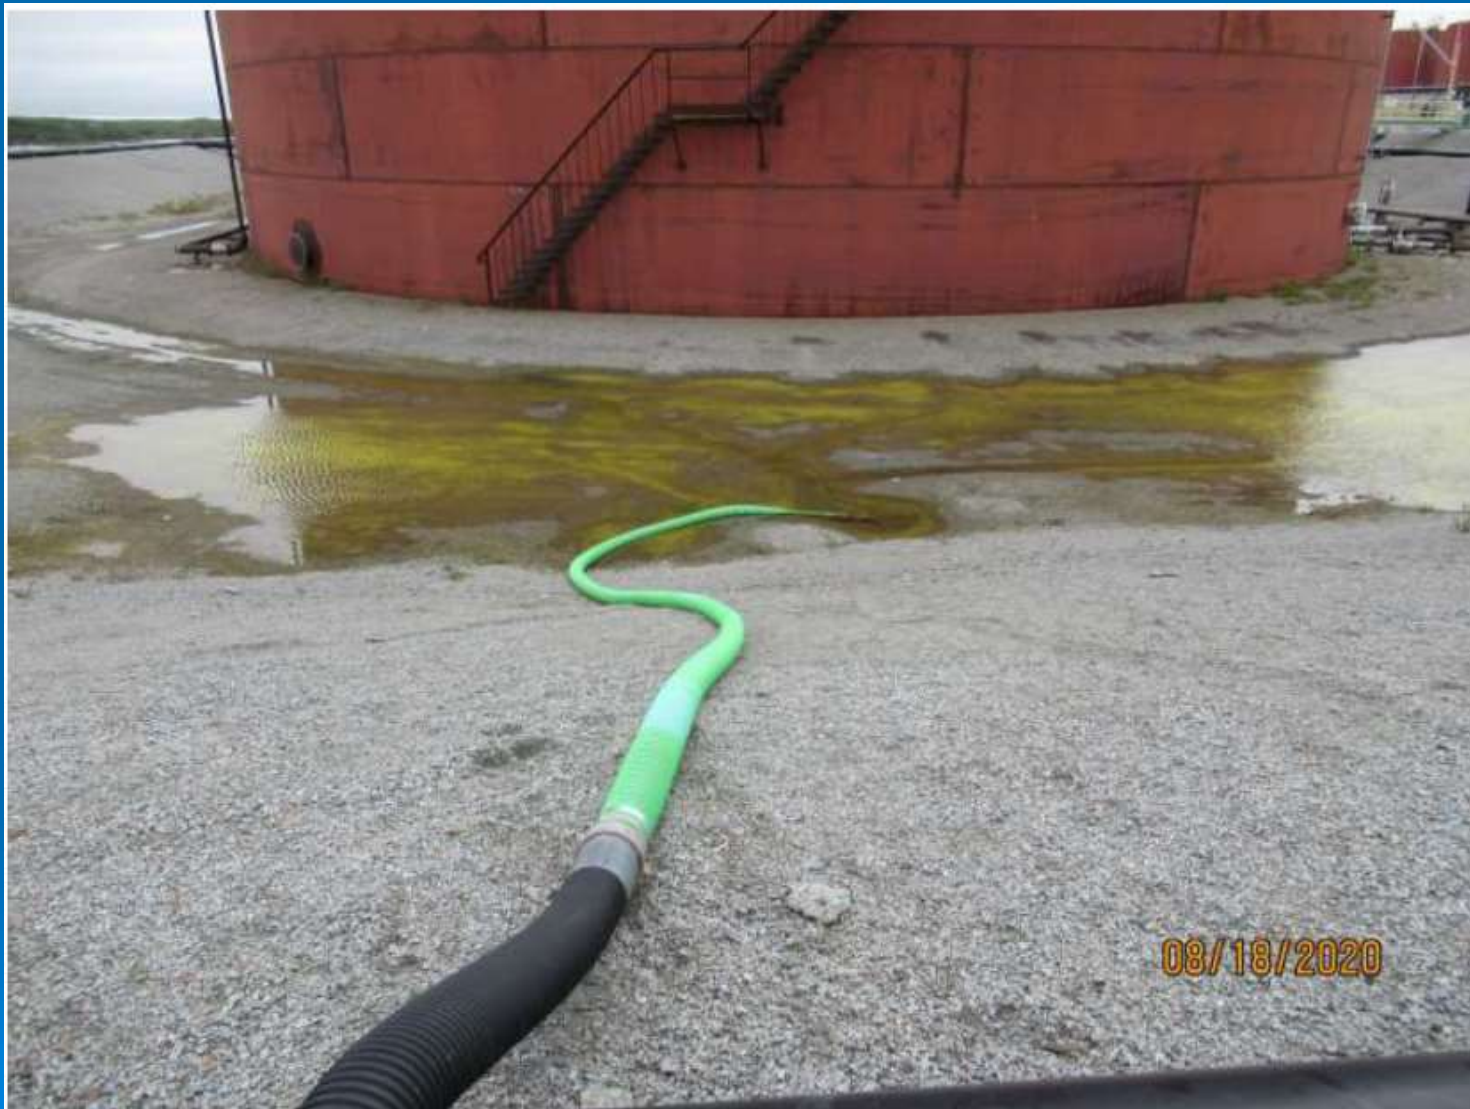
Photo 22: Water from the 12 million litre fuel tanks was being pumped out from the berm sump.

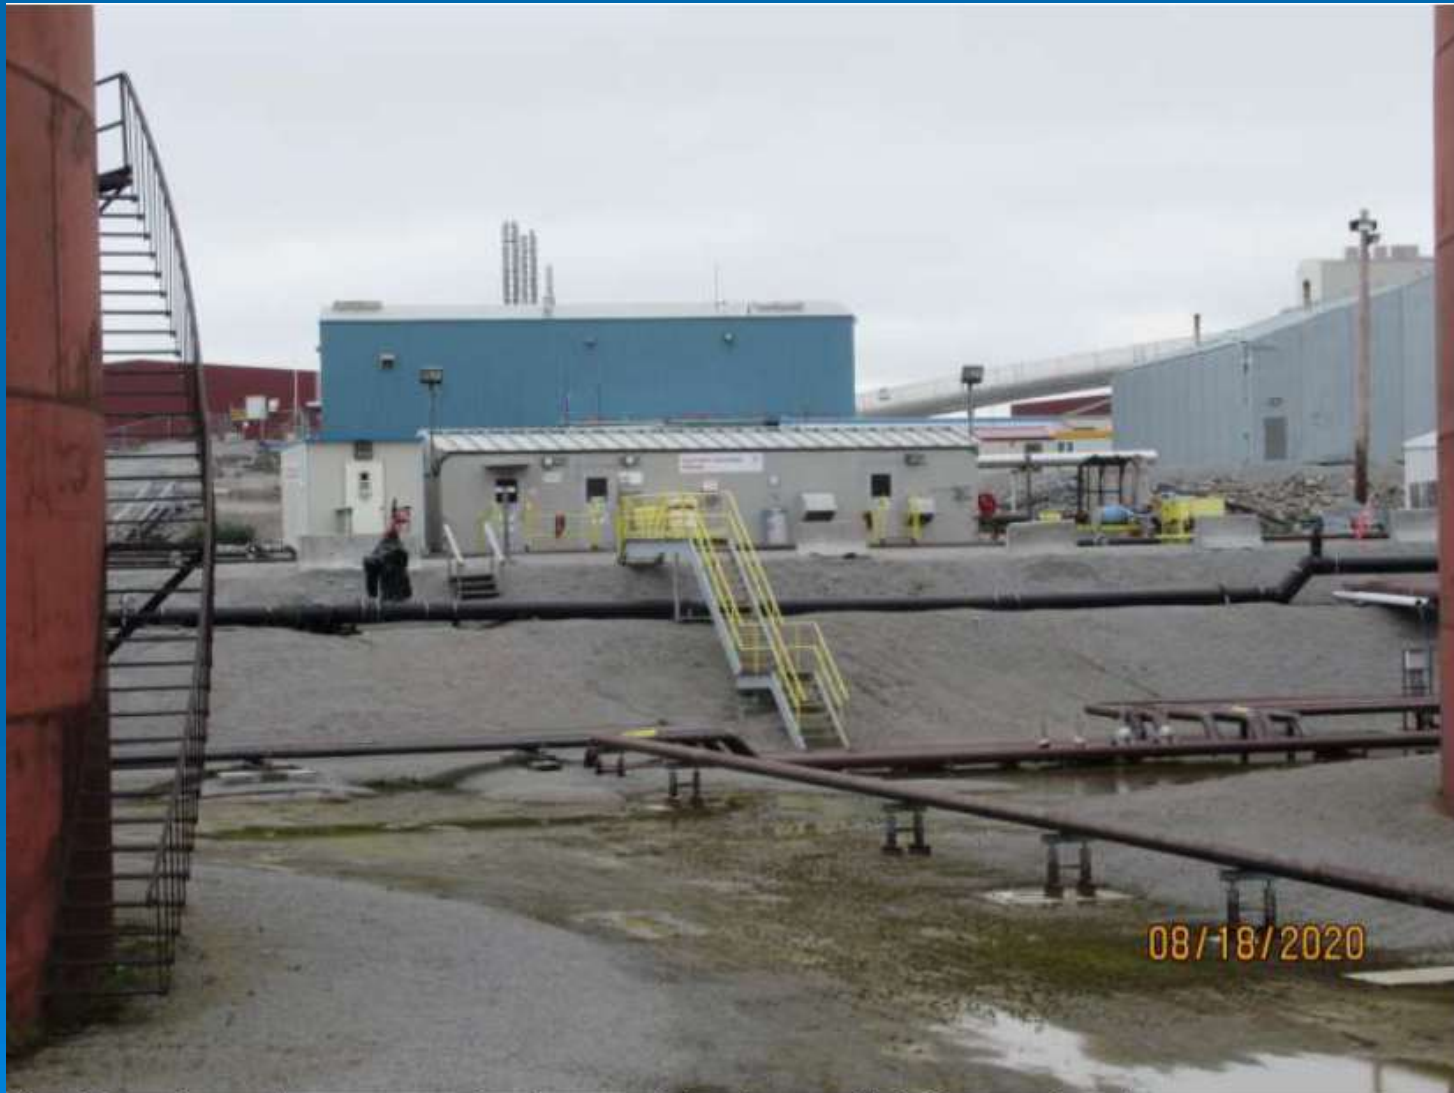
Photo 23: Secondary containment structures have been pumped clean of water at this fuel farm transfer station.

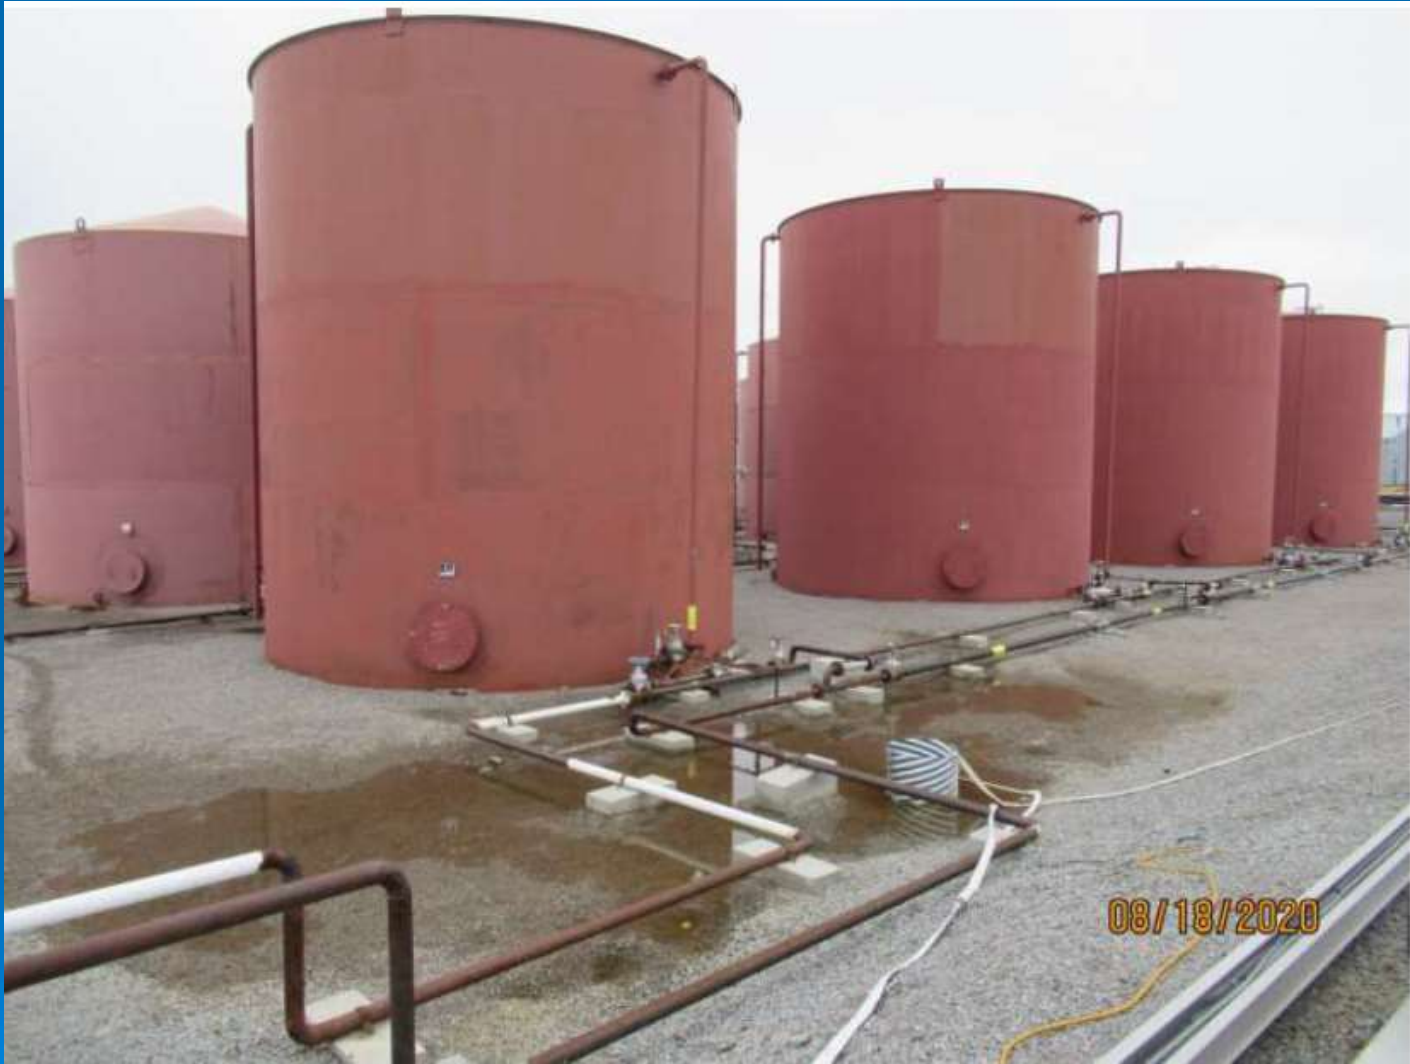
Photo 24: Water was being actively pumped out of the sump within the 330,000 L fuel storage tank facility.

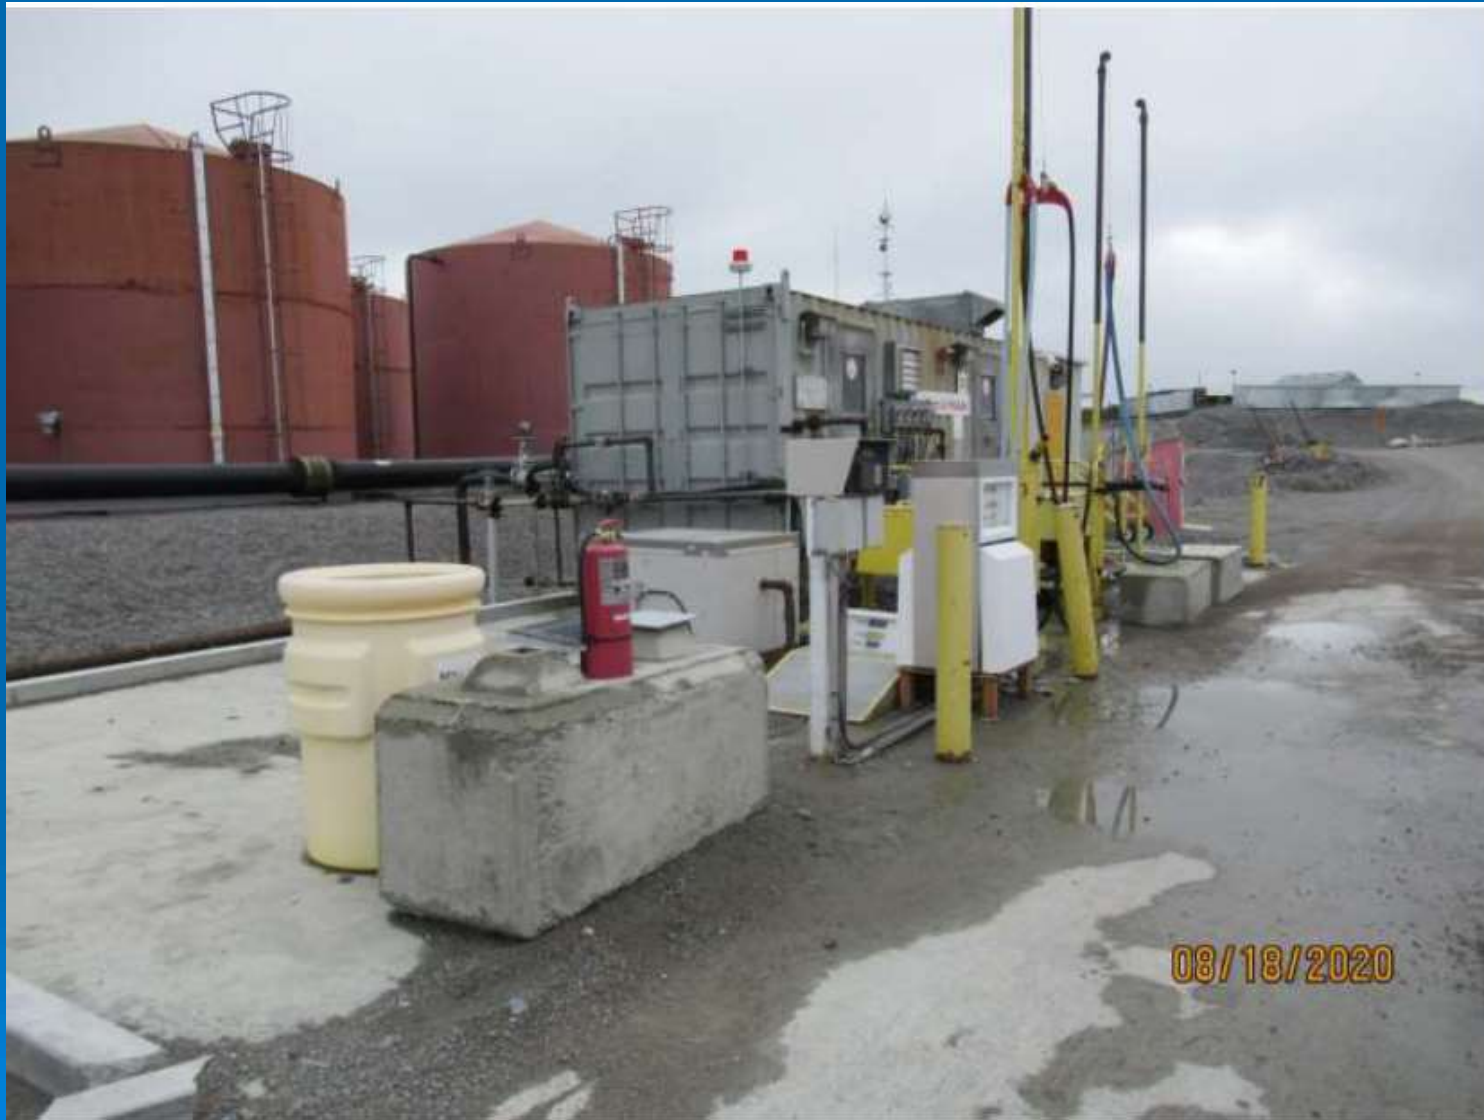
Photo 25: The 330,000 L fuel transfer facility was being prepared for the seasonal over-winter shutdown.

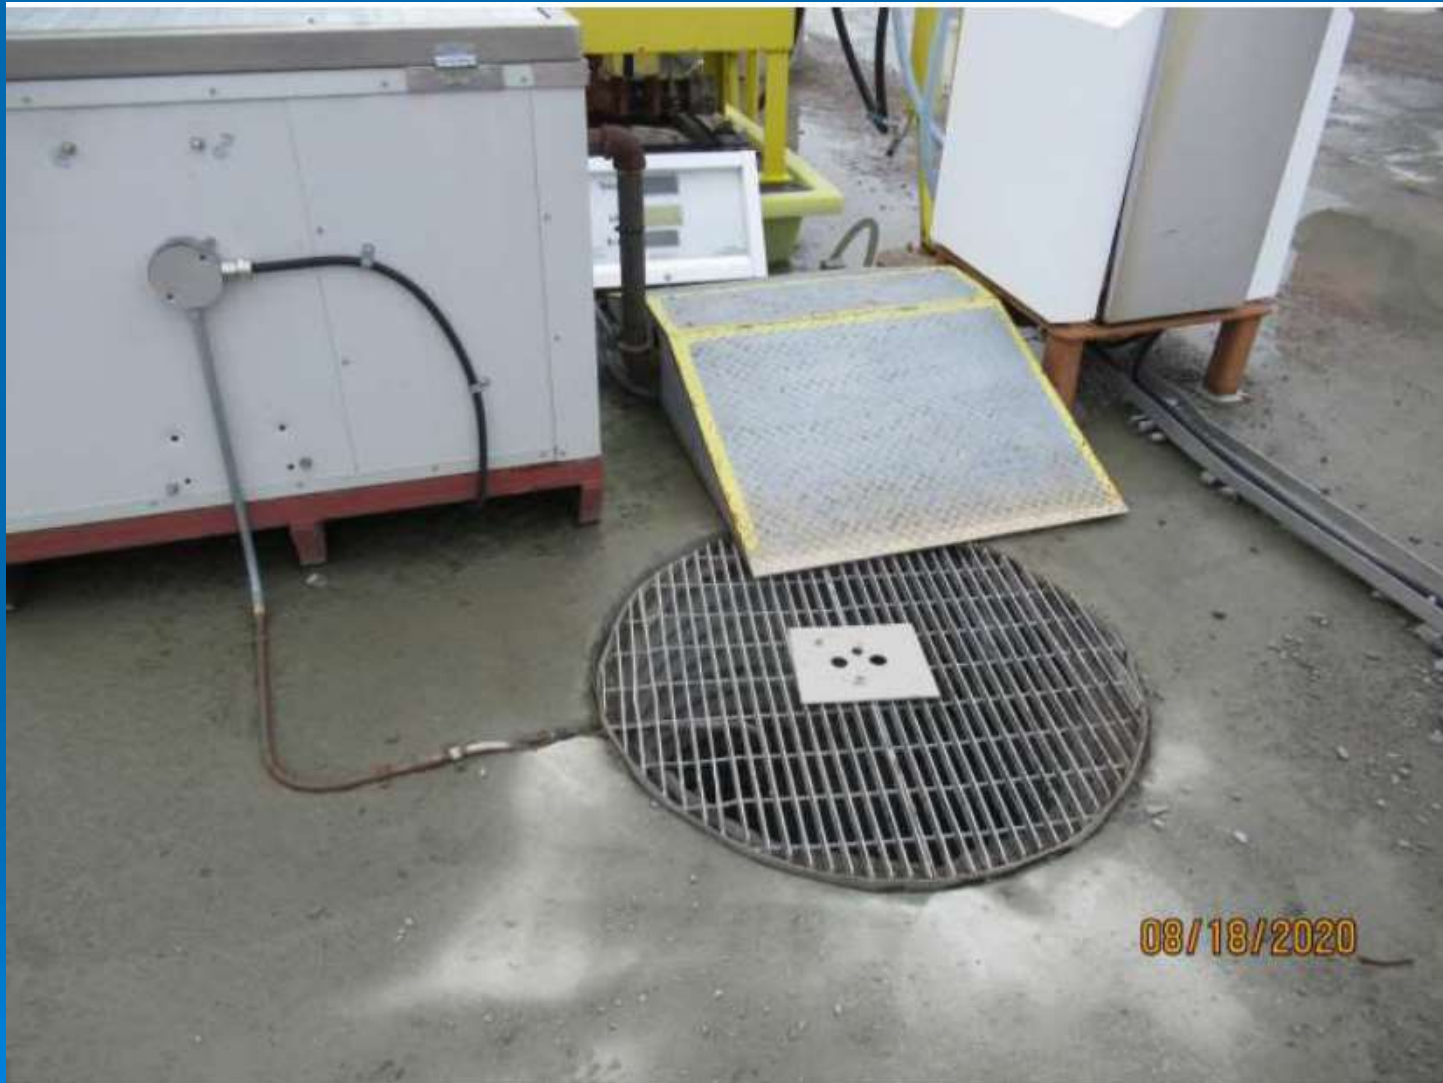
Photo 26: Water from this sump at the transfer station in Photo #25 was sucked out via vacuum truck and transported to the mine WMP.

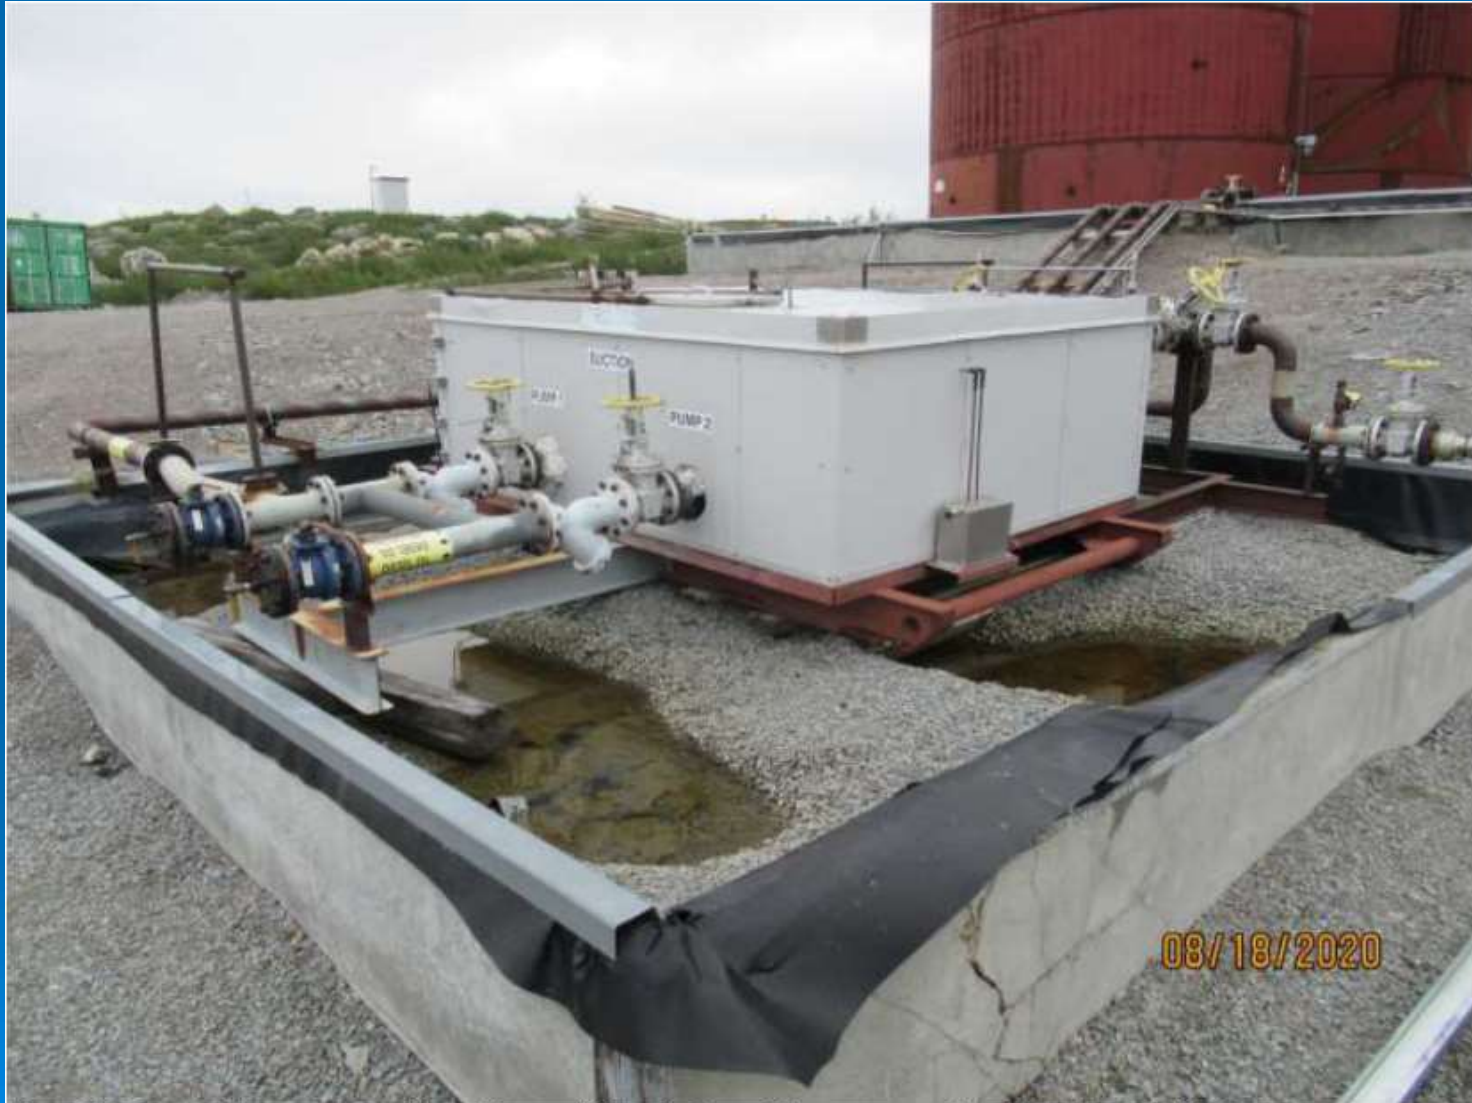
Photo 27: The remaining water from this tank berm will be sucked out with a vacuum truck and brought to the WMP.

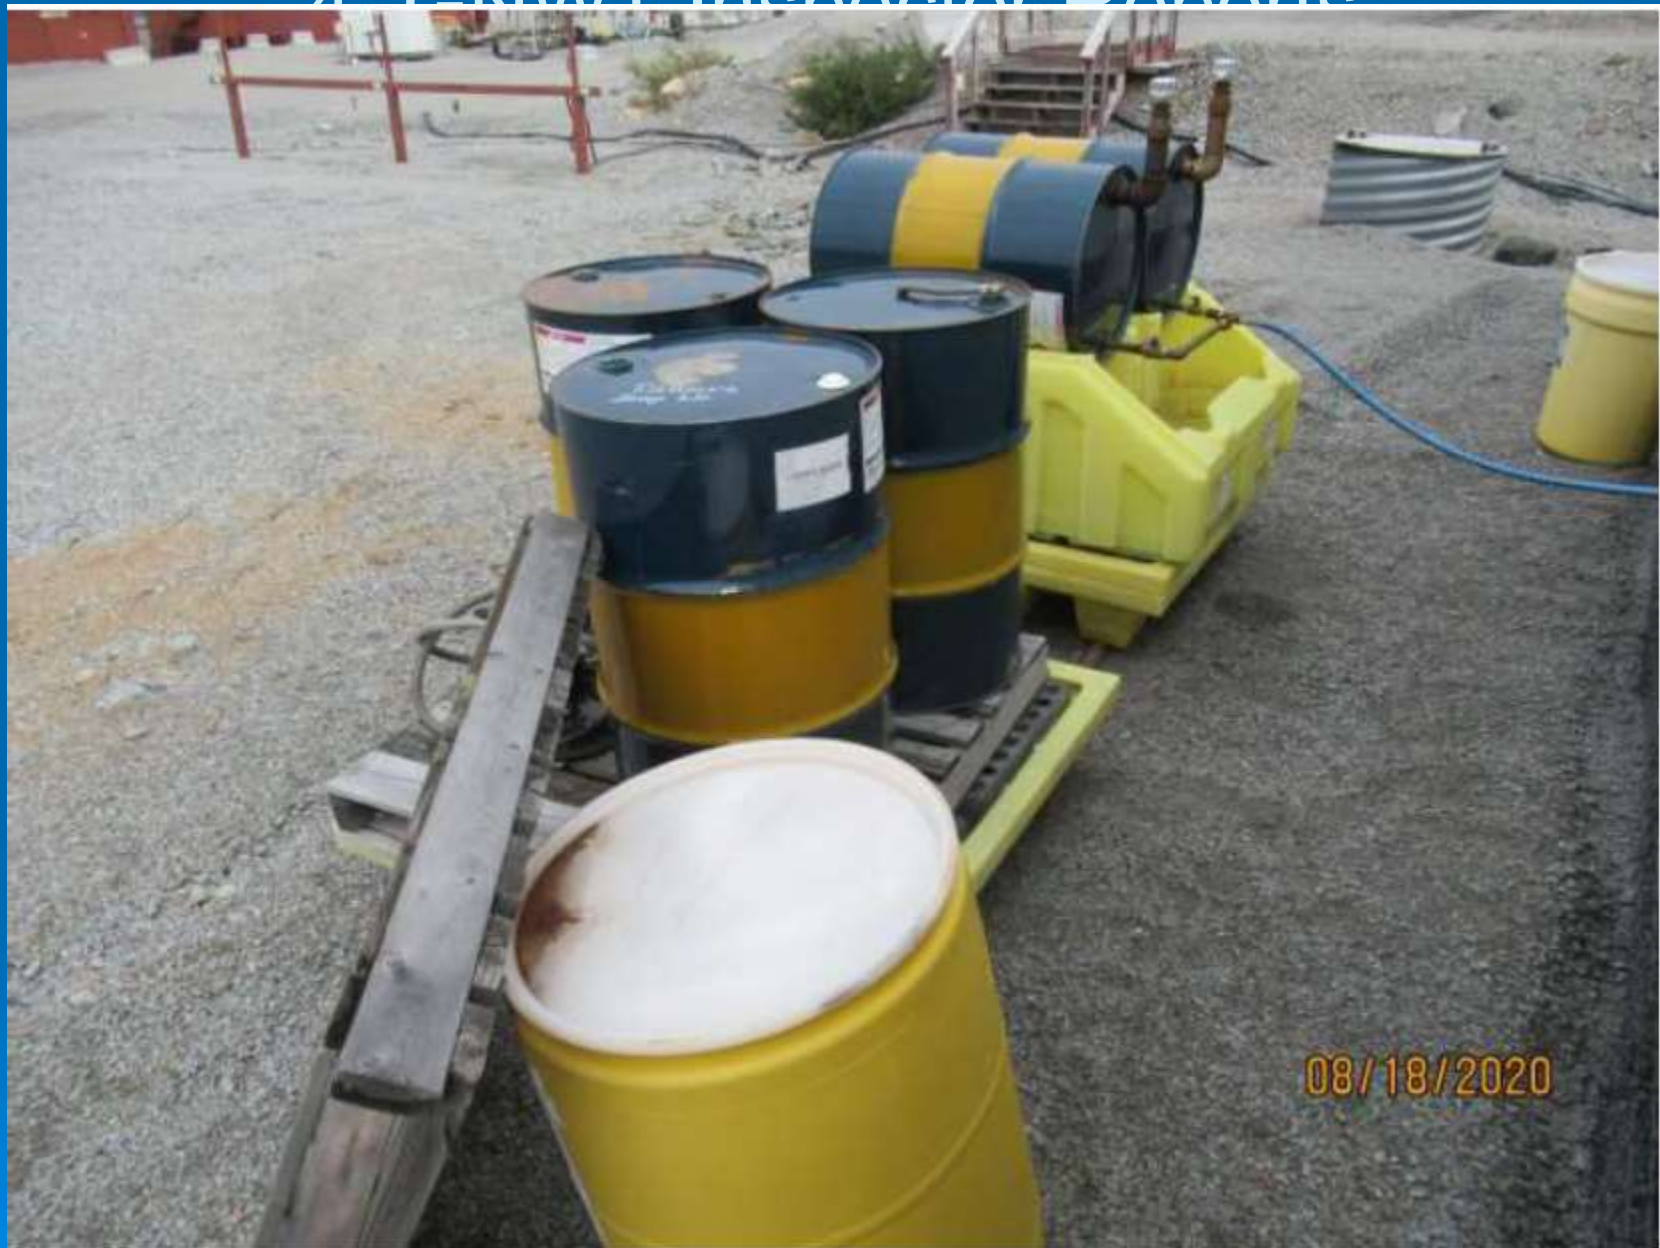
**Photo 28: The lines of active drums must be properly diapered with hydrocarbon absorbent matting prior to the seasonal shutdown.**
