# July & August 2020 Environmental Update for SLEMA Board

September 1, 2020

### ➤ **August 18 GNWT Inspection Report**

An Inspection of the Snap Lake Diamond Mine Project was conducted by Inspector Joe Heron on August 18, 2020;

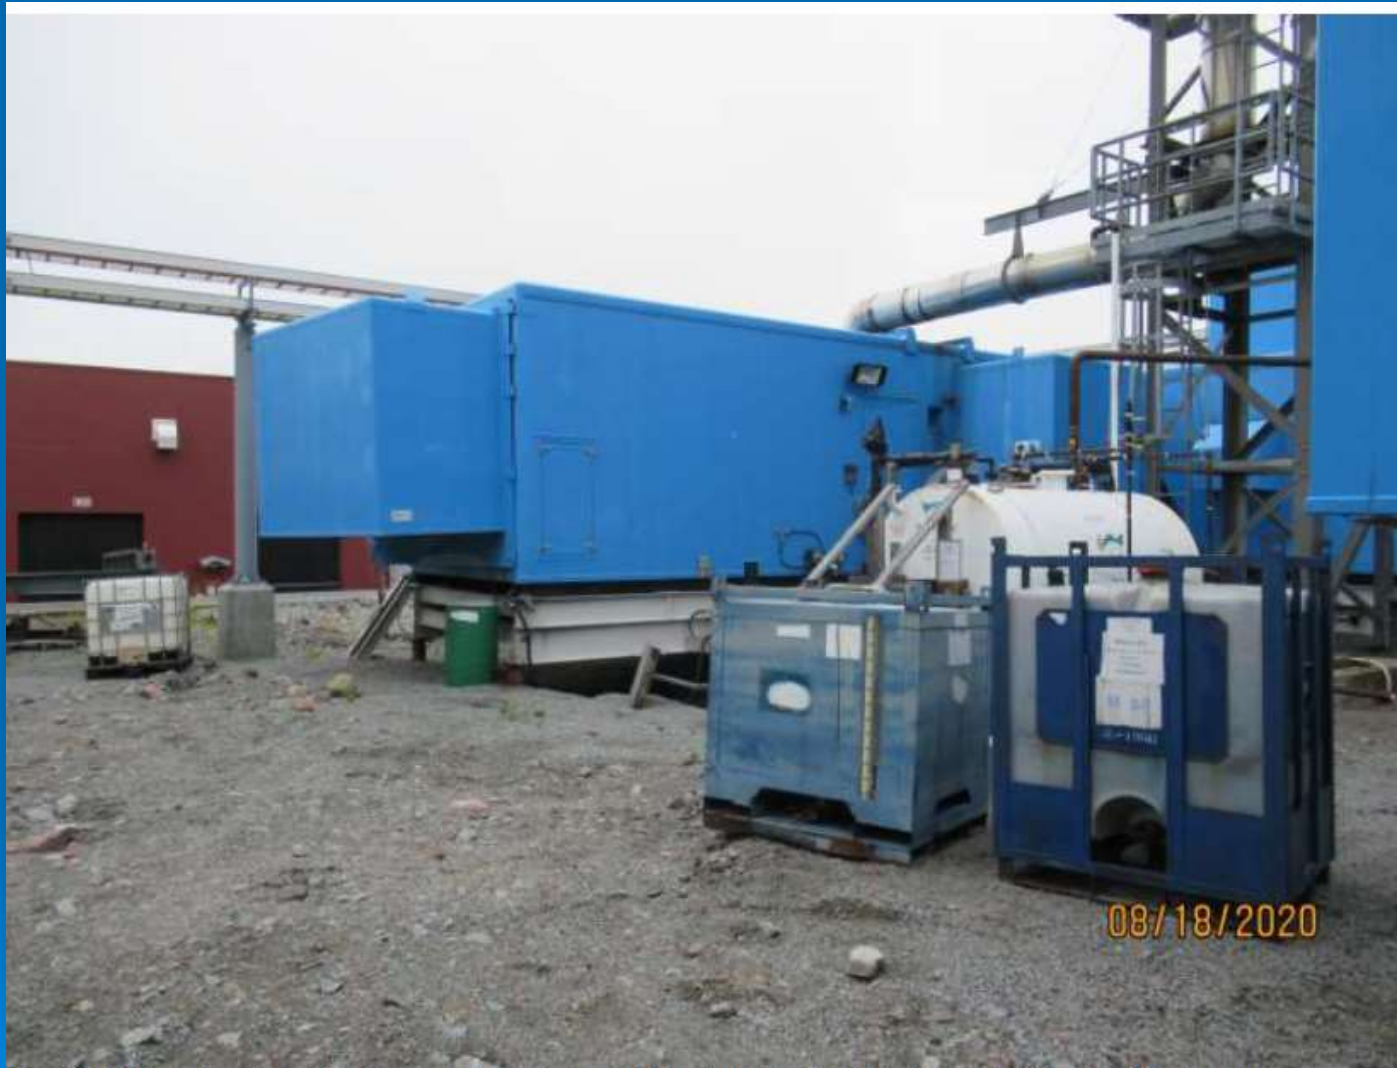
Photo 29: Hydrocarbons from the mine generator station were being drained and put into totes and will be staged for the winter.

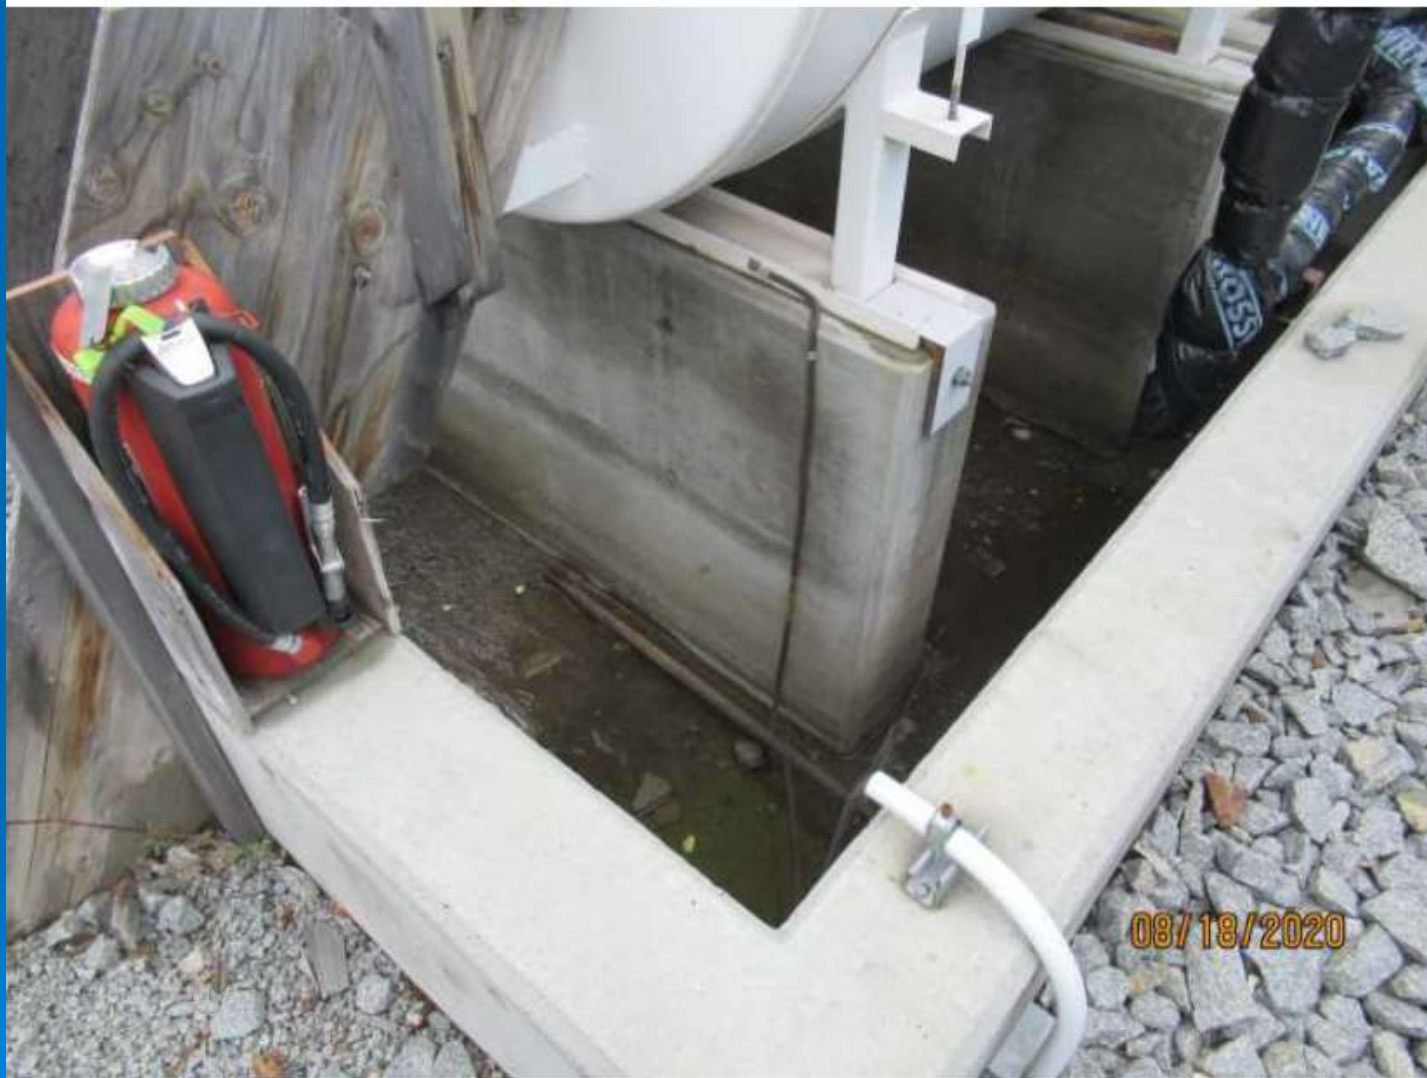
Photo 30: Water from within the berm of the tank seen in Photo #29 was sucked out with a vac truck and deposited into the mine WMP.

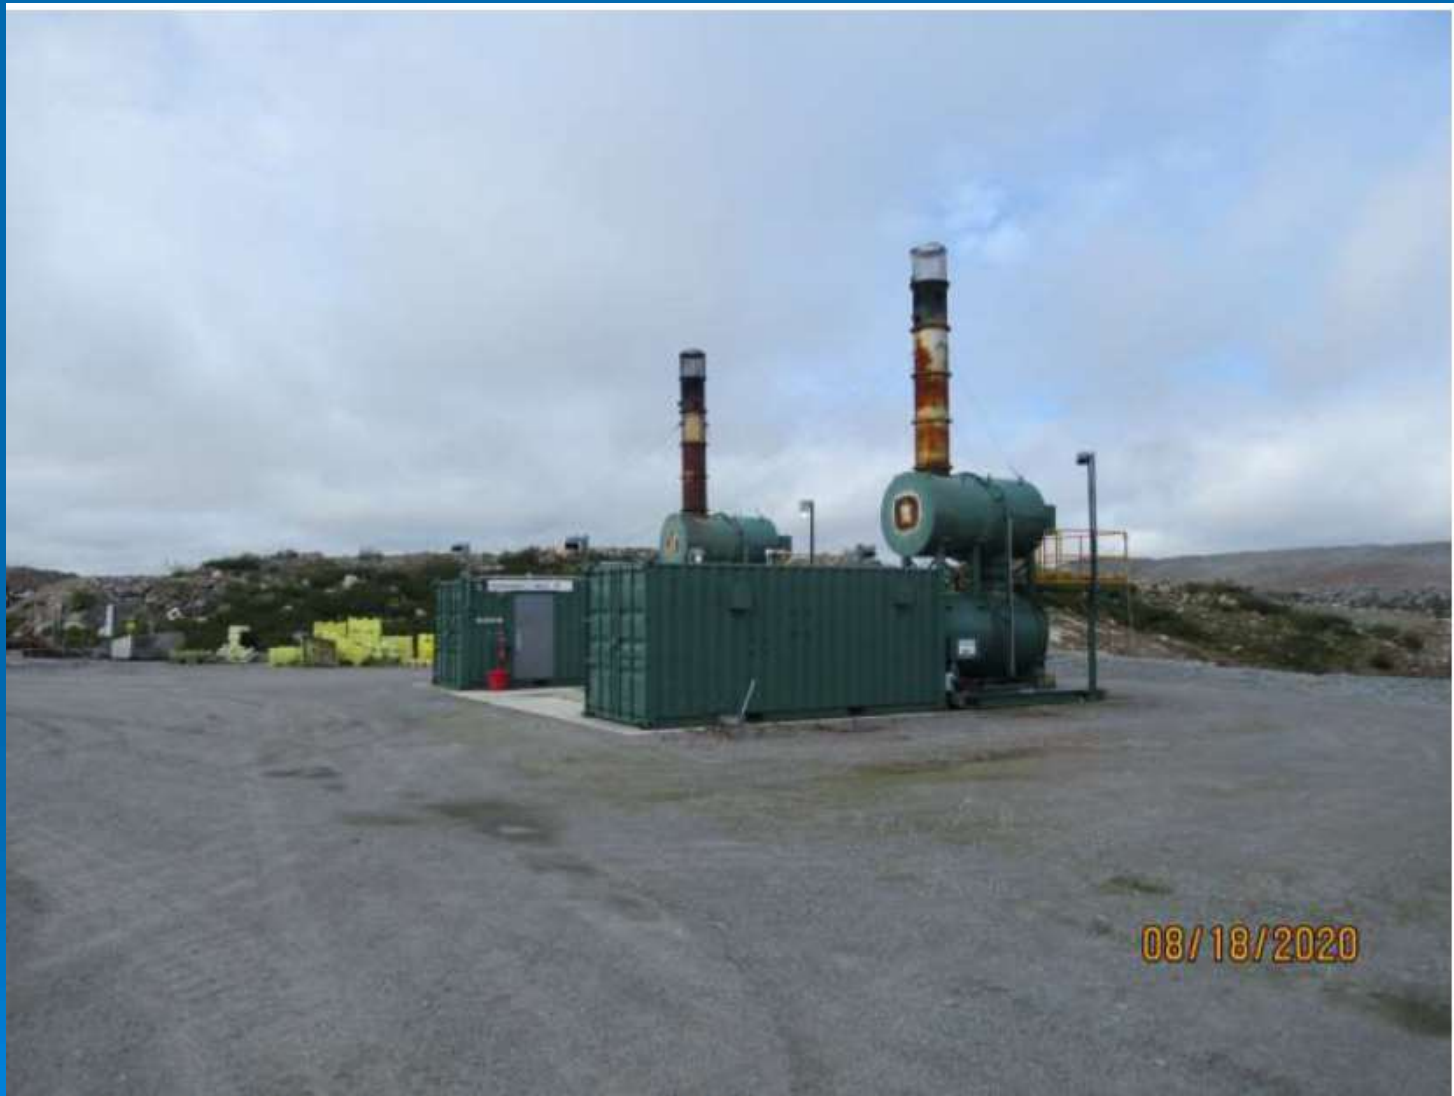
Photo 31: Crews were conducting final burns of burnable waste at the mine incinerators.

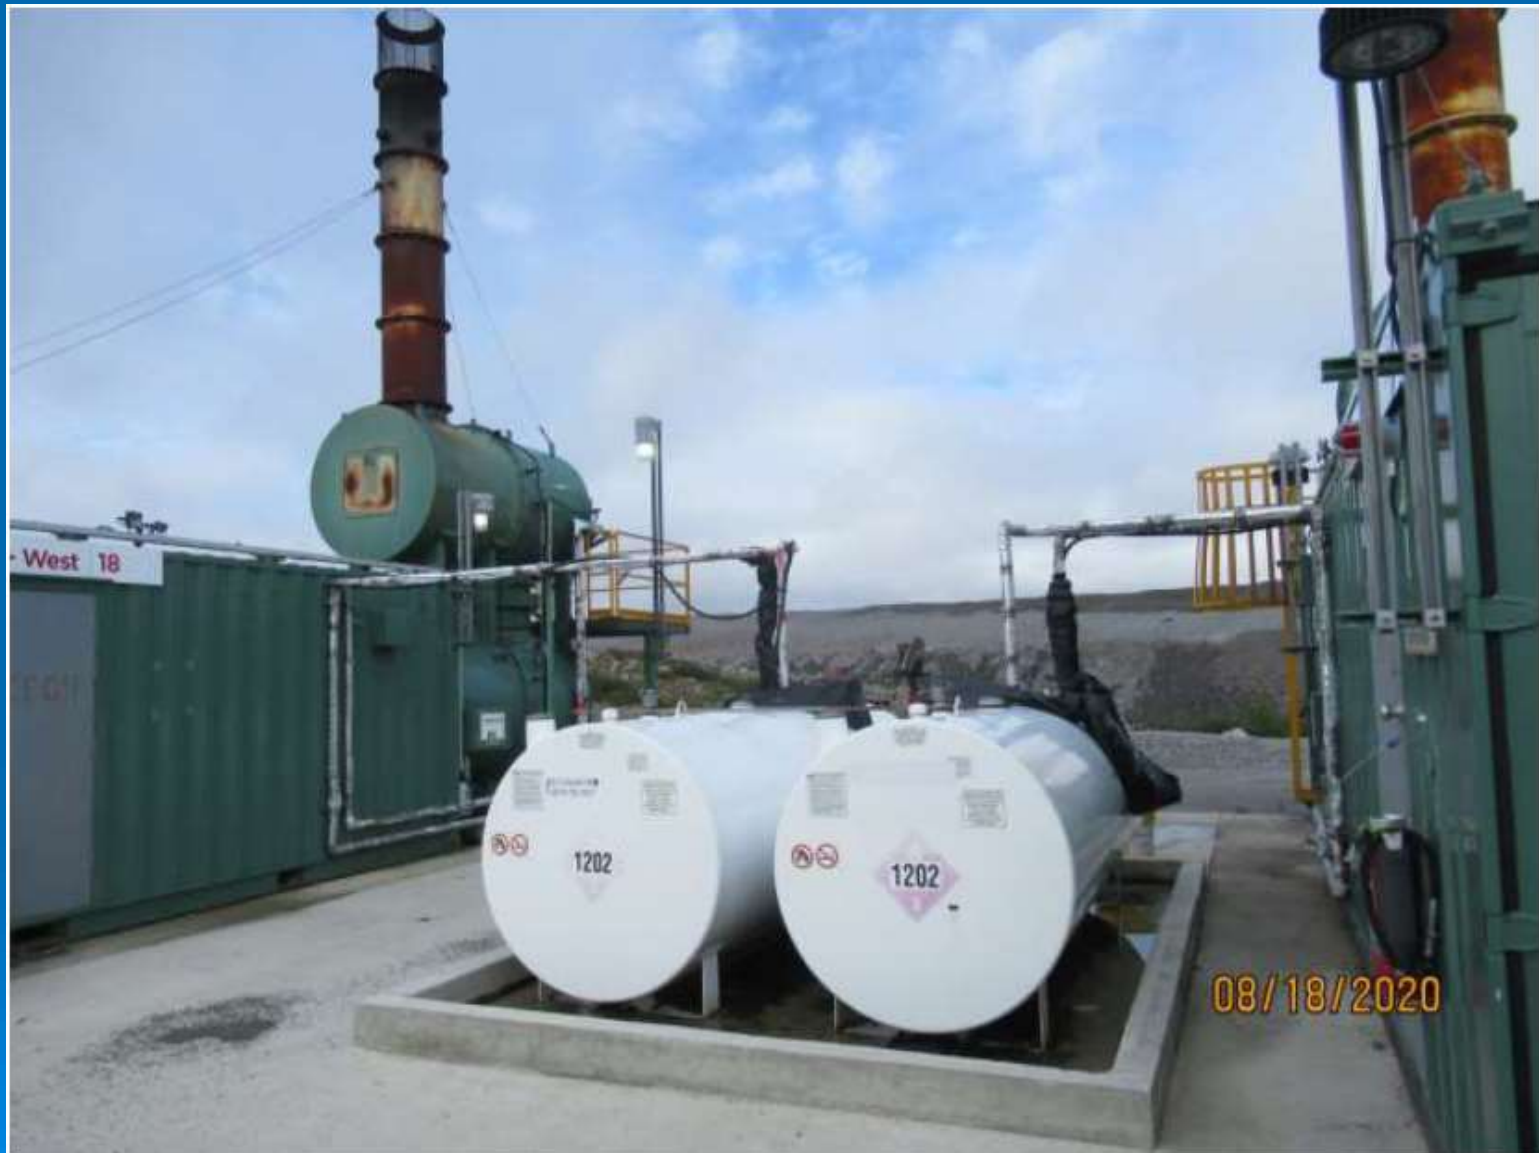
Photo 32: Water from within the incinerator fuel tanks will be sucked out with a vacuum truck and deposited into the mine WMP.

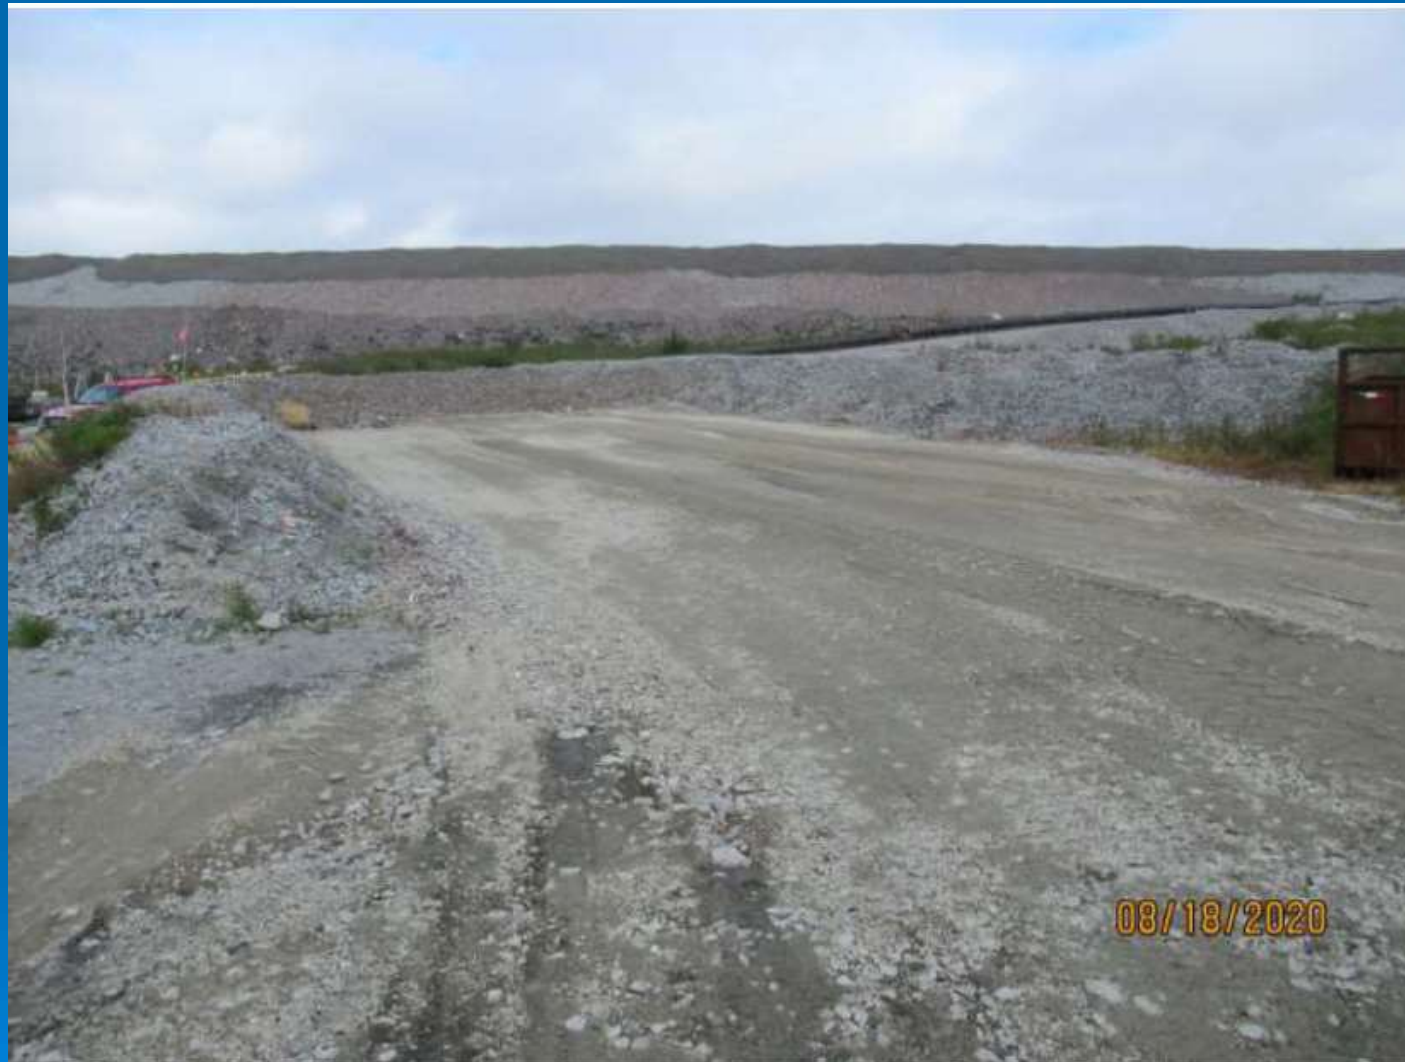
Photo 33: As seen here, the mine burn pit operations were complete for the season and the area was restored until next season.

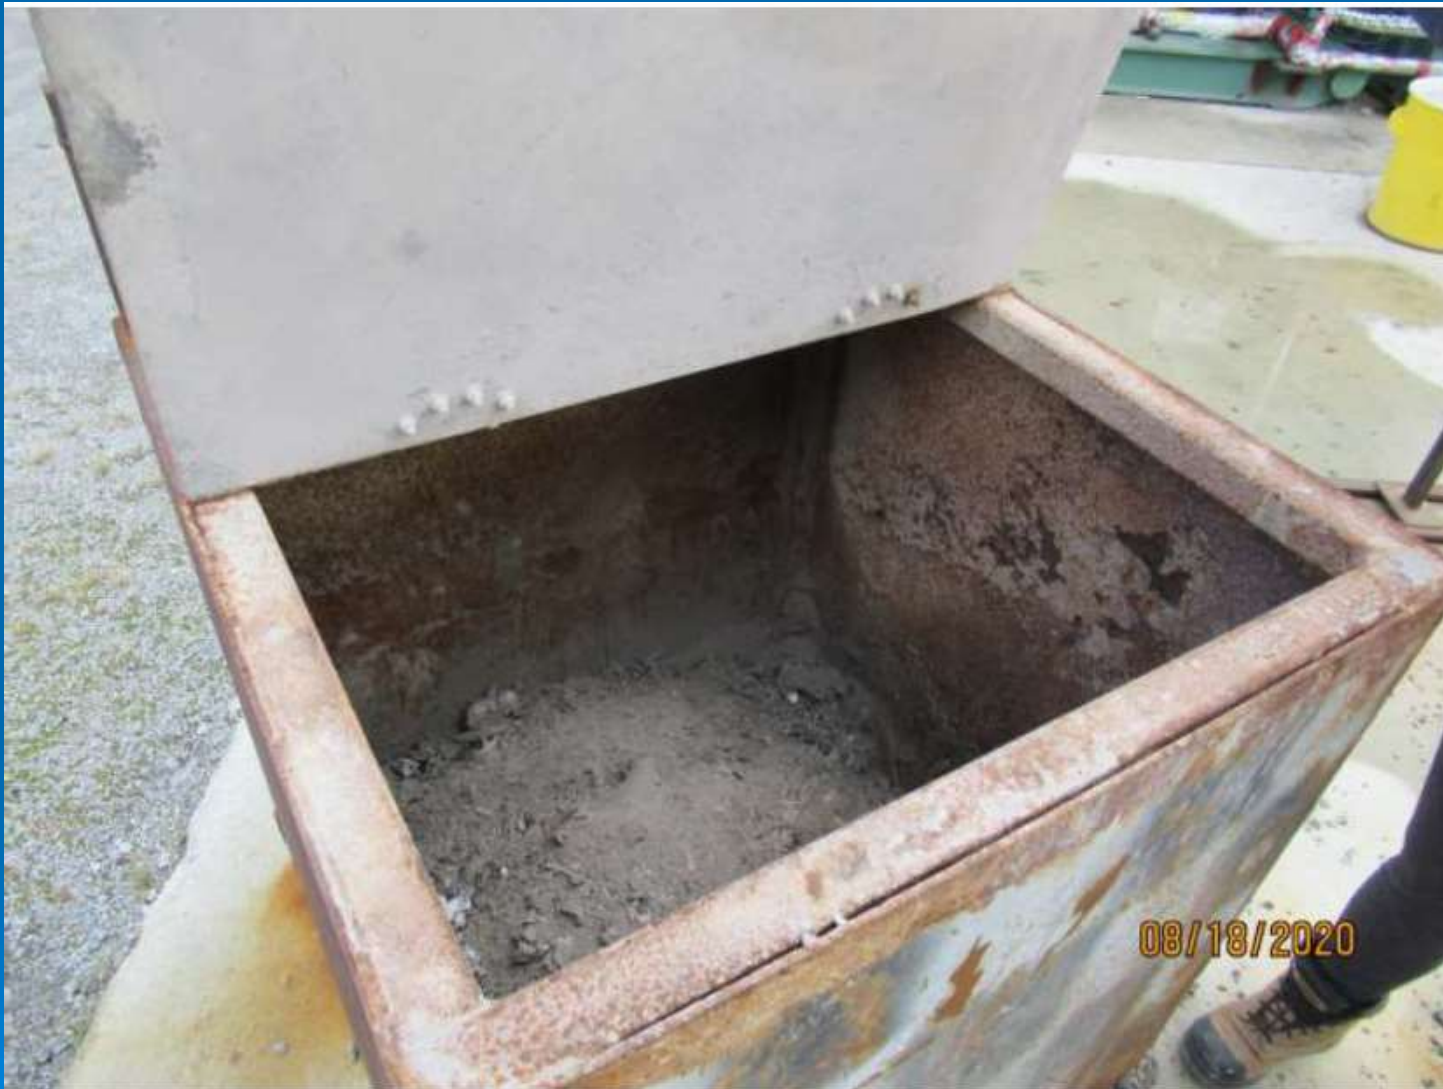
Photo 34: Ash from the mine incinerators is deposited into this ash bin prior to testing and disposal.

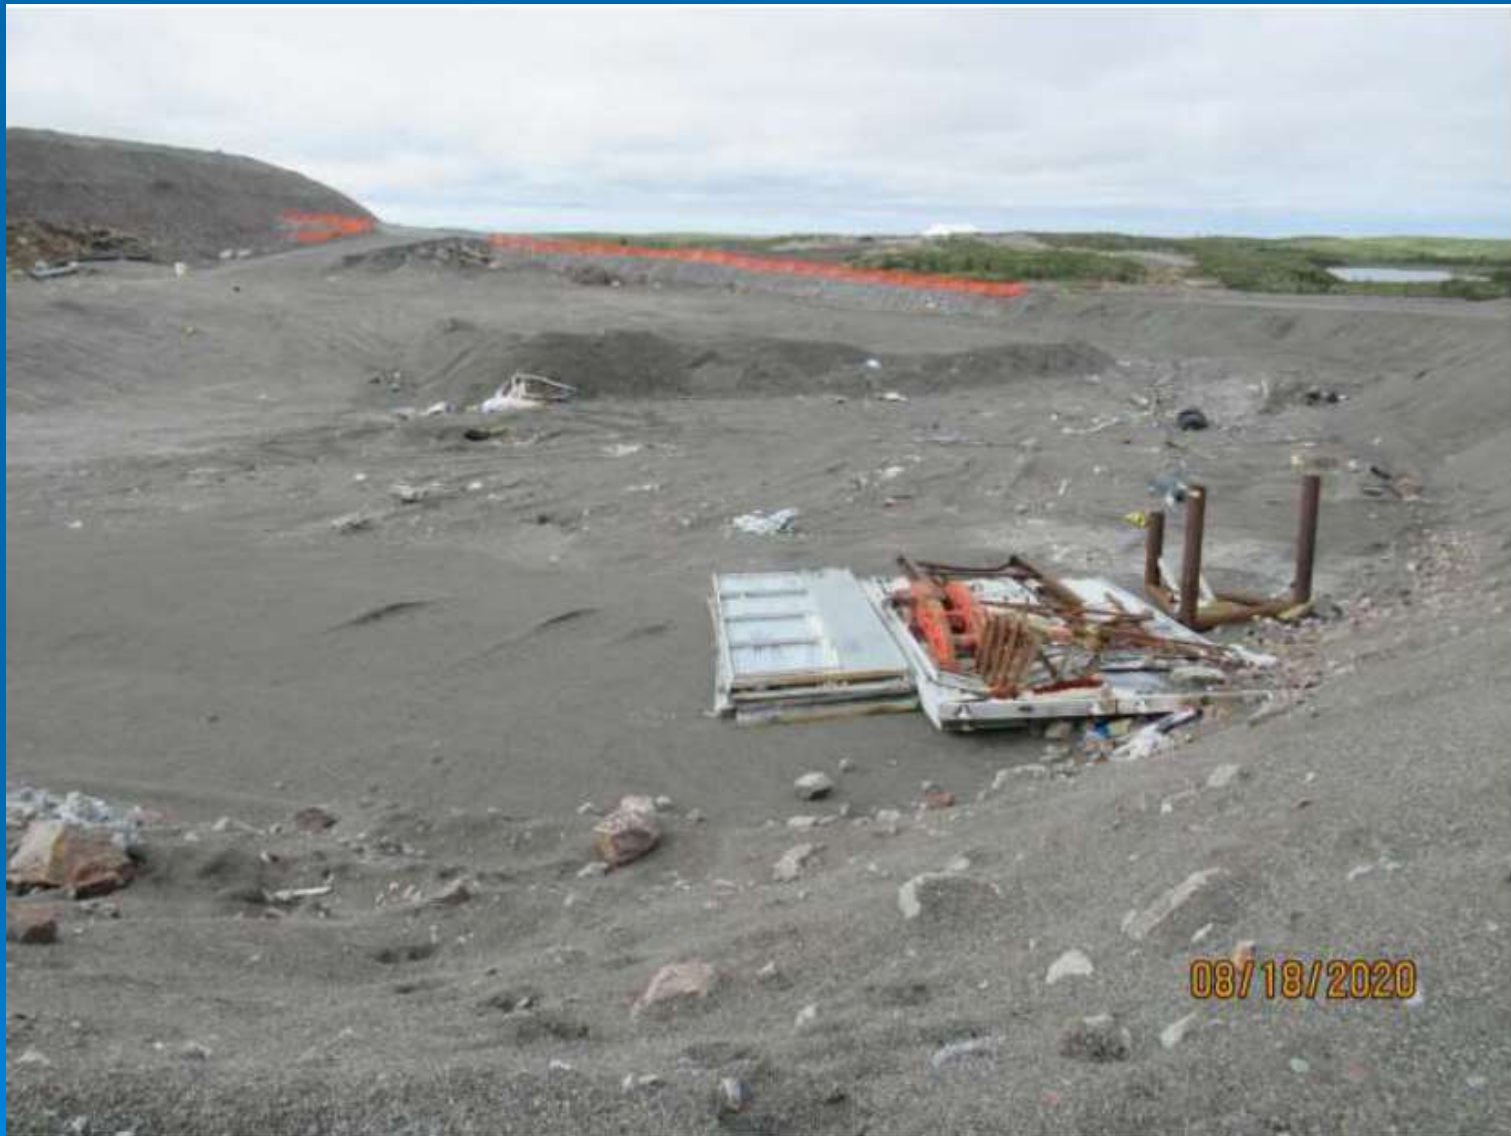
Photo 35: It appeared only acceptable materials were being placed into the mine landfill.

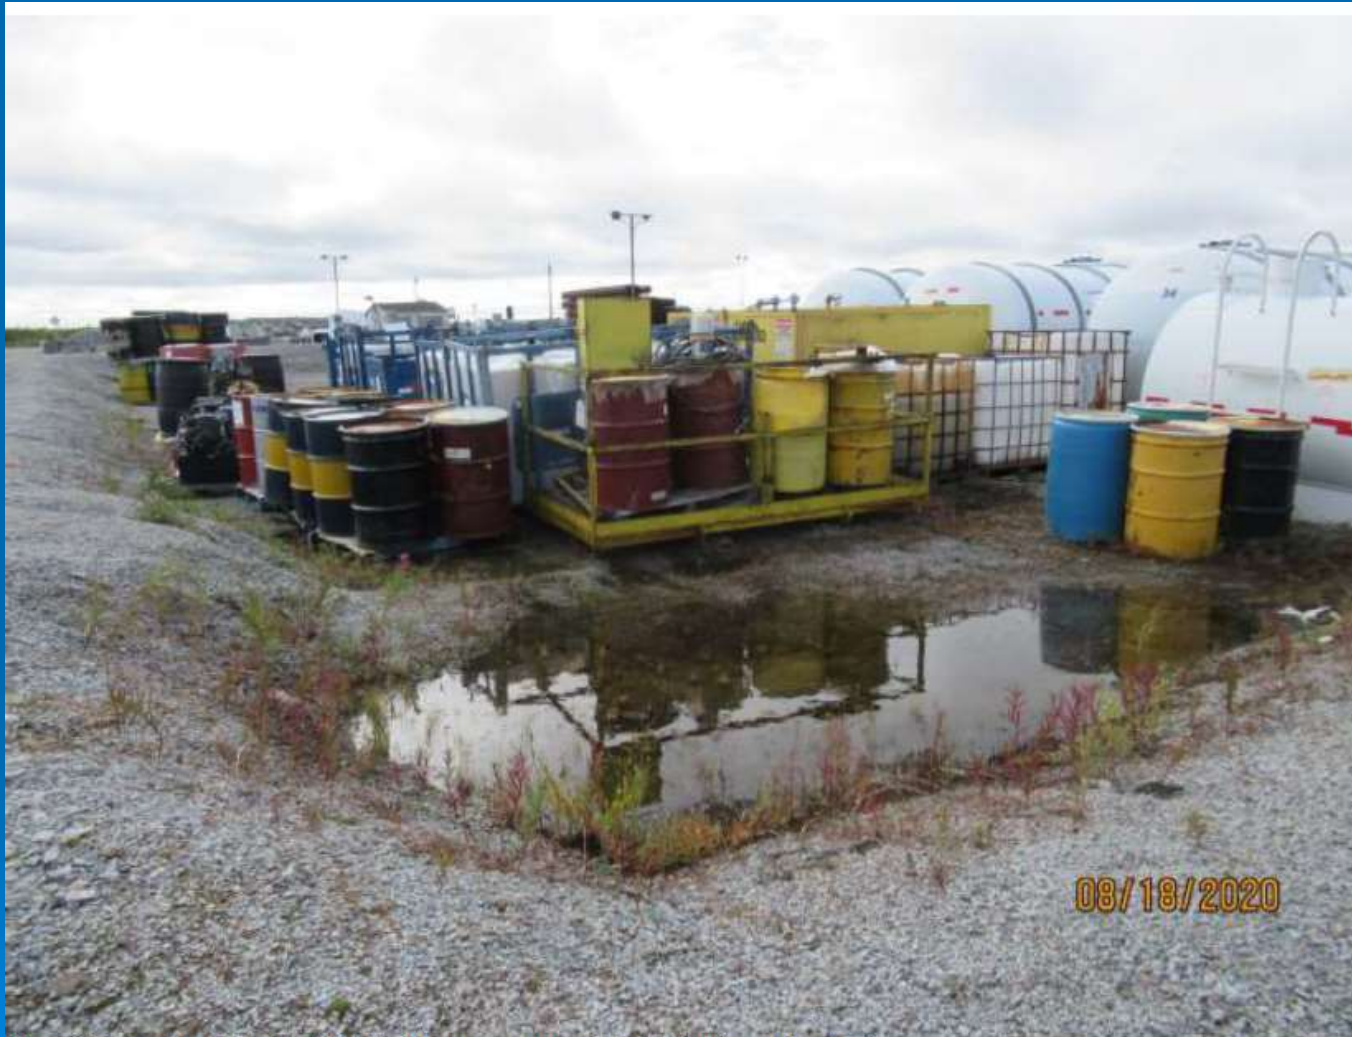
Photo 36: Materials within the WTA lined berm were properly labeled and containerized.

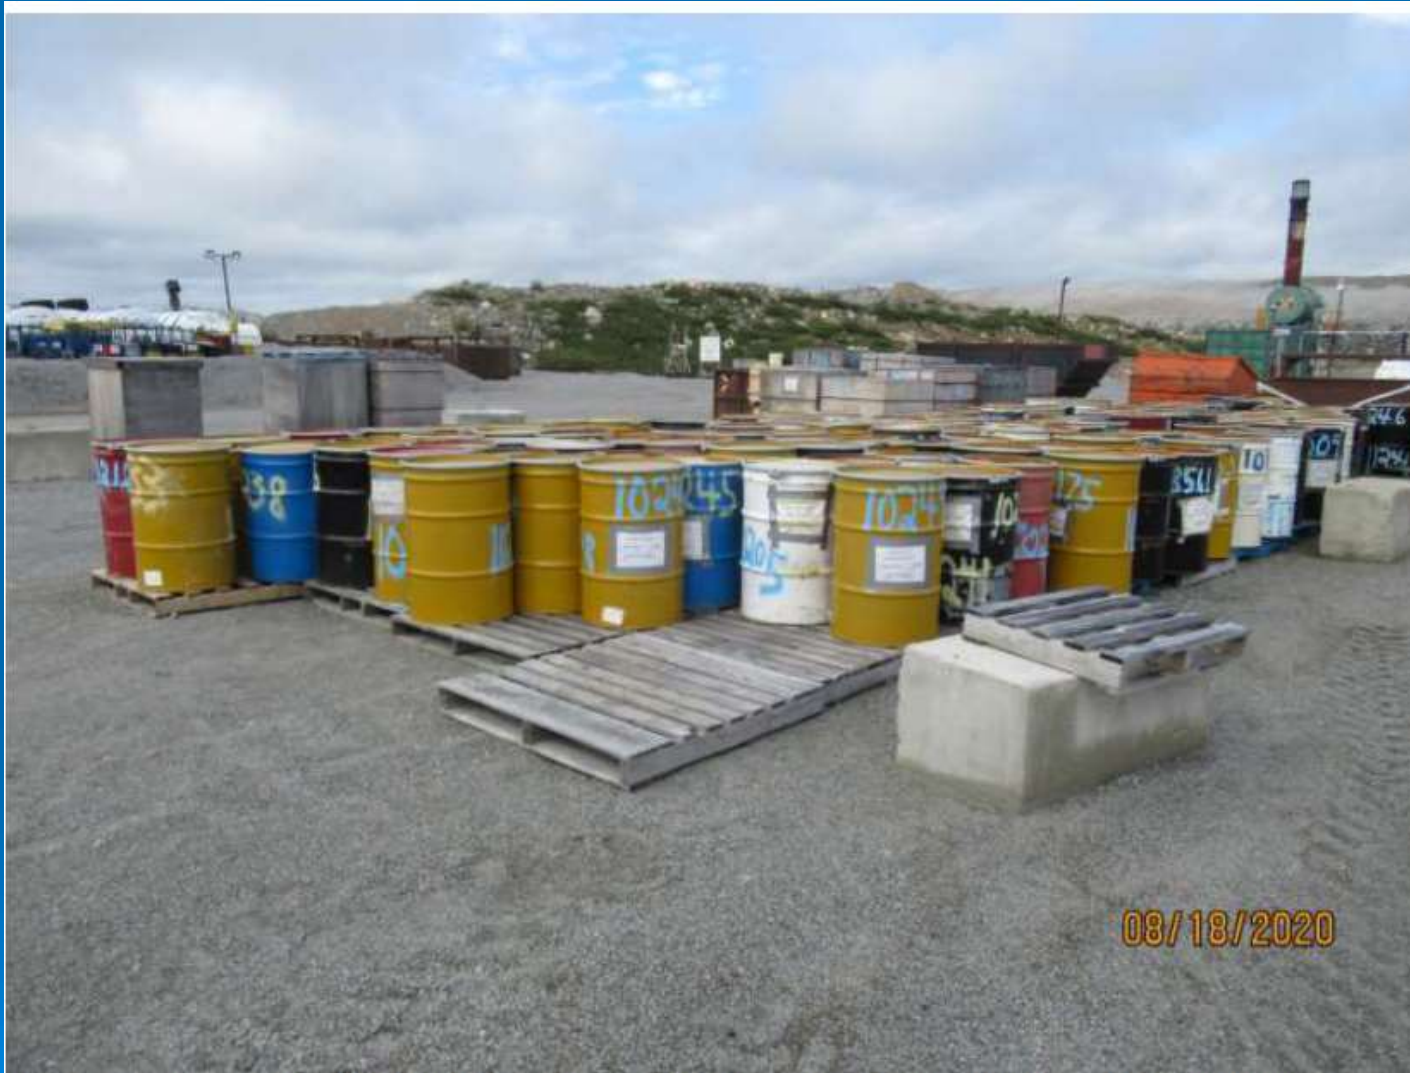
Photo 37: Properly containerized and labeled waste at the mine WTA that is awaiting transfer offsite disposal at approved facilities.

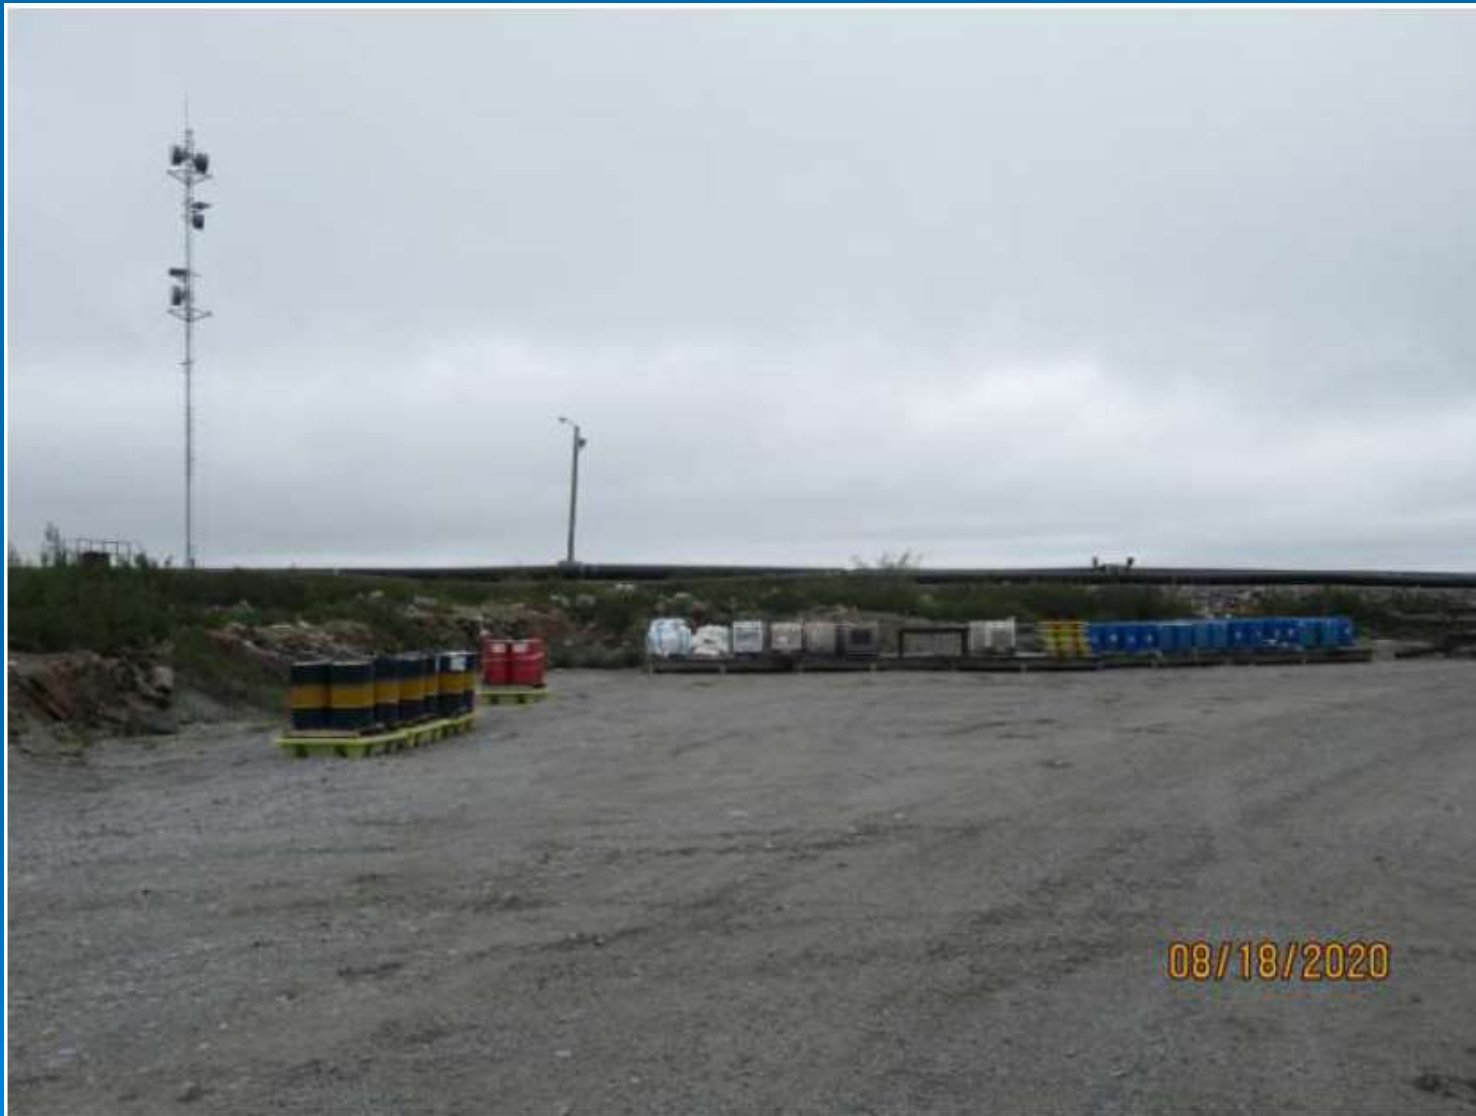
Photo 38: Staged hydrocarbons adjacent to the mine generator building that will be used for necessary over-winter operations.

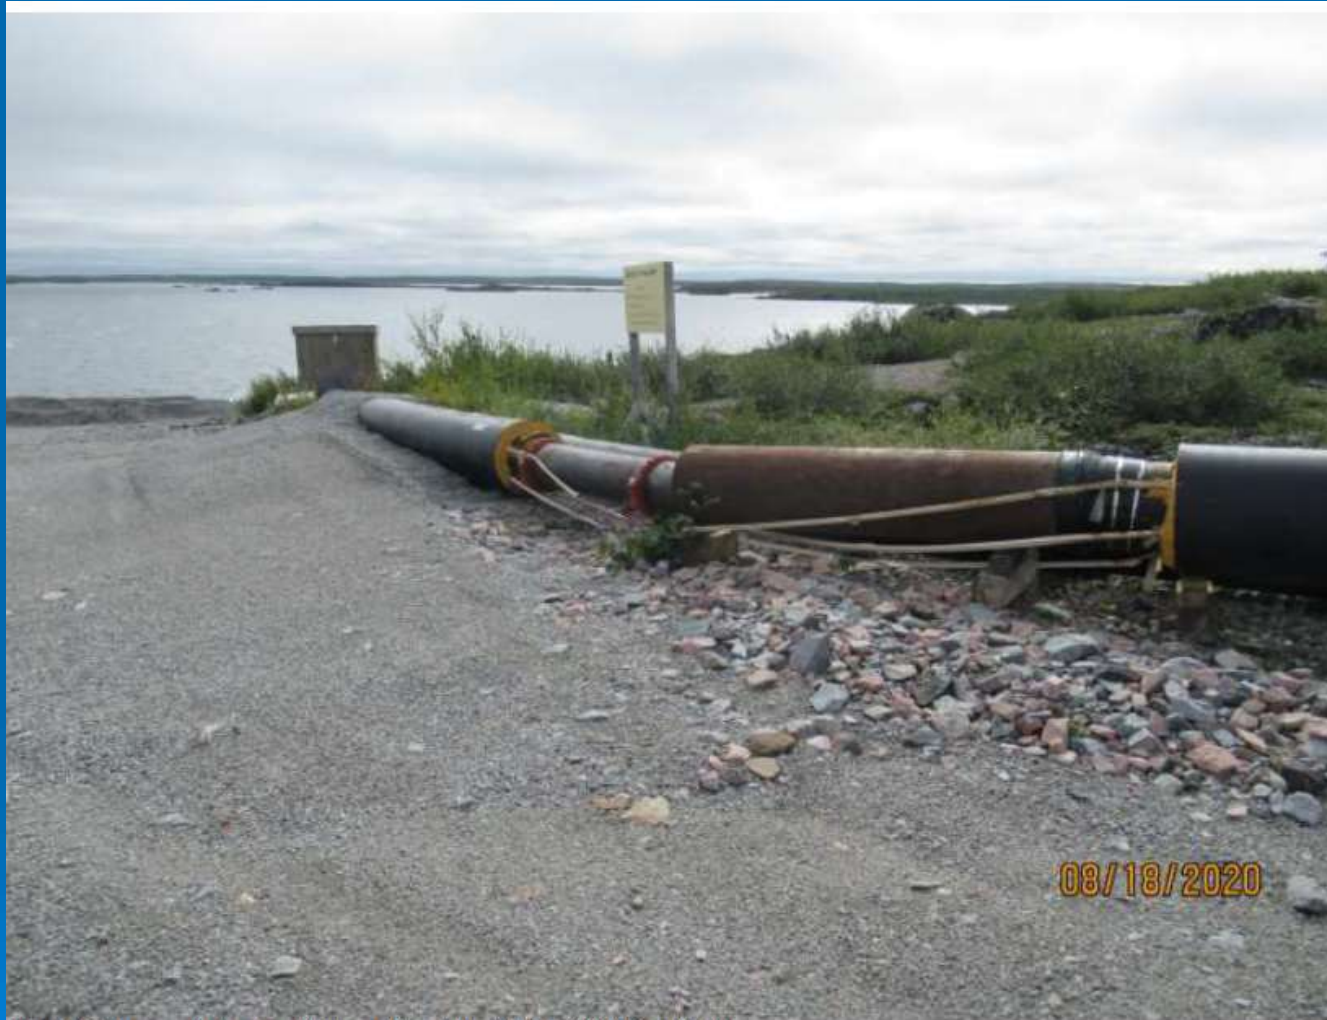
- **Spill NT-NU 2020176**
  - On June 11, 2020 a spill of treated Effluent occurred near the diffuser discharge ramp area and was recorded as Spill NT-NU 2020176.
  - The water discharge line was repaired and it appeared the water diversion berms on the ramp were re-established as per the Inspectors instructions during the June 18, 2020 inspection (Photos #39 & #40).

Photo 39: The repaired water discharge line at the NT-NU 2020176 spill site.

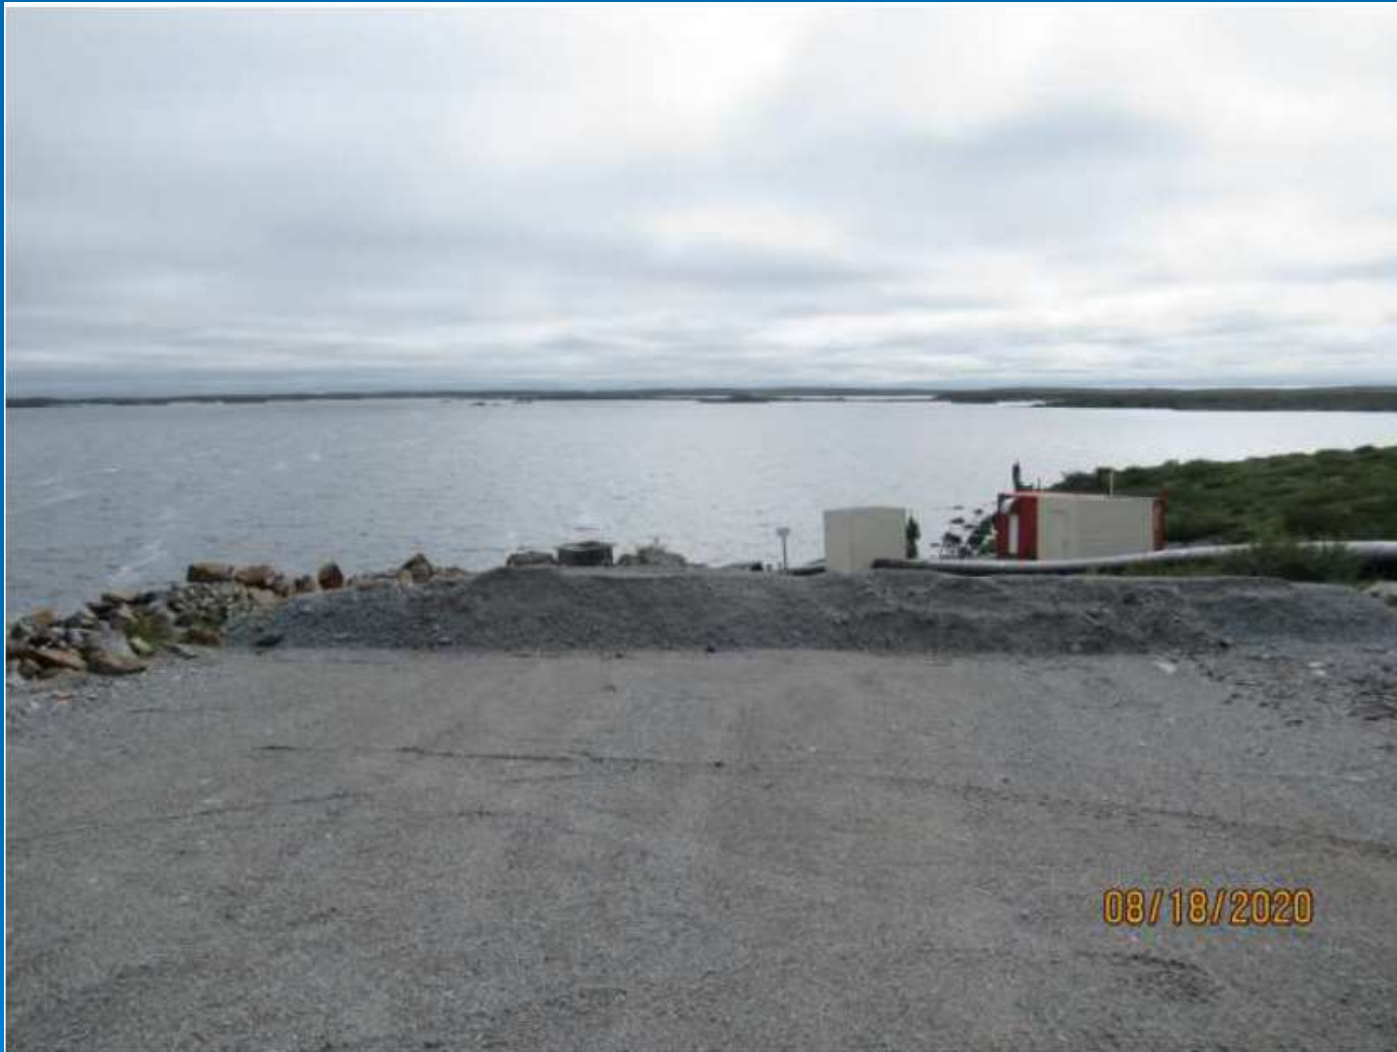
Photo 40: This berm that was previously washed away in parts has been completely restored.
