May-June 2021 Environmental Update for SLEMA Board

July 8, 2021

➤ Regulatory site inspection was conducted on May 26, 2021, by Inspector Joe Heron.

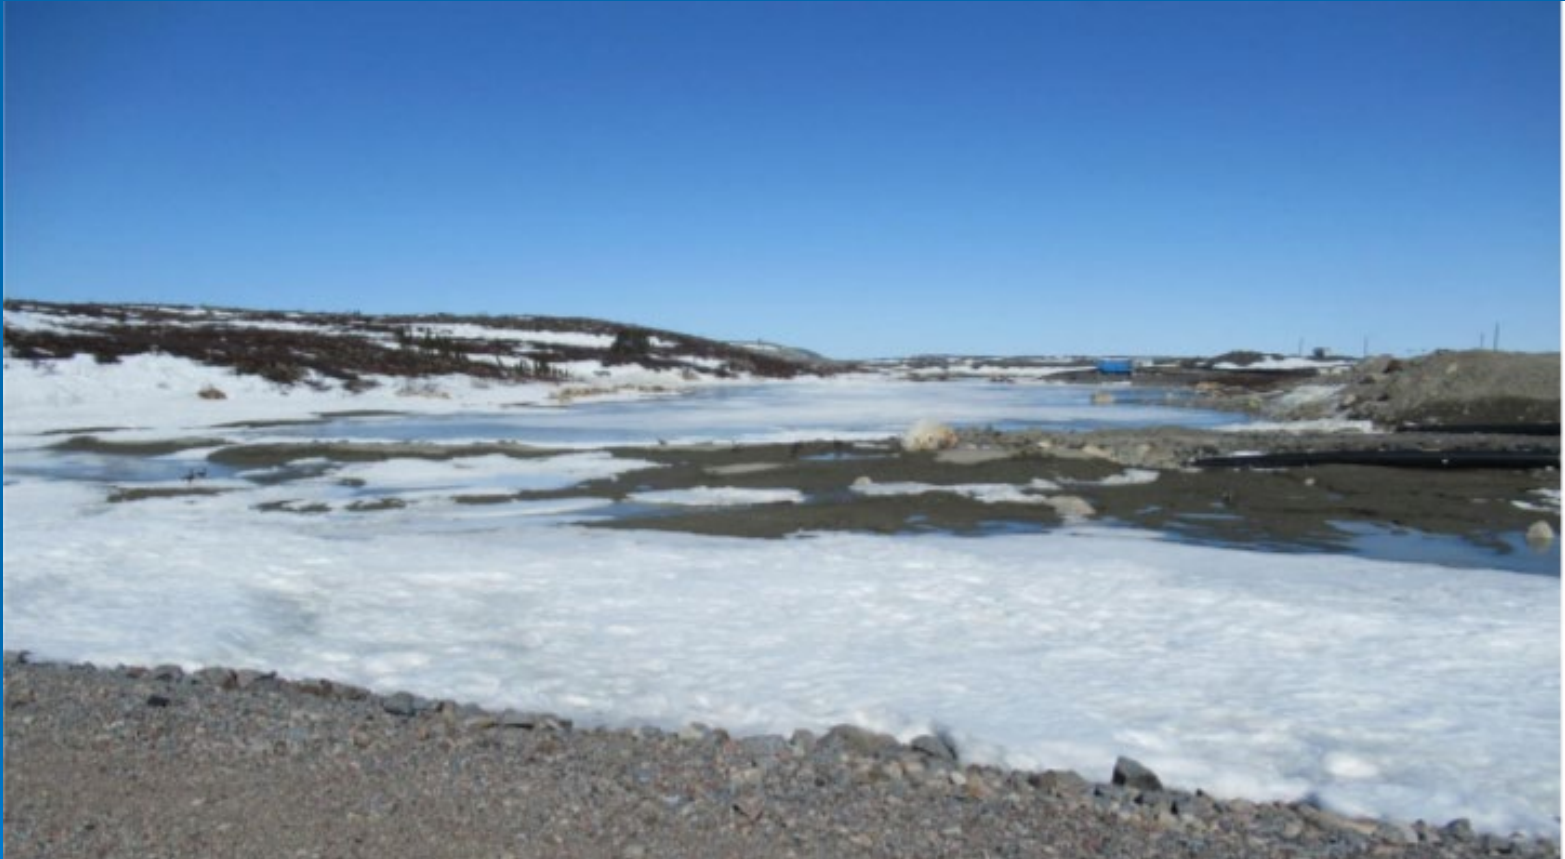
Photo 1: Looking north at the Snap Lake Mine WMP

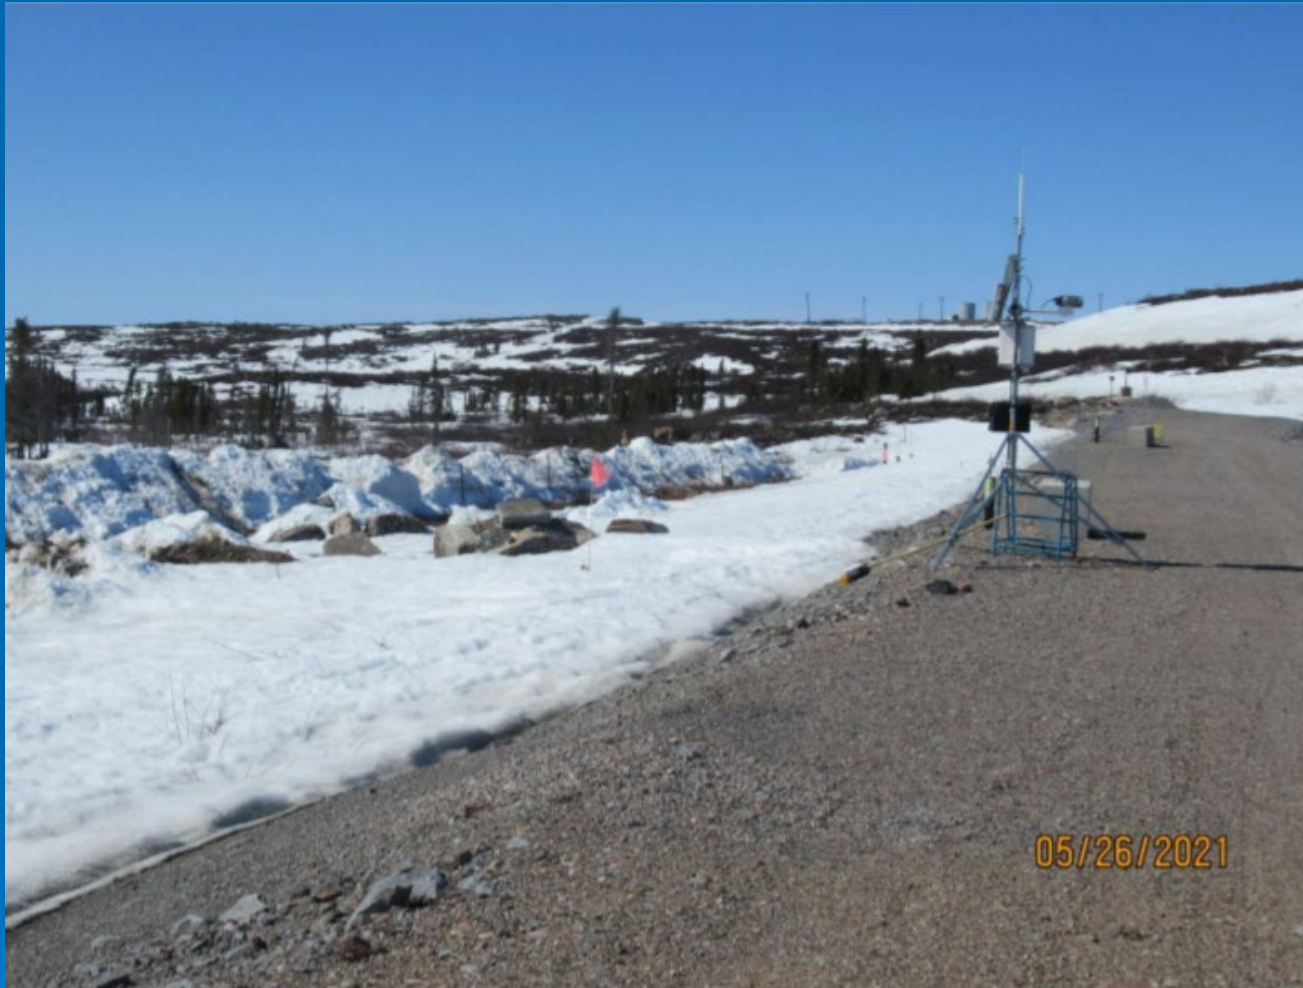
Photo 2: Looking west at the south dyke of the WMP. The remote camera, ground thermistors and piezometers can be seen

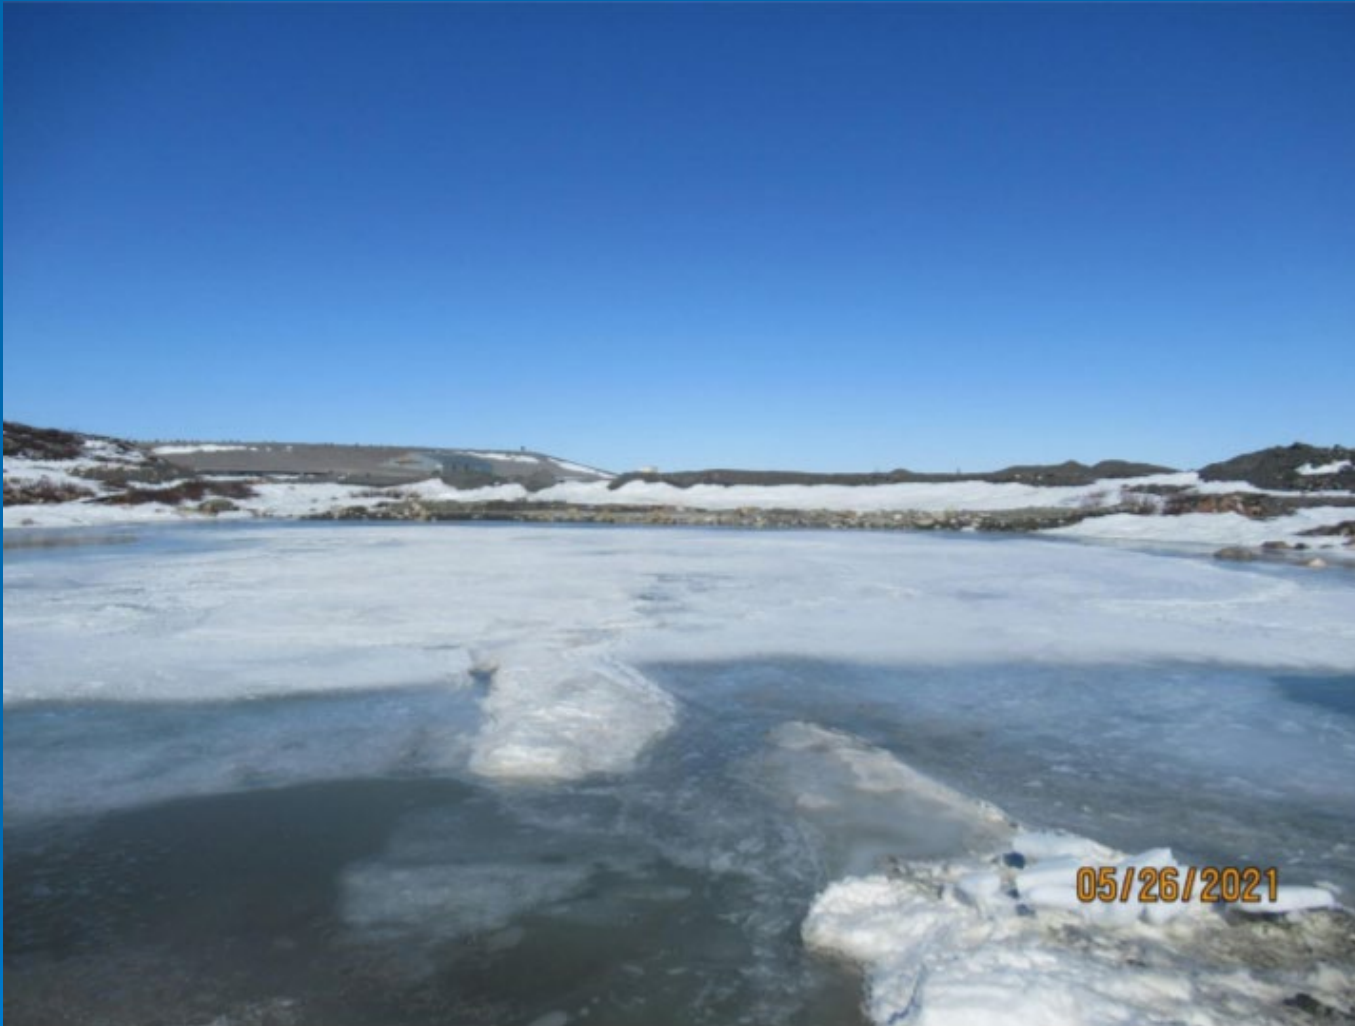
Photo 3: Looking north at the regraded north dyke on the WMPs

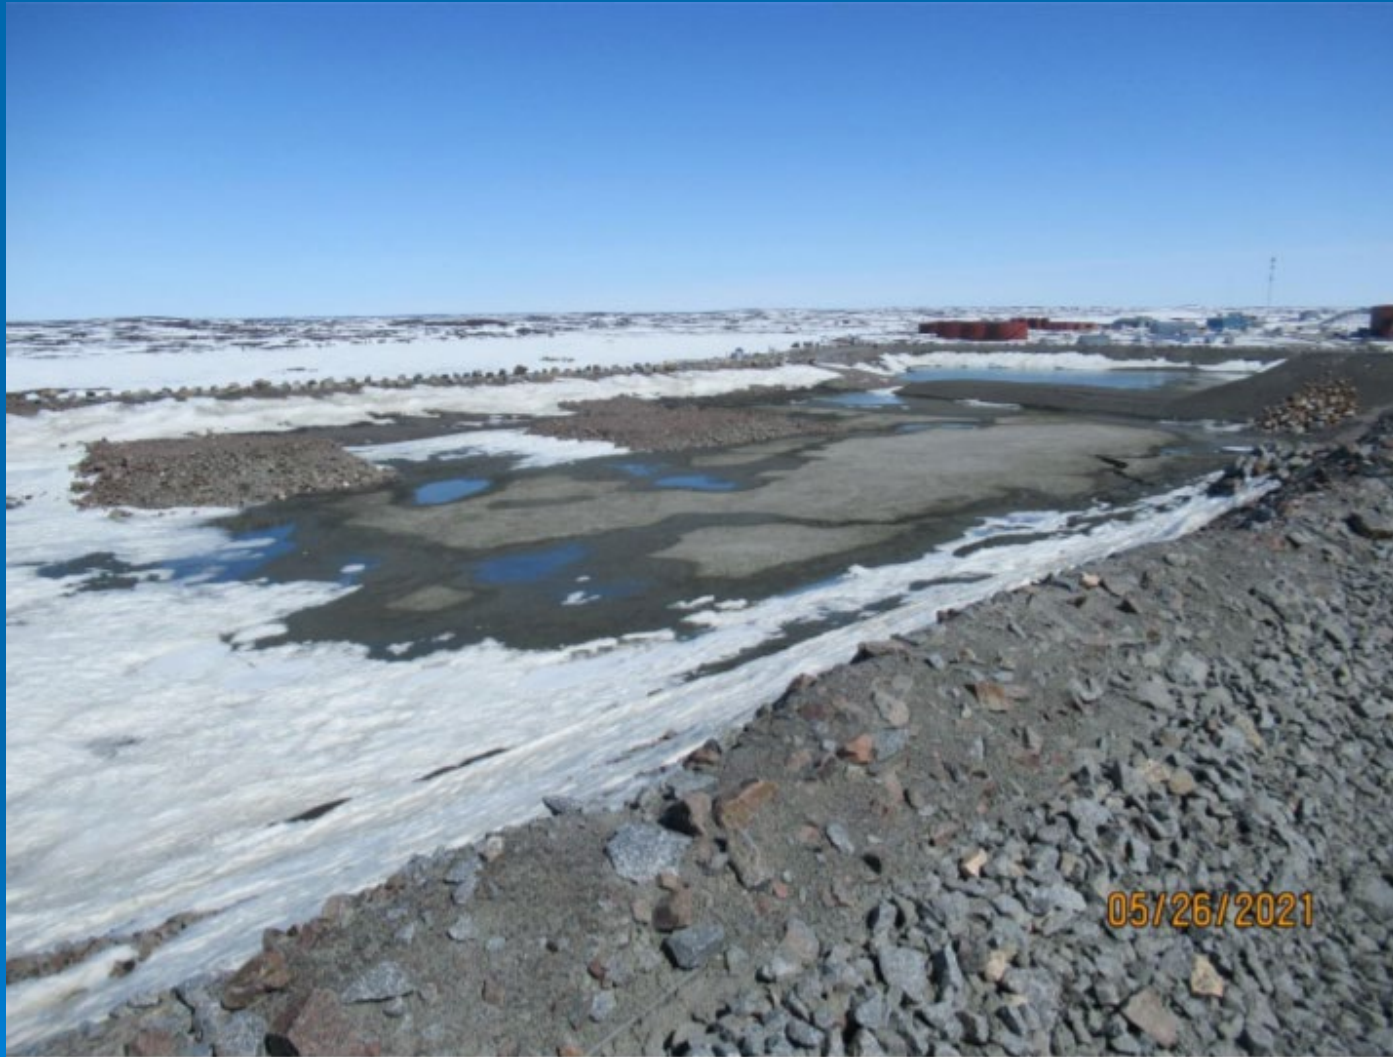
Photo 4: Looking at the North Pile East Cell - Cell 4. Water is present on the east of the cell

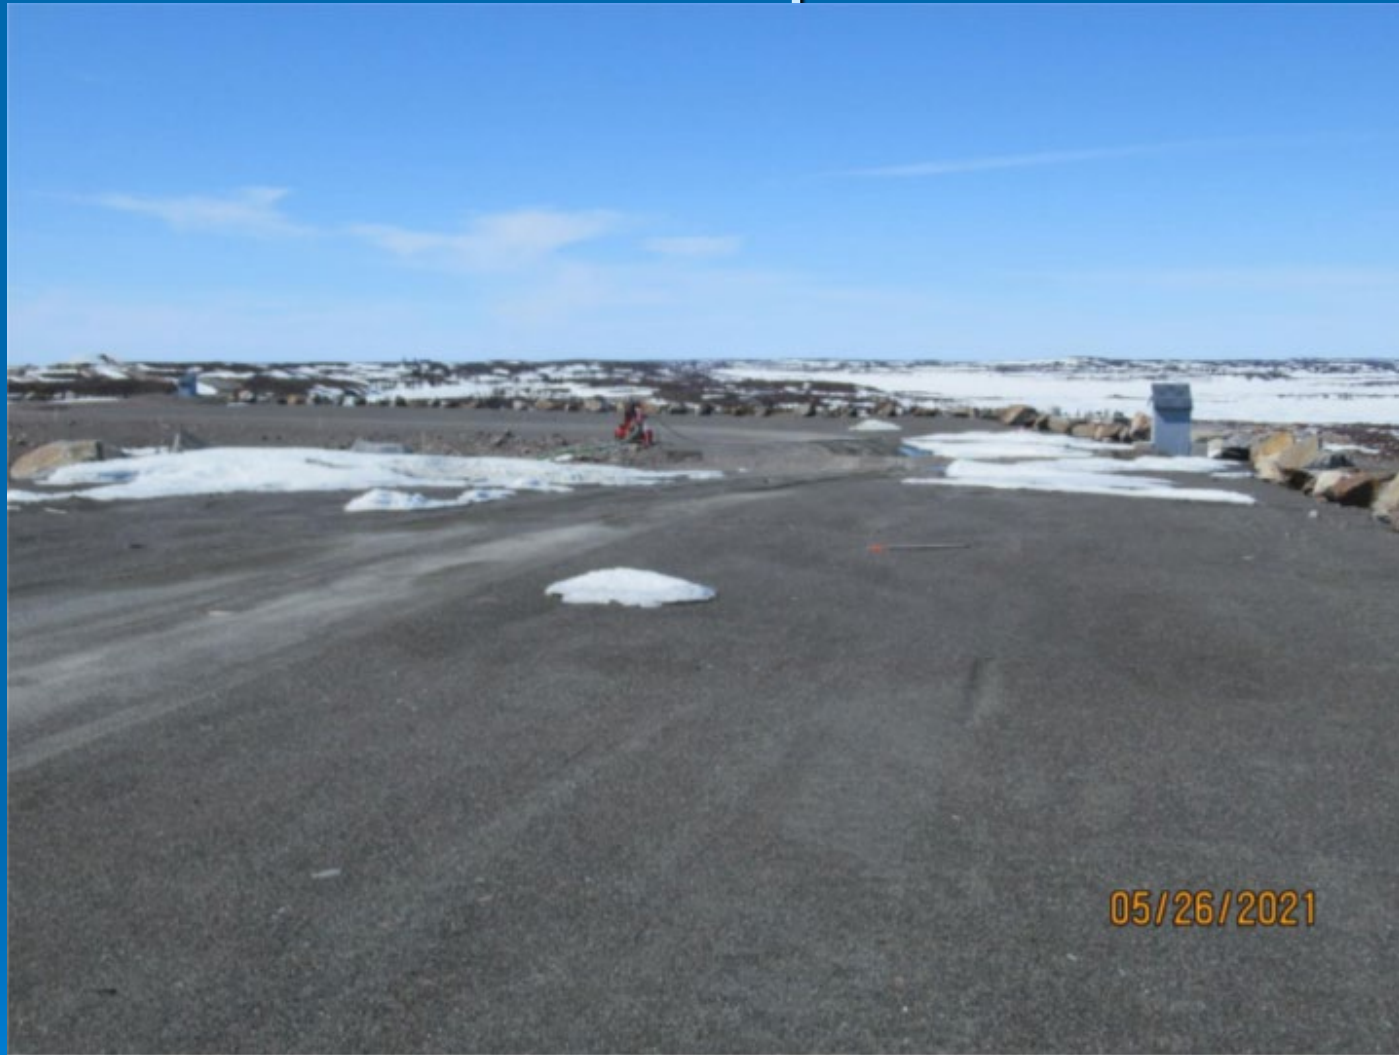
Photo 5: Looking north at a diesel water pump staged on the east of the cell in Photo #4 and a covered thermistor that was installed in 2020

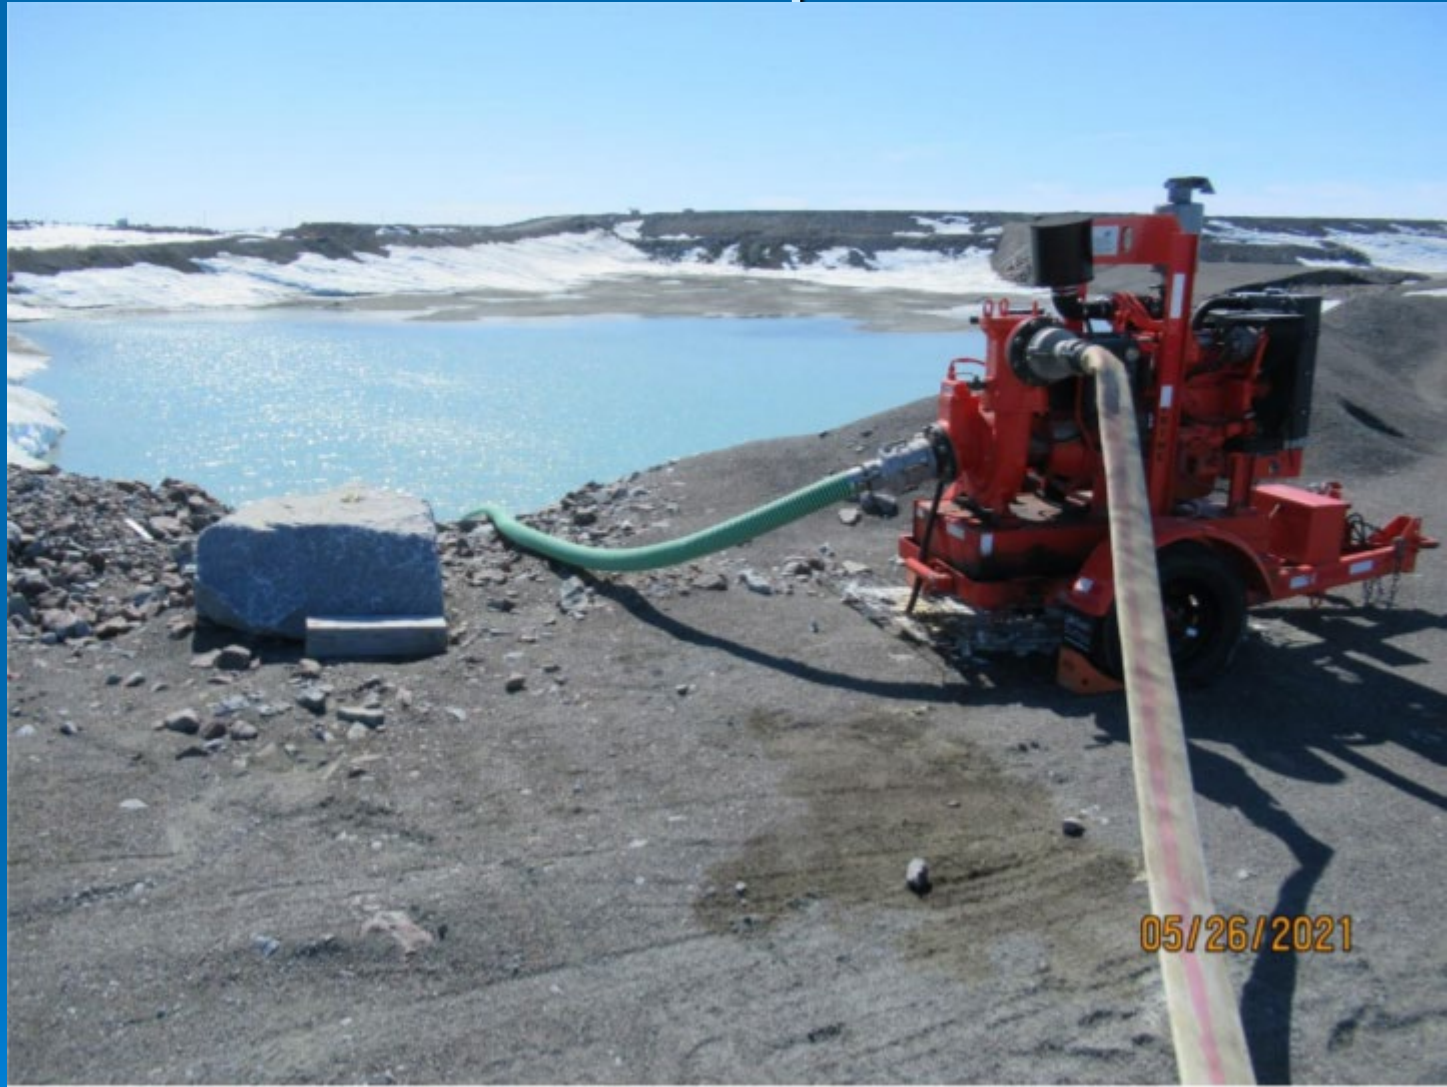
Photo 6: Secondary containment structures under the pumps must be maintained and hydrocarbon impacted soils cleaned up and disposed of.

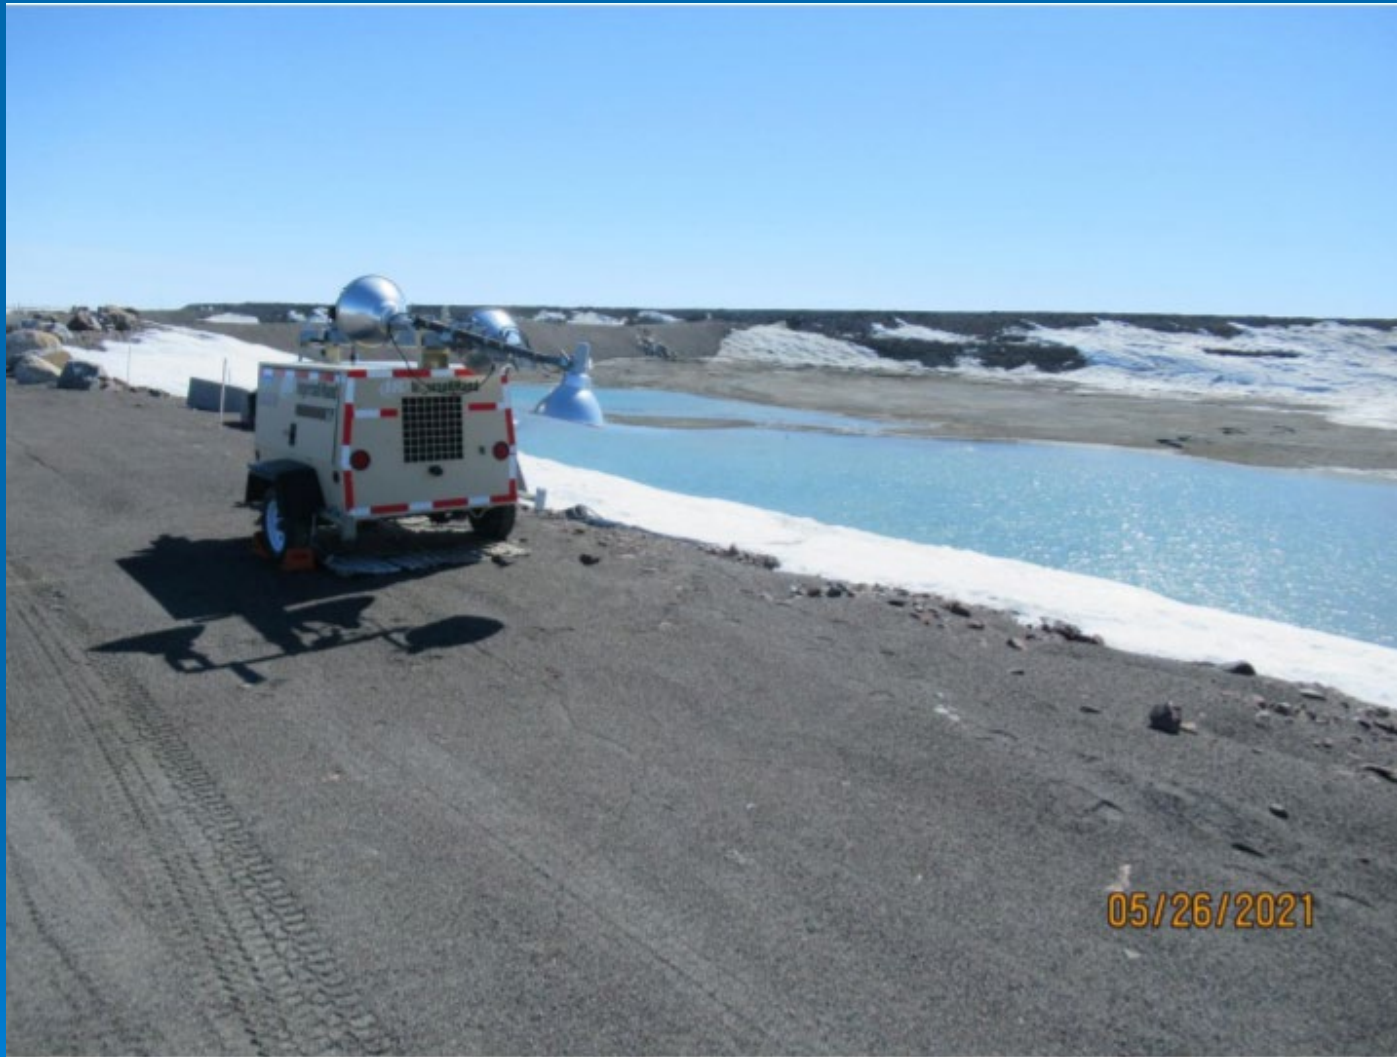
Photo 7: This generator is used to power an electrical pump that is being used to pump water out of cells on the North Pole.

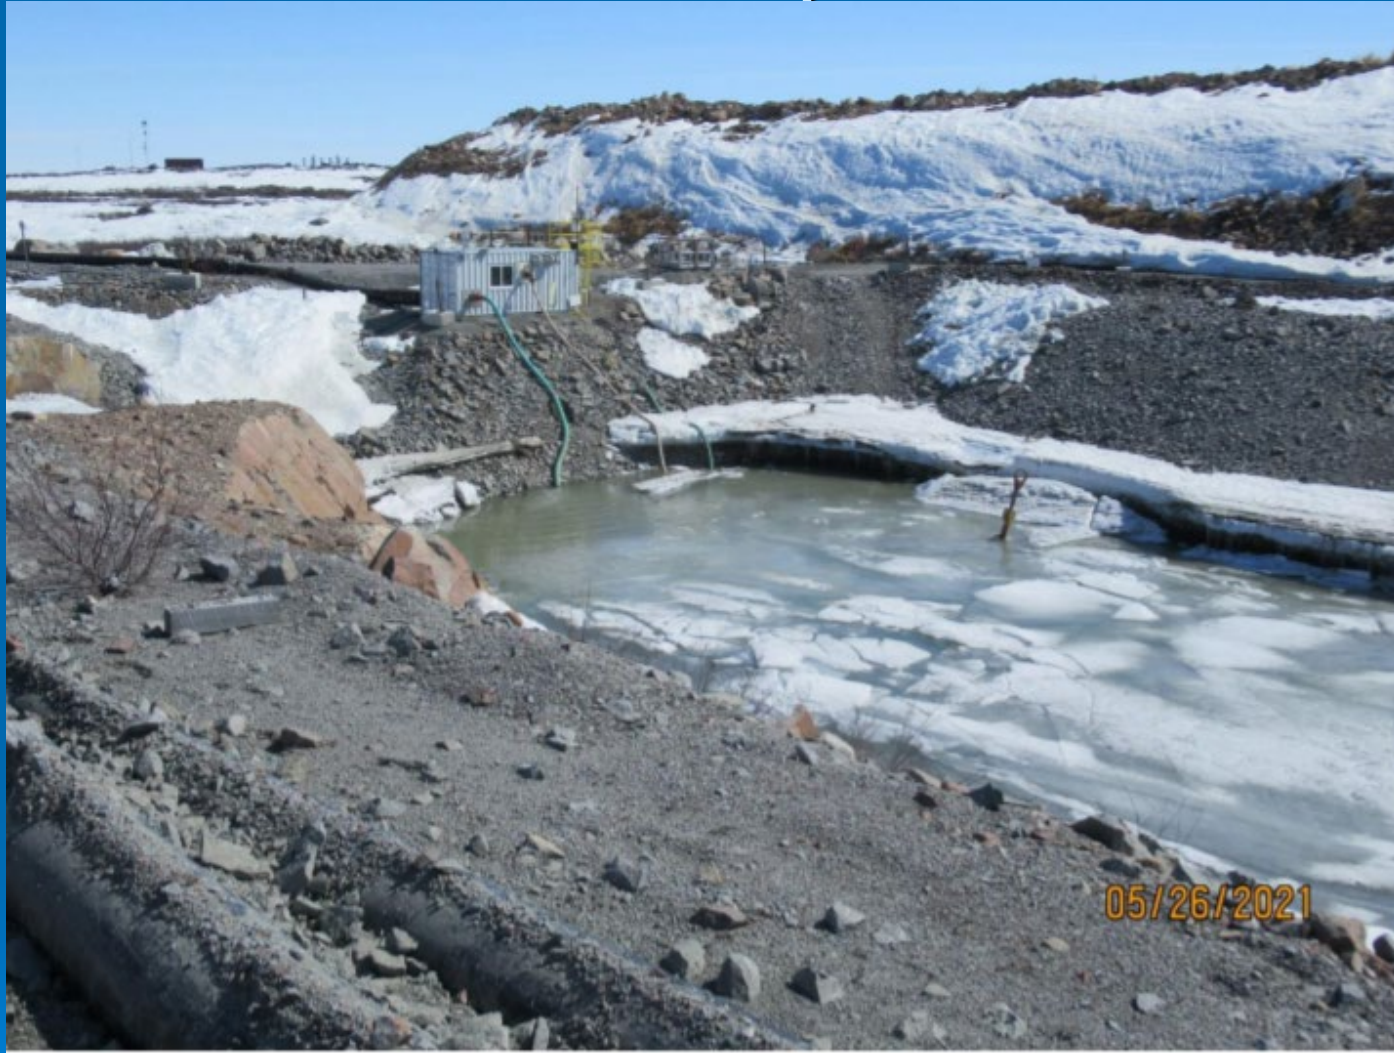
Photo 8: The pumps were recirculating water at PS #2. It appeared the staff gauge required surveying.

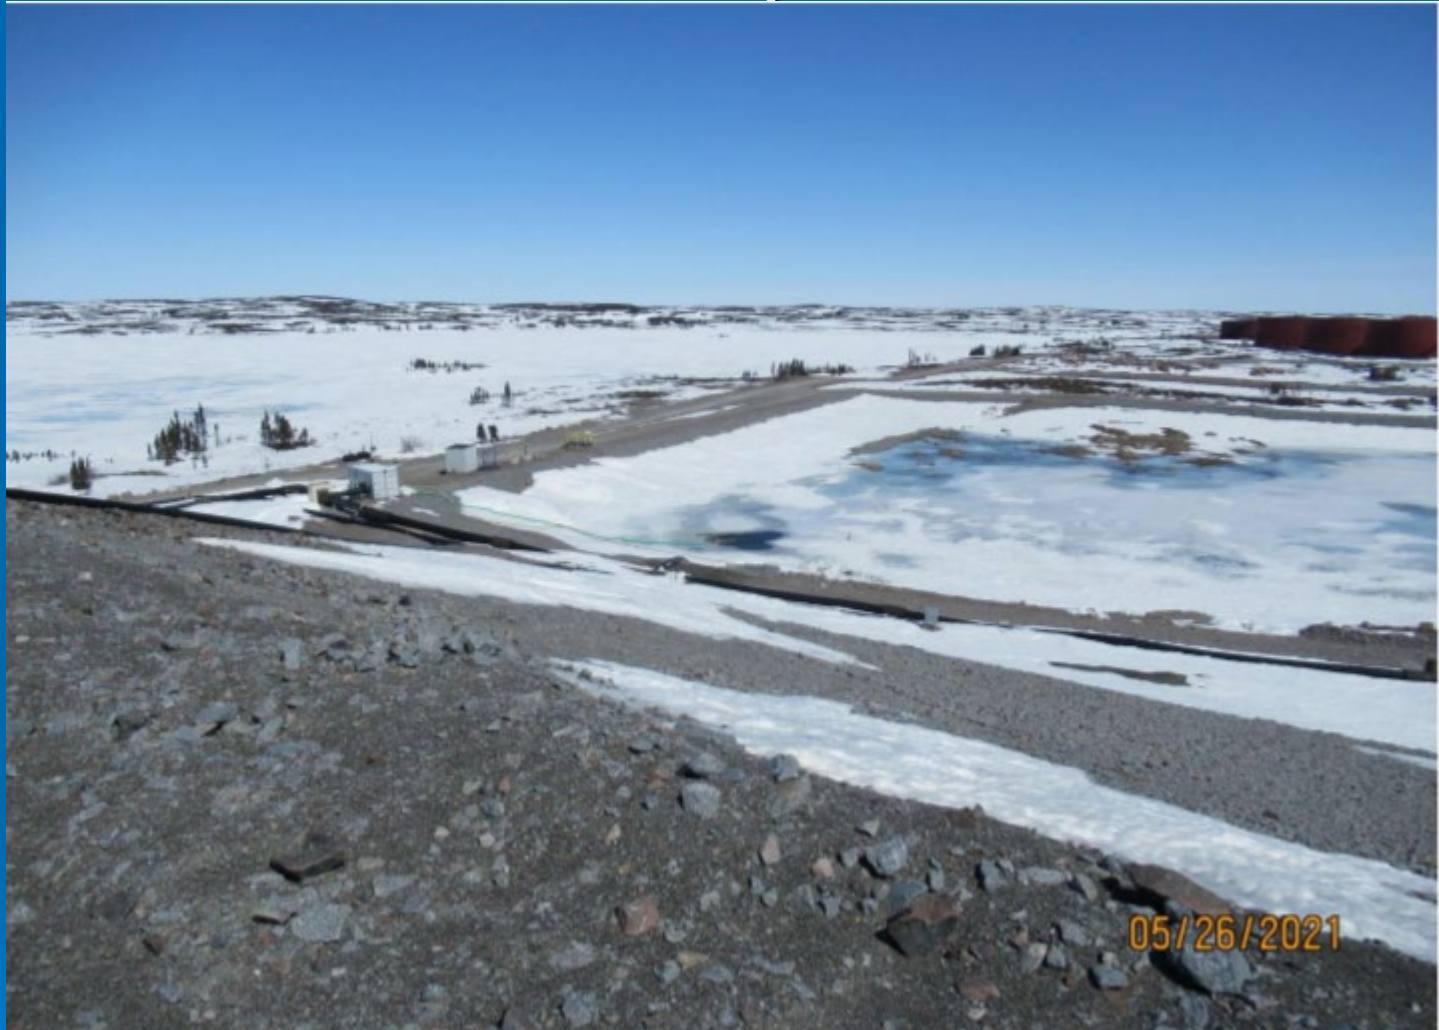
Photo 9: The pump station at PS #3. On the centre-left of the photo, a dewatering line can be seen running from the top of the North Pile down into the sump.

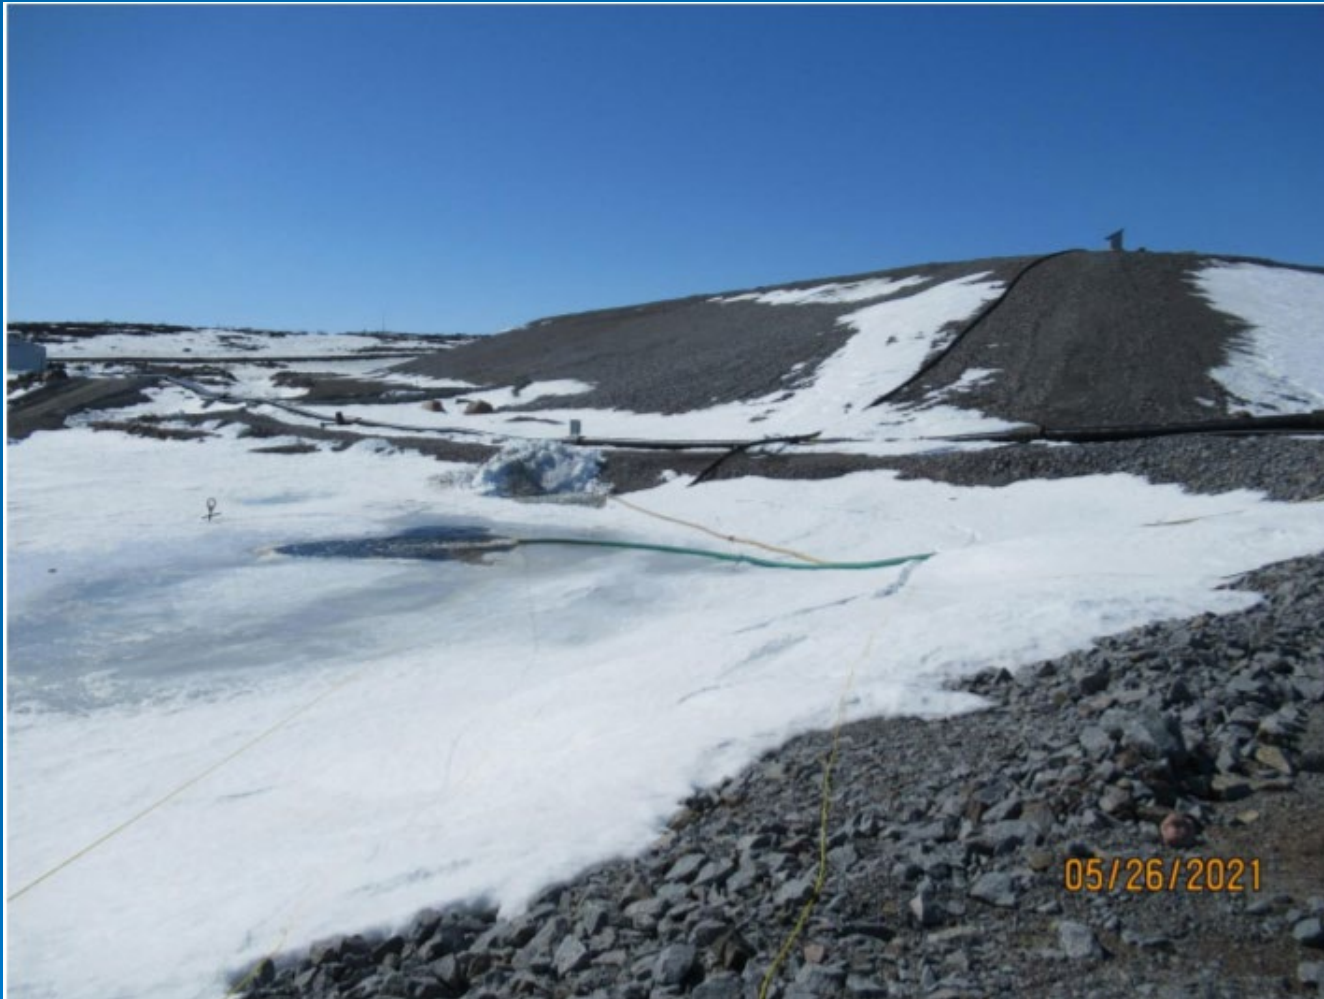
Photo 10: Water was being recirculated in PS #3. Water that is pumped from the east of the North Pile reports to the sump

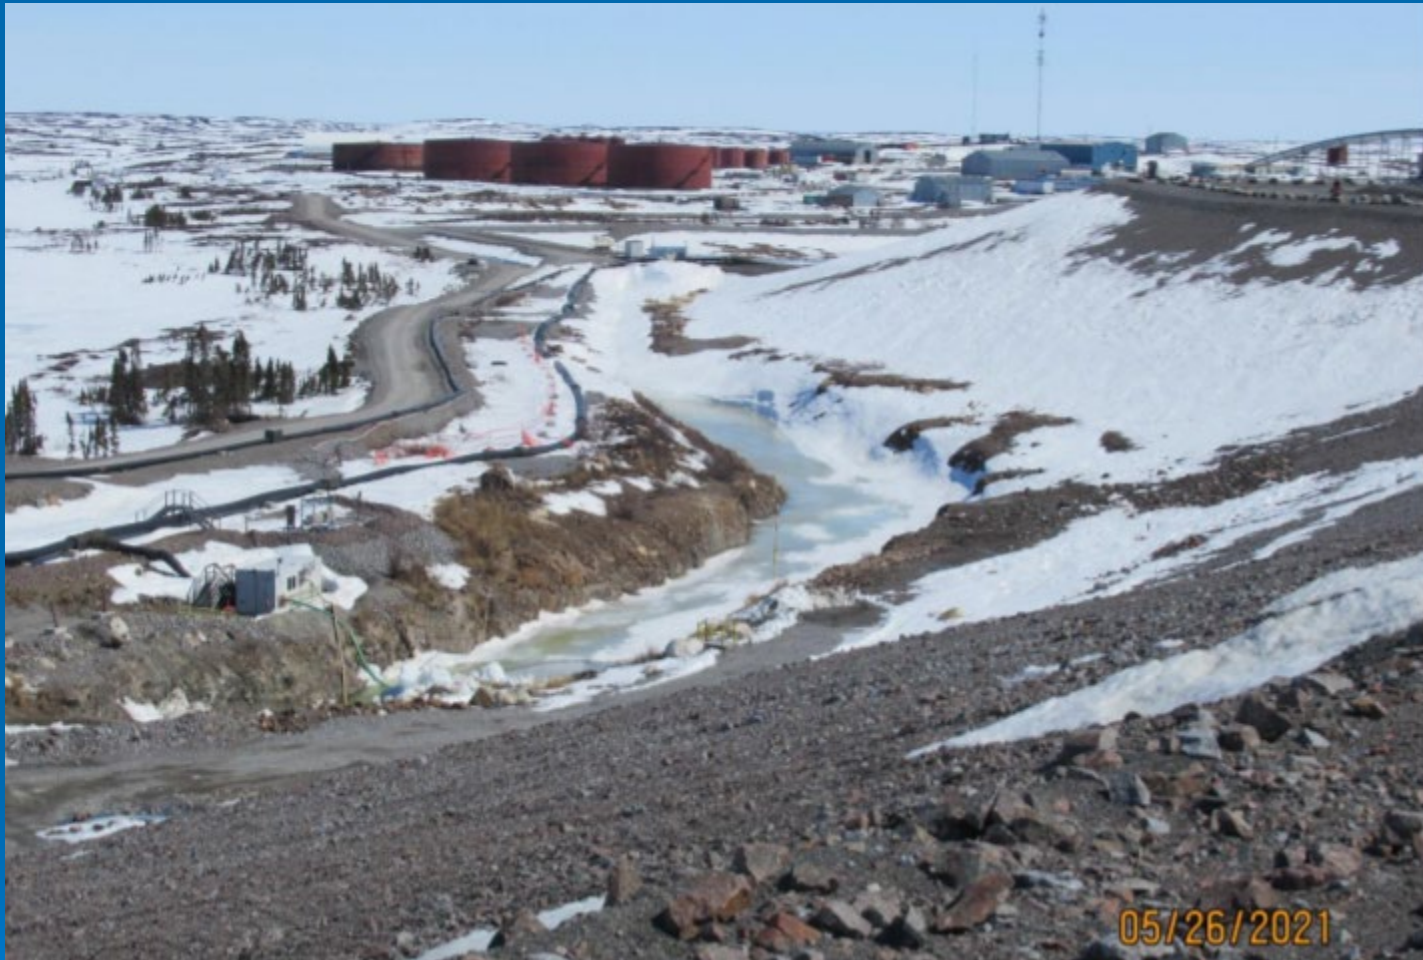
Photo 11: Looking east at PS #4. The pumps are recirculating water here to keep the water lines from freezing

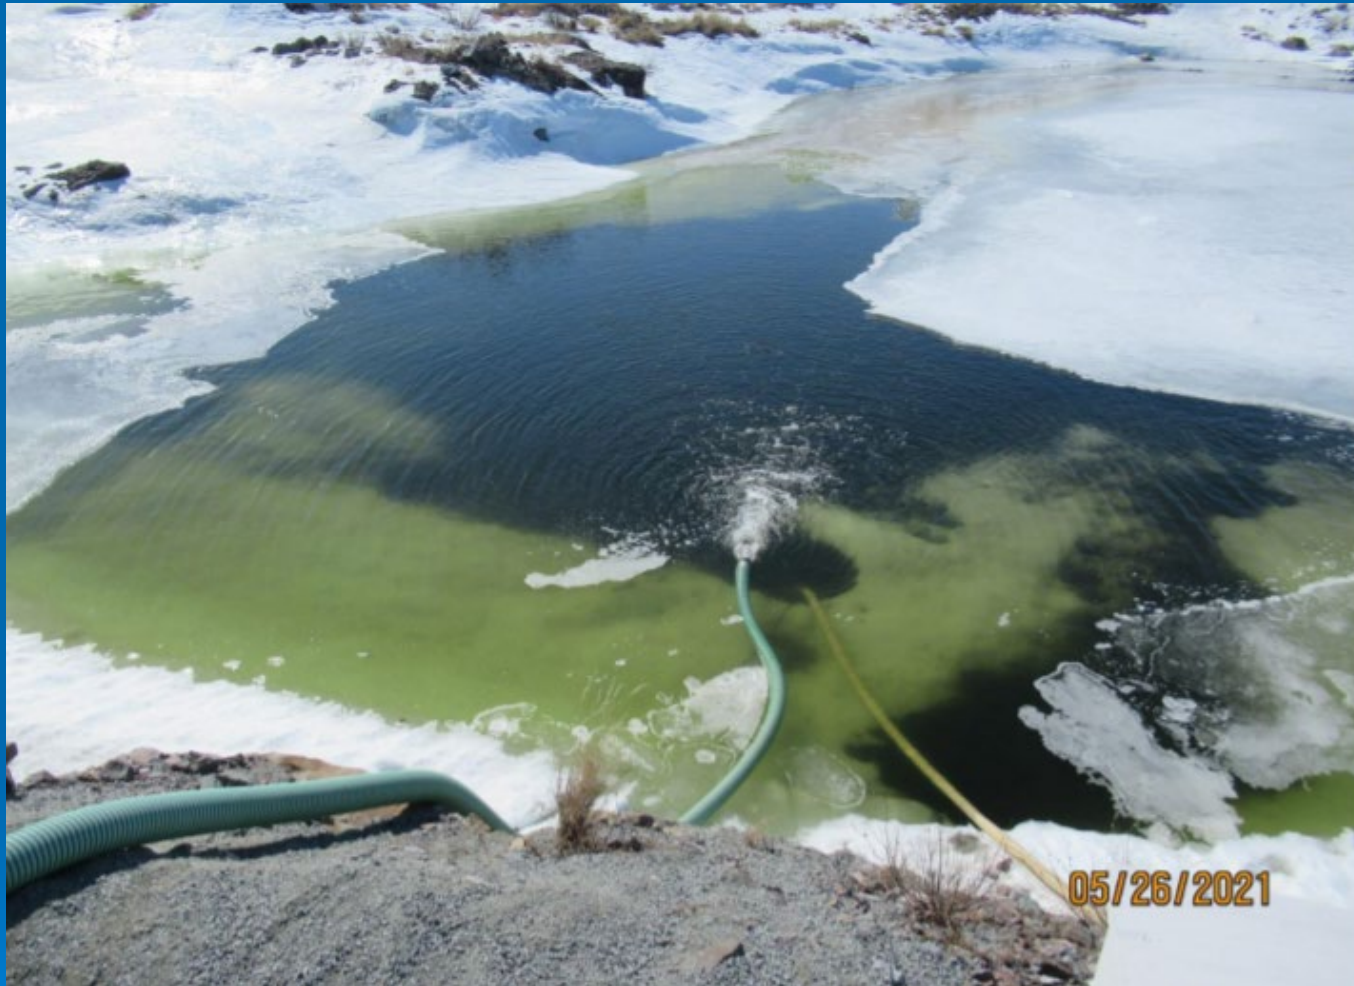
Photo 13: Water recirculation at PS #5

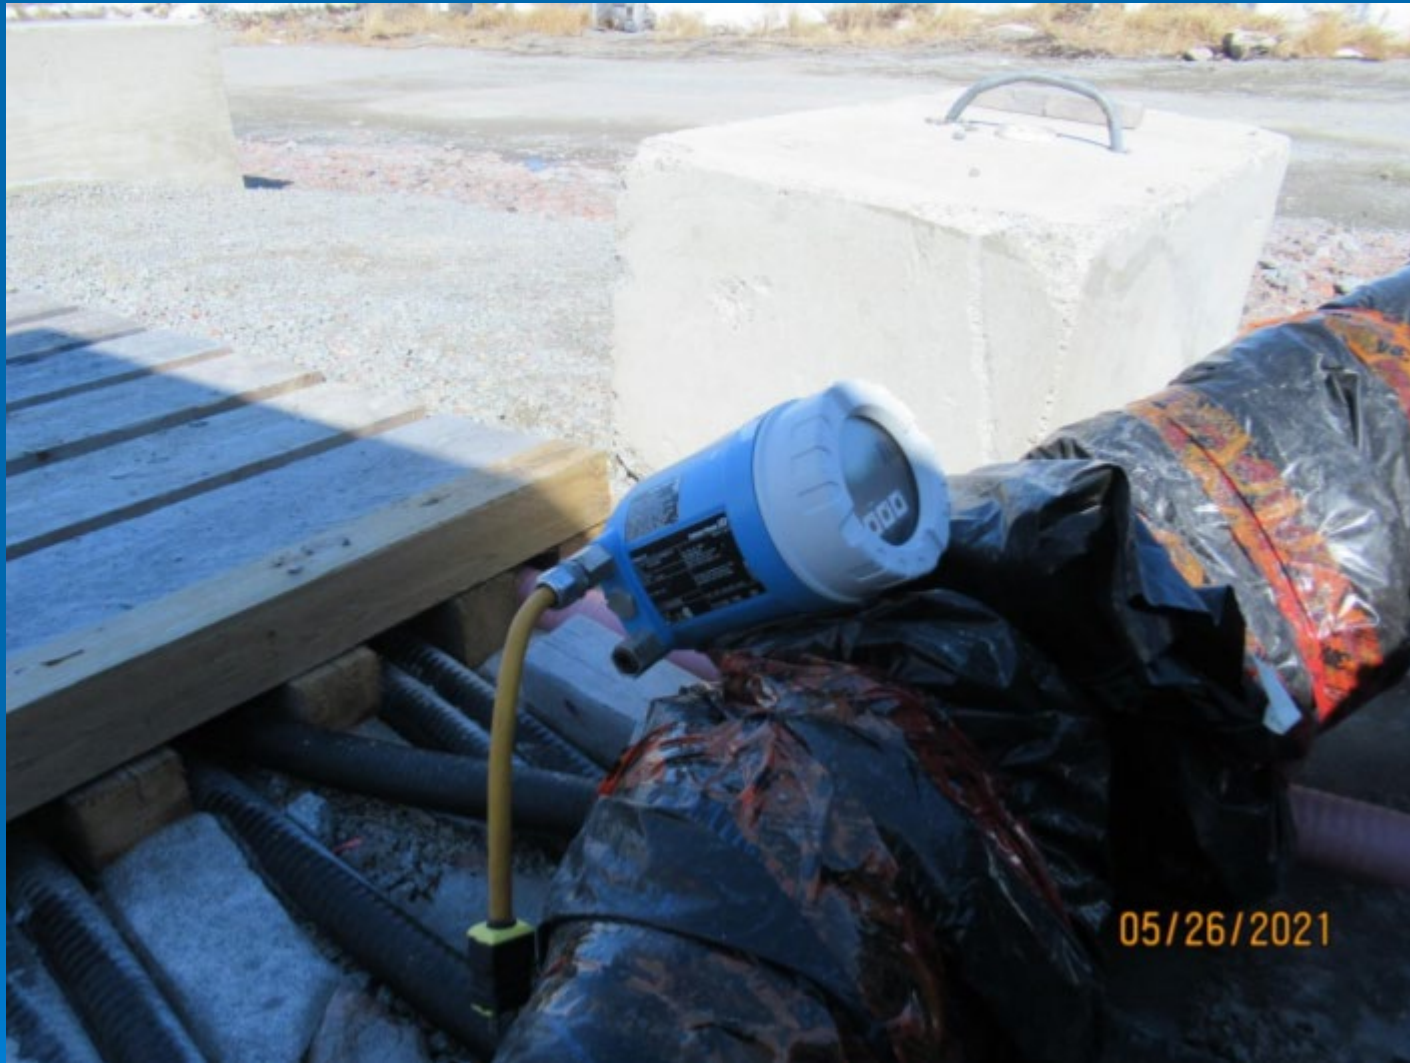
Photo 14: This totalizer at PS #5 will help track water volumes and flows once pumping commences.

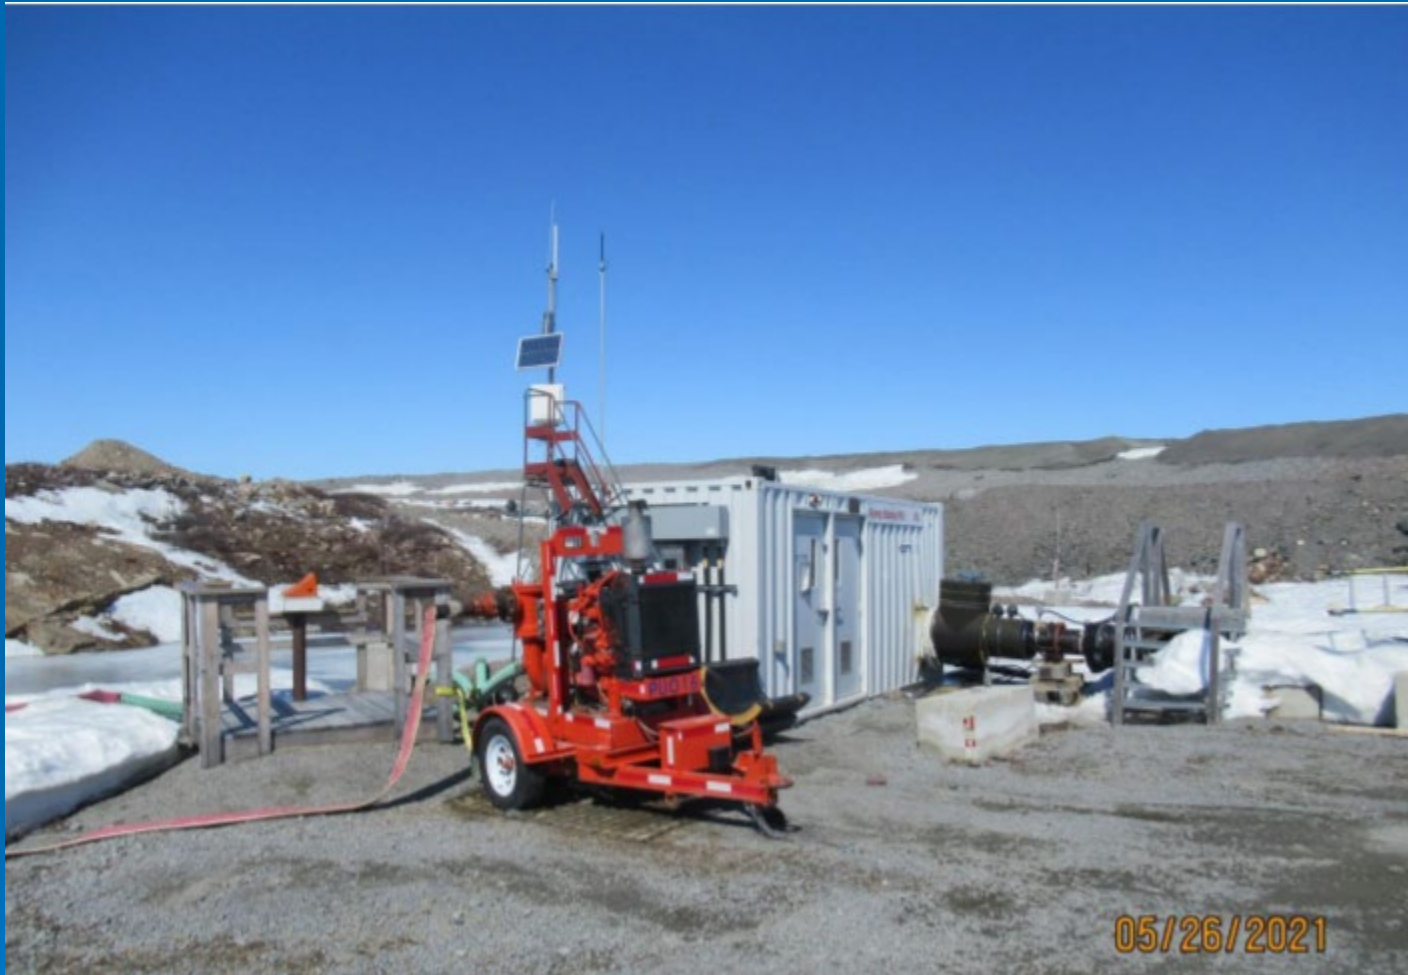
Photo 15: Diesel pump located at PS #1.

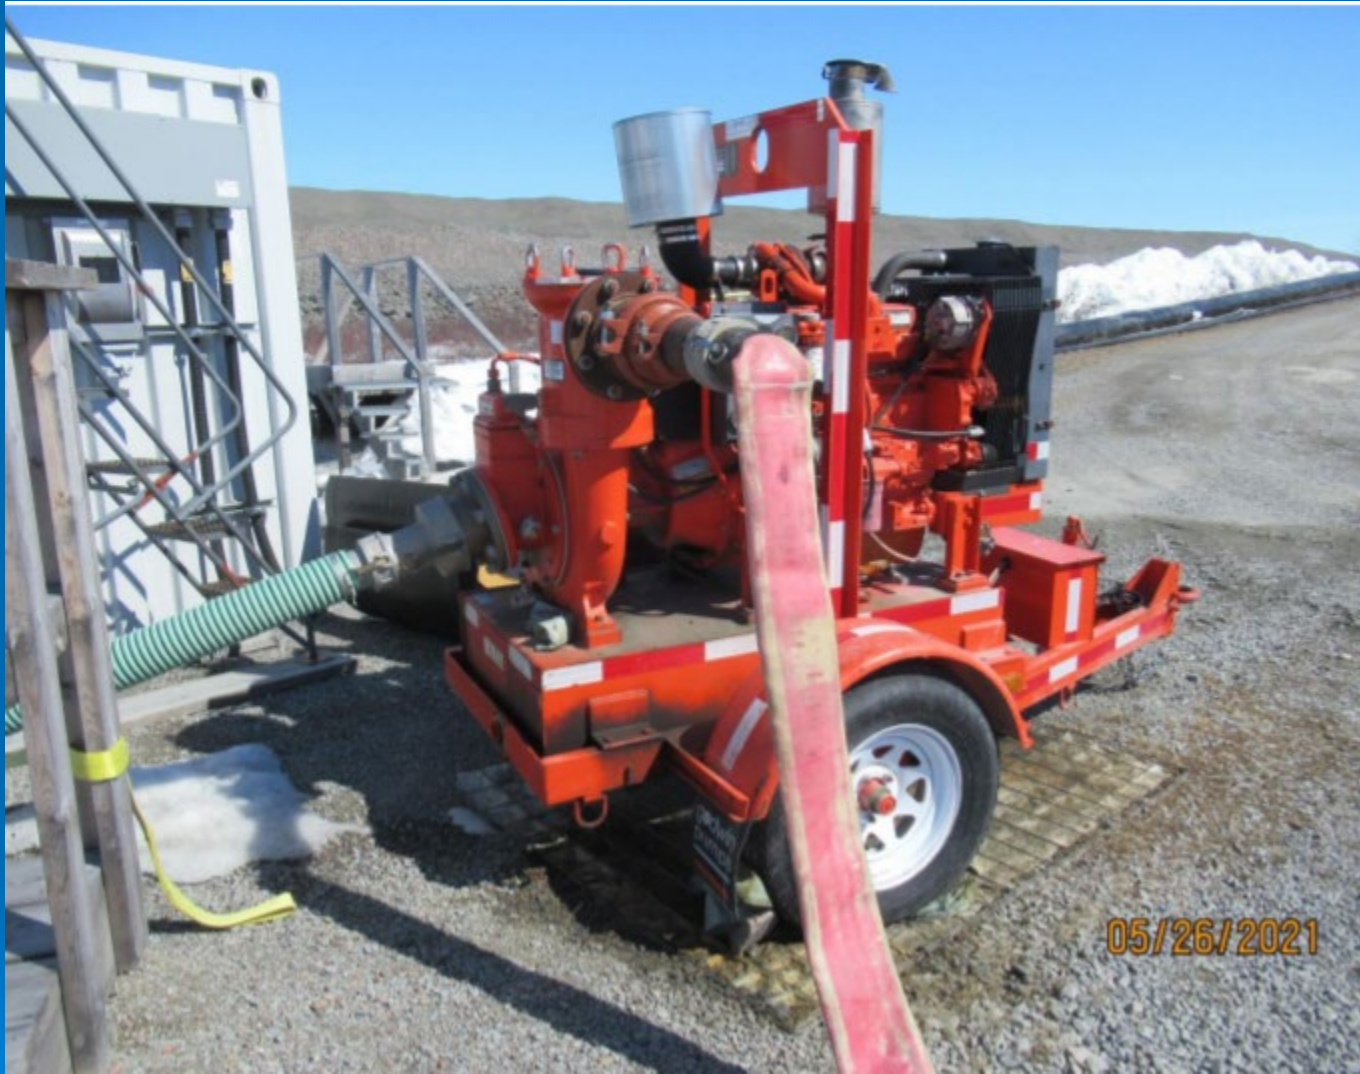
Photo 16: The secondary containment under this pump was saturated and required changing.

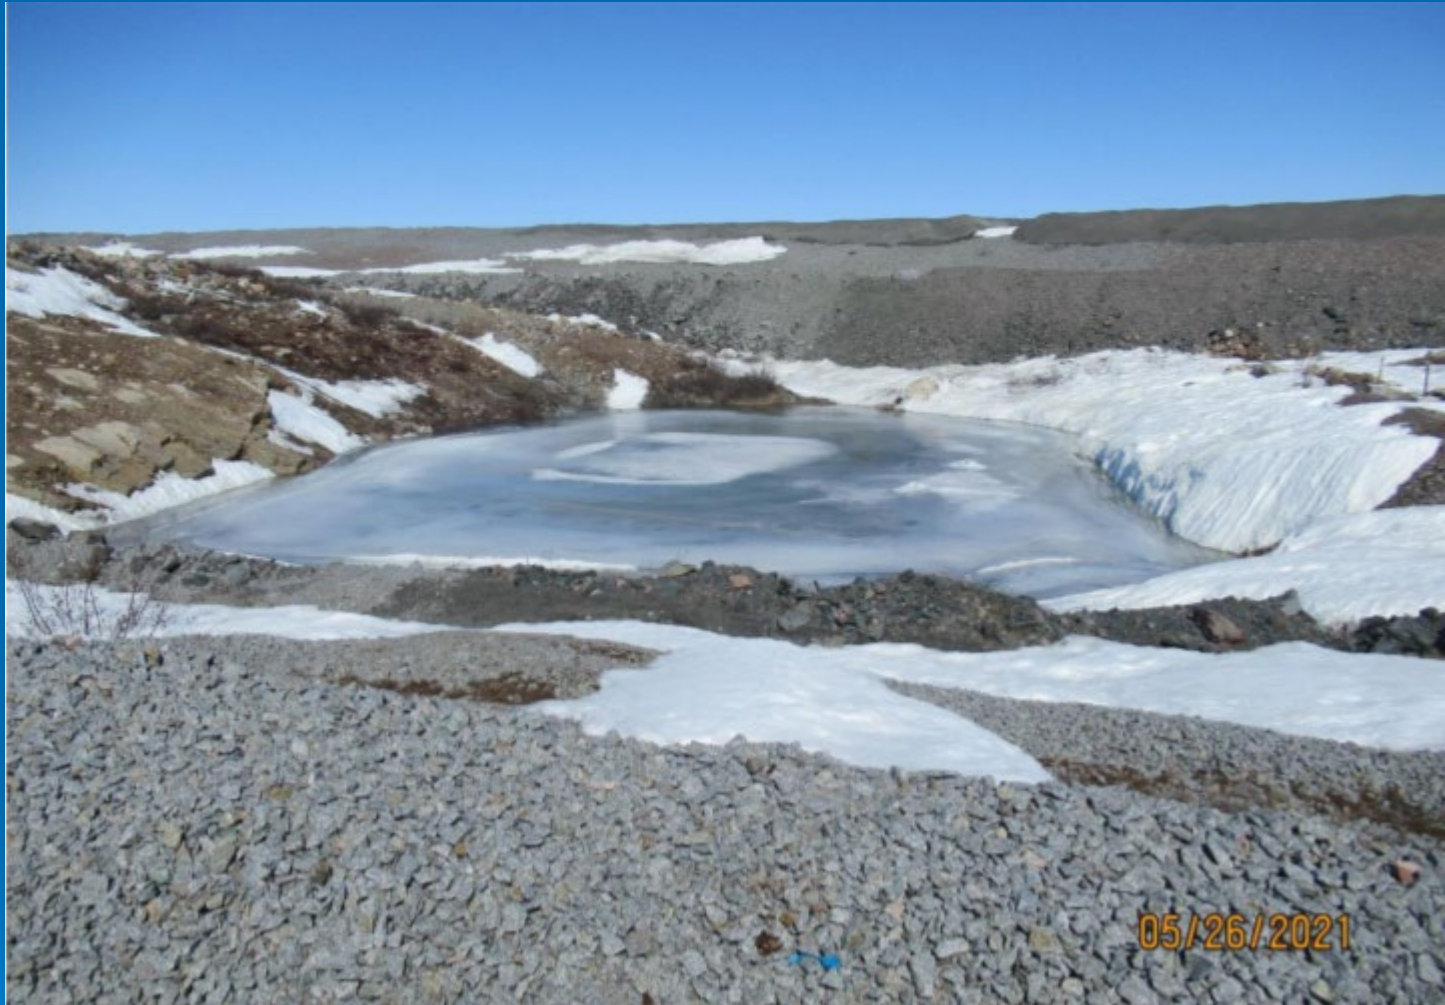
Photo 17: The pump was not recirculating water at PS #1 and the staff gauge will be re-established and shot in by a surveyor.
