May-June 2021 Environmental Update for SLEMA Board

July 8, 2021

➤ Regulatory site inspection was conducted on May 26, 2021, by Inspector Joe Heron.

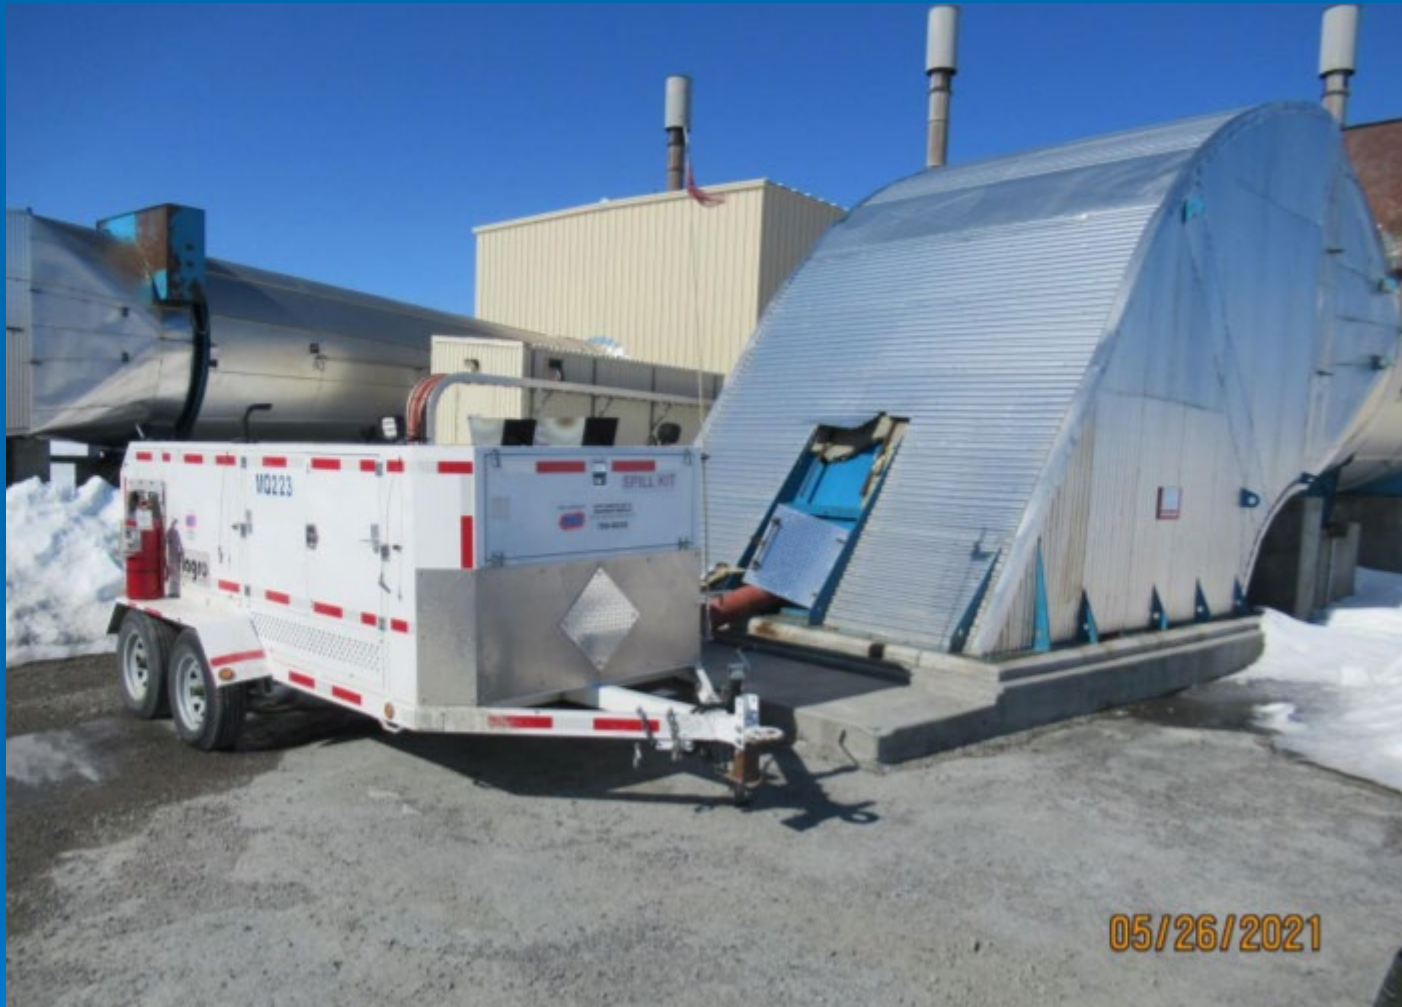
Photo 18: A self-contained heater was thawing out the bottom of the FAR monitoring station where the UG water levels are measured.

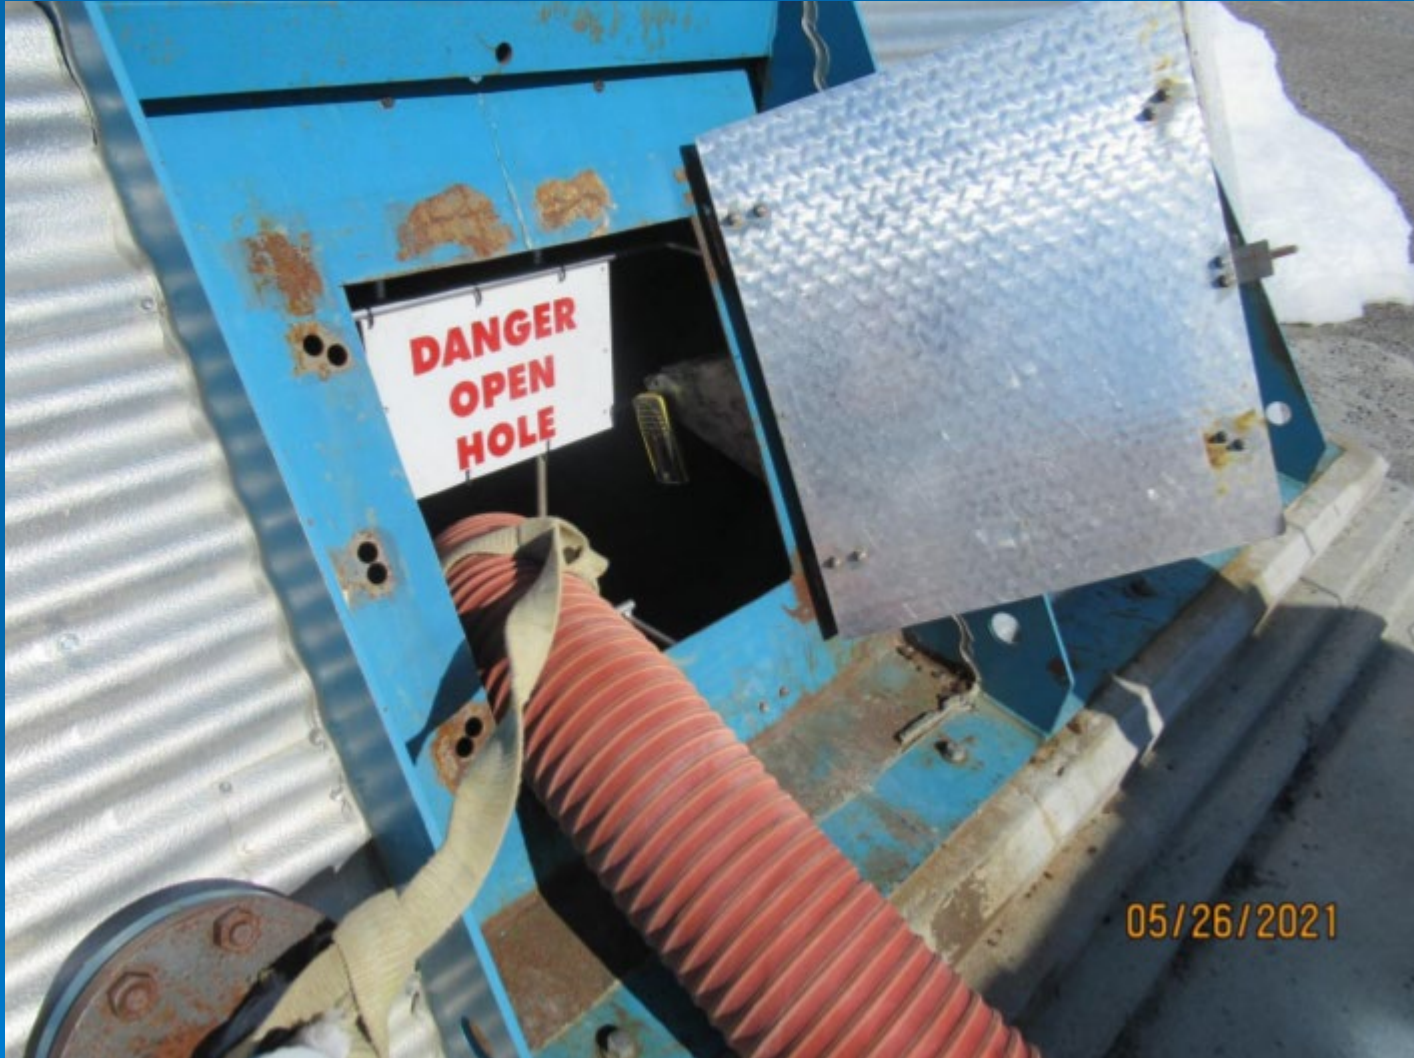
Photo 19: A meter was installed to help in the monitoring of the UG water levels

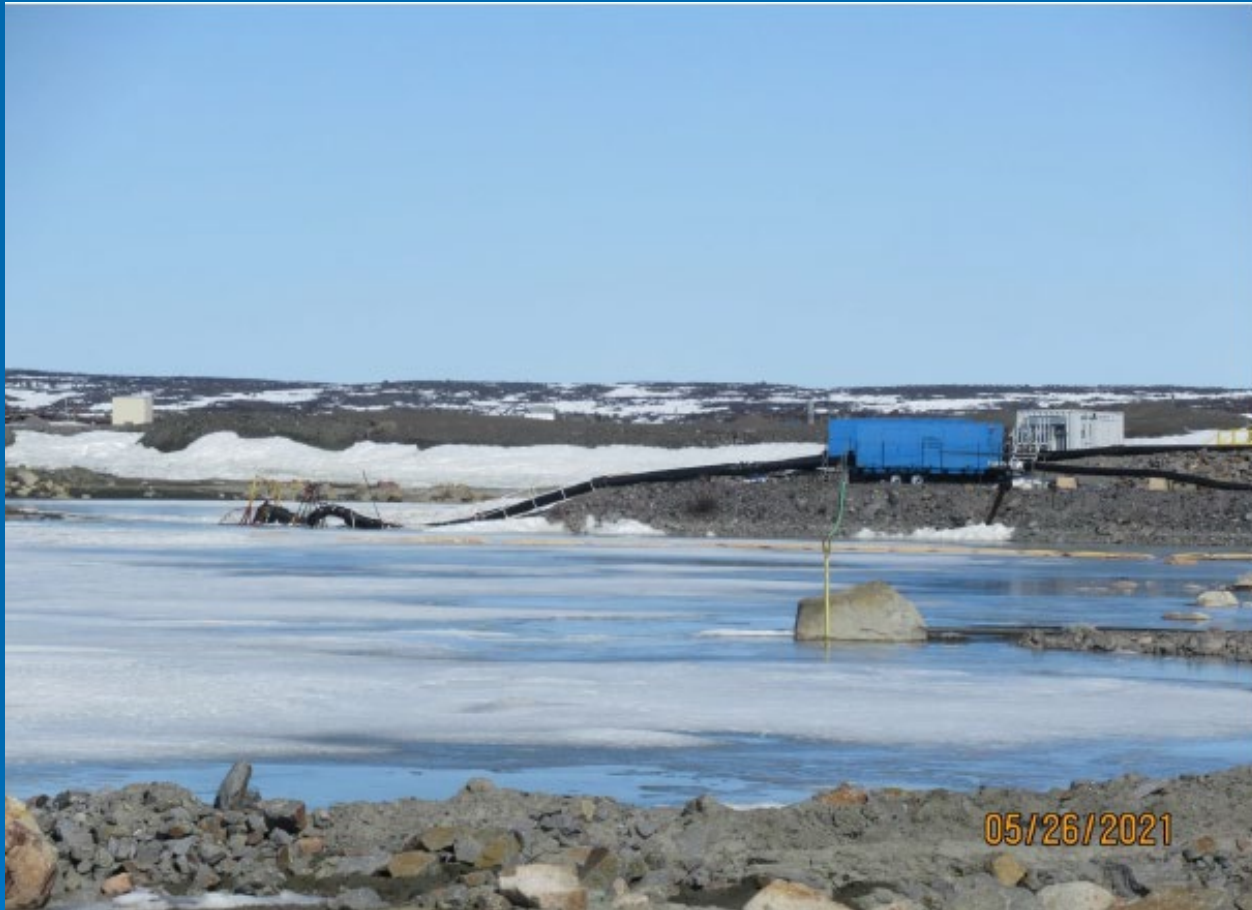
Photo 21: Looking north at the submersible electric pumps at the mine WMP.

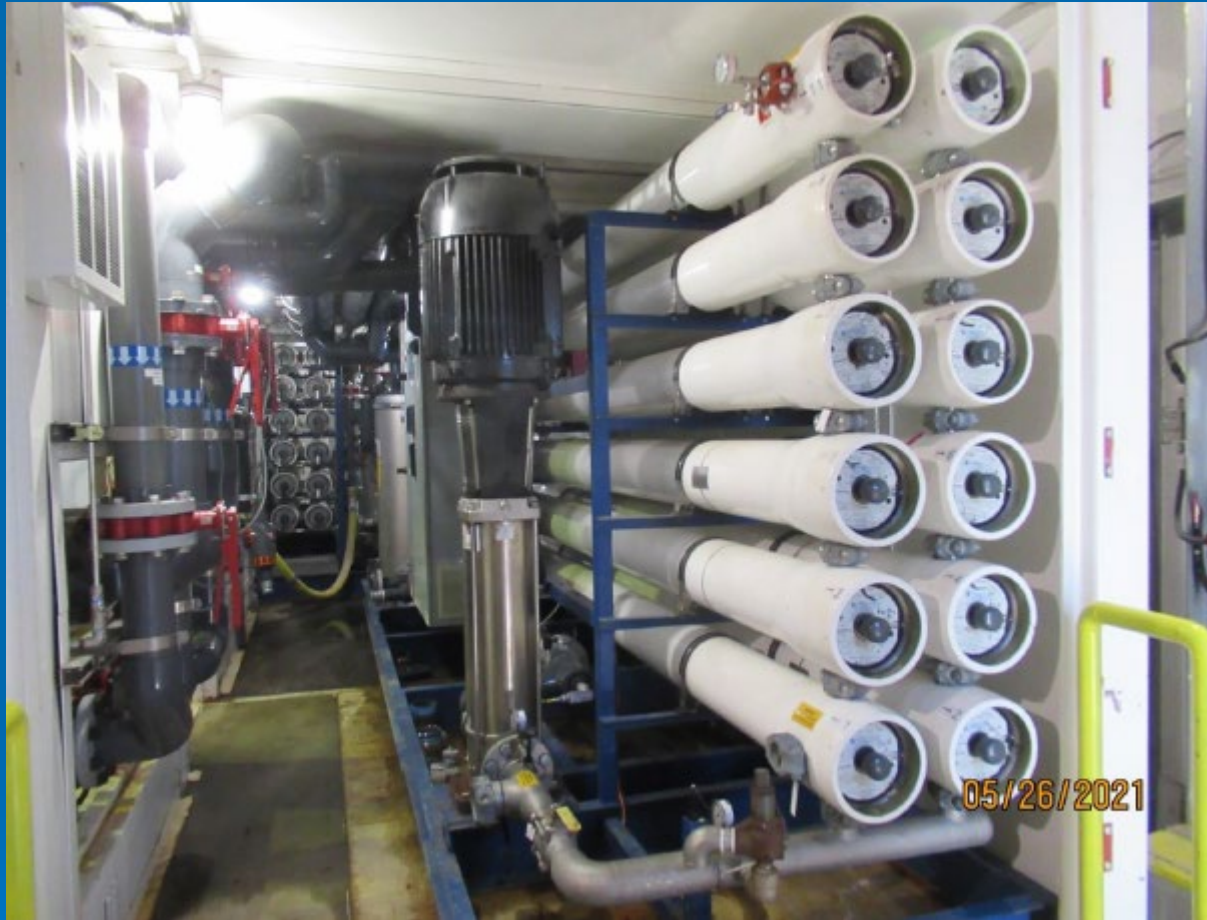
Photo 22: Looking at the RO filtration units of the mine Reverse Osmosis filtration unit.

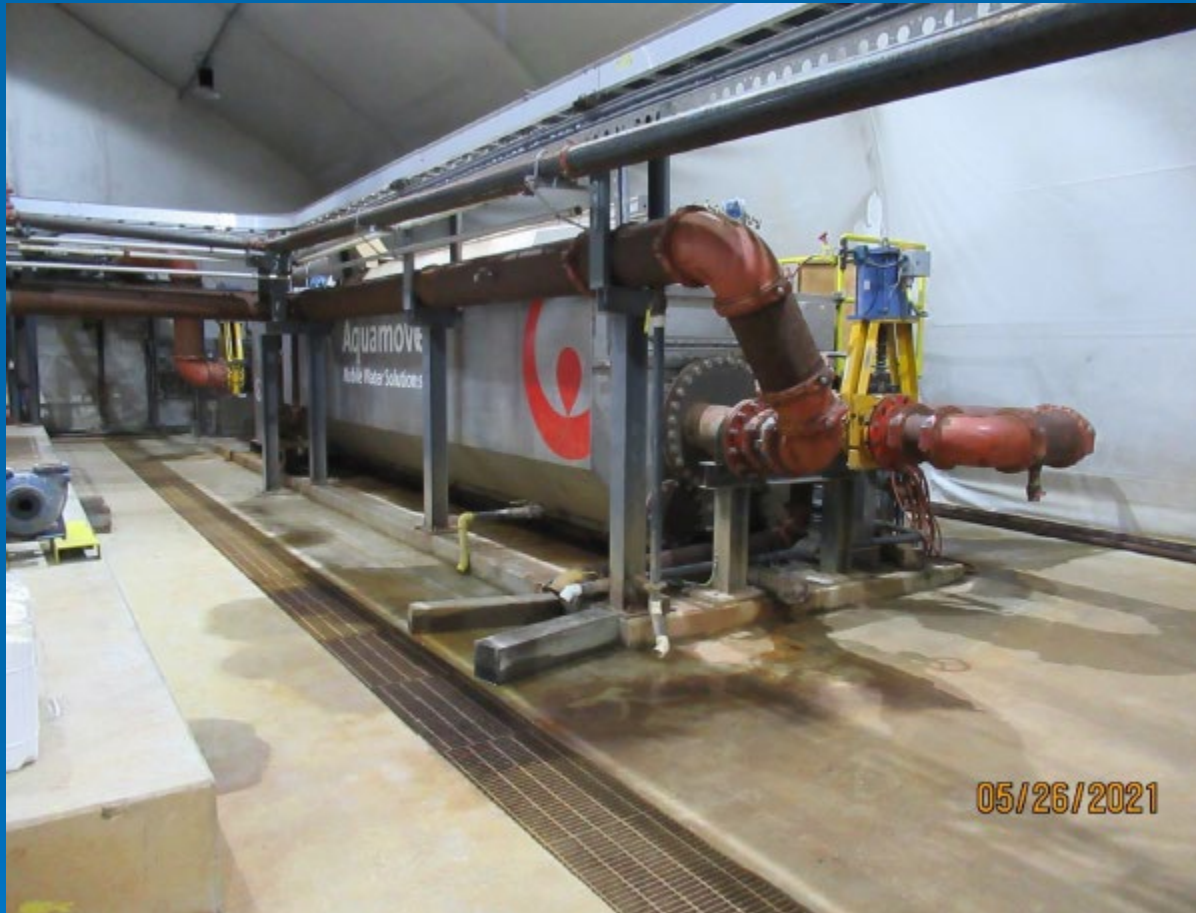
Photo 23: The disc filter unit at the modular WTP.

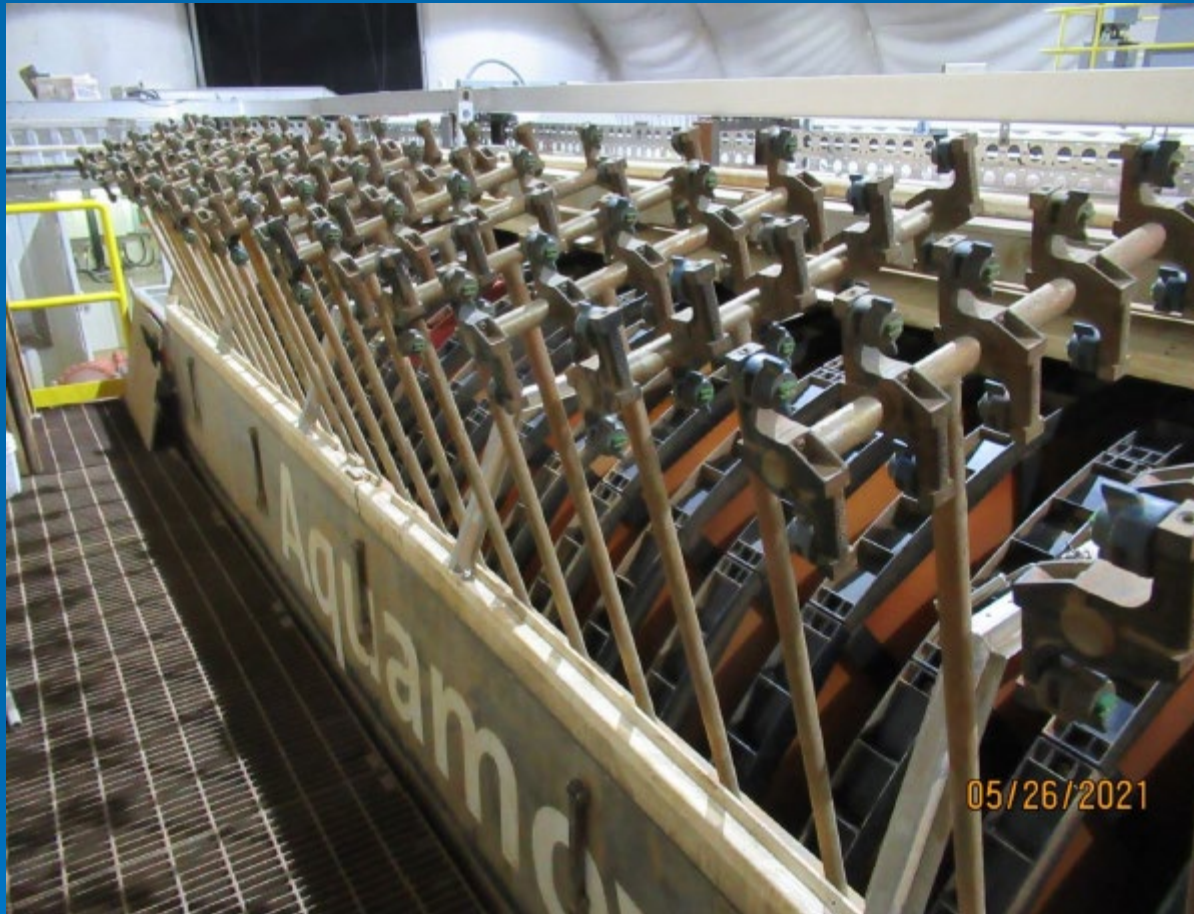
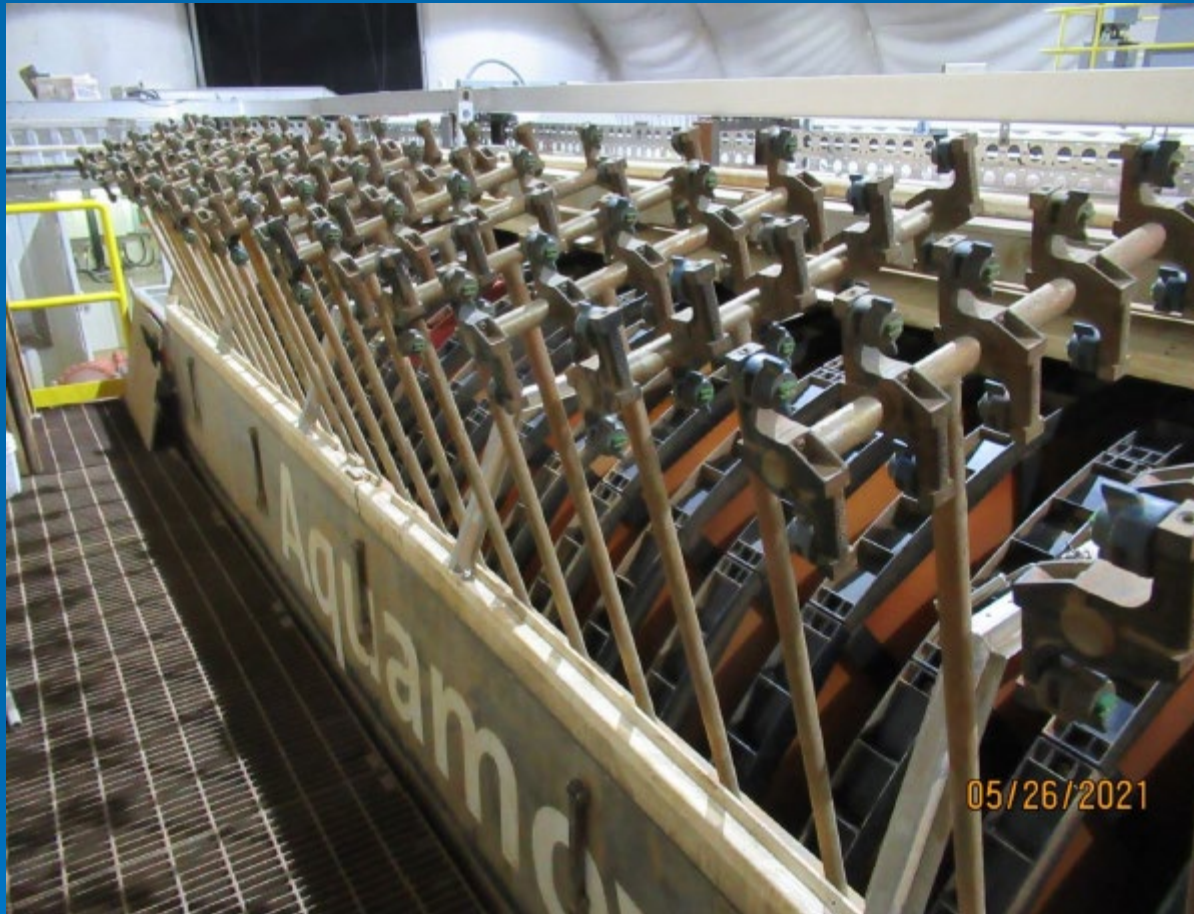
Photo 24: A look at the filter discs within the unit in Photo #23.

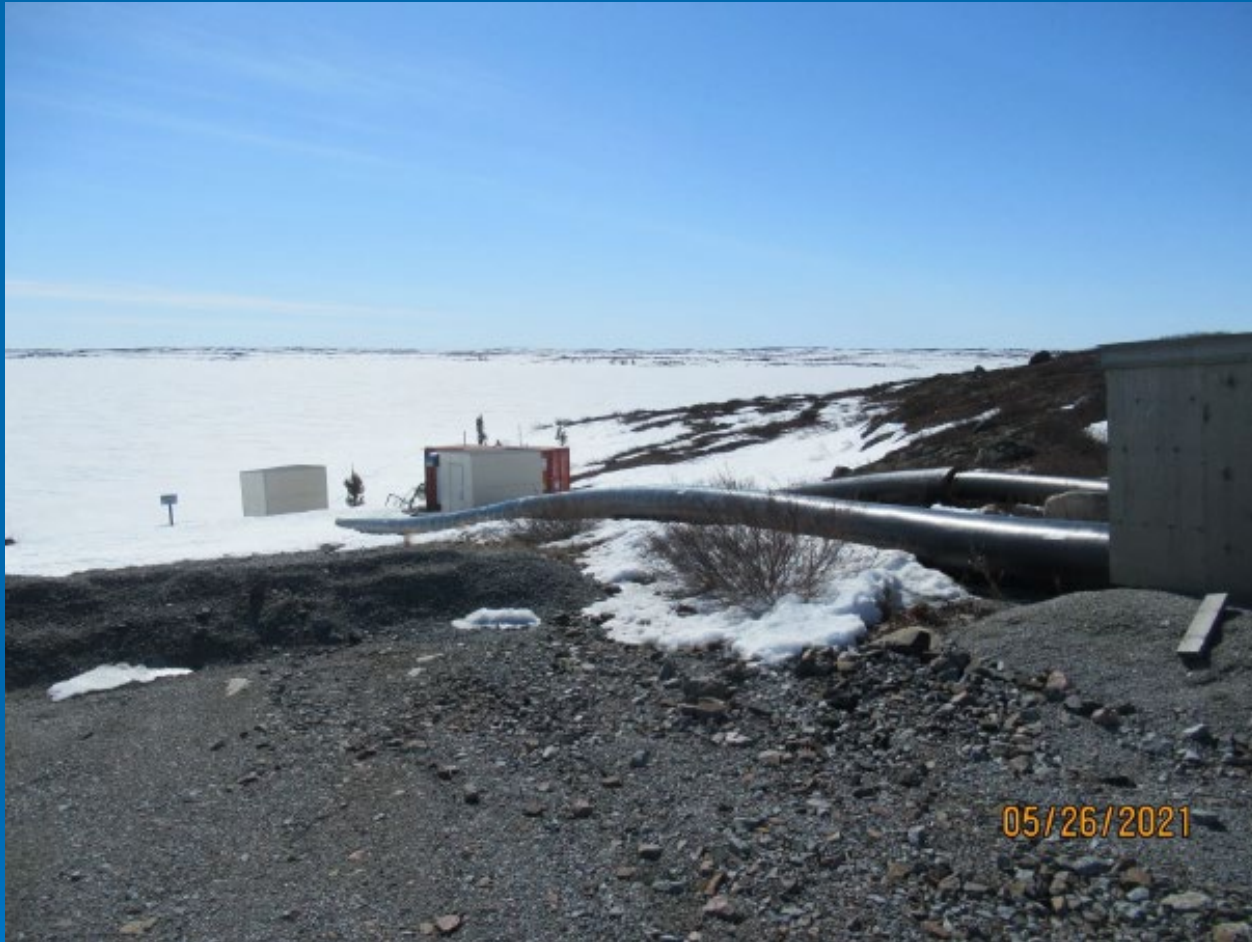
Photo 25: The Snap Lake Mine discharge diffuser location

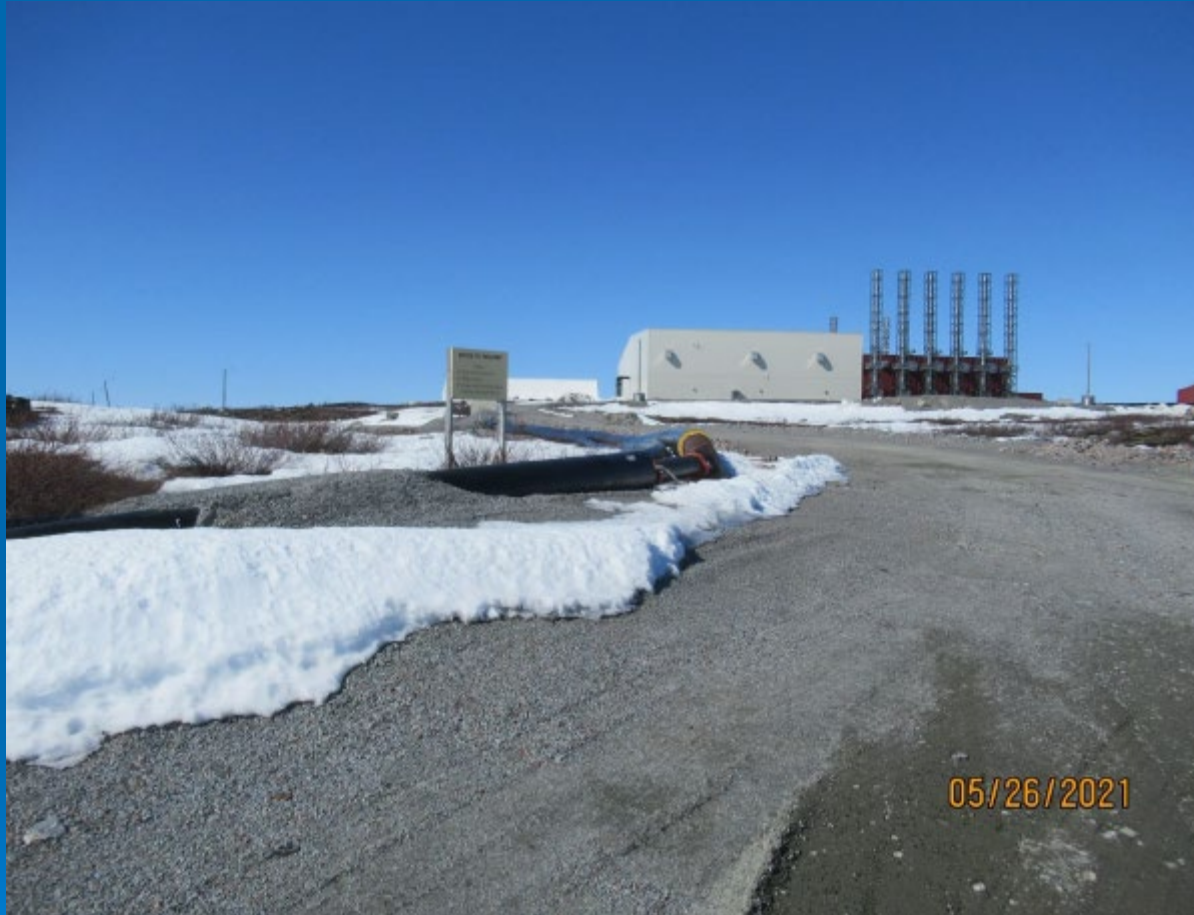
Photo 26: The heat-traced discharge line from the mine WTP to the discharge location in Photo #25.

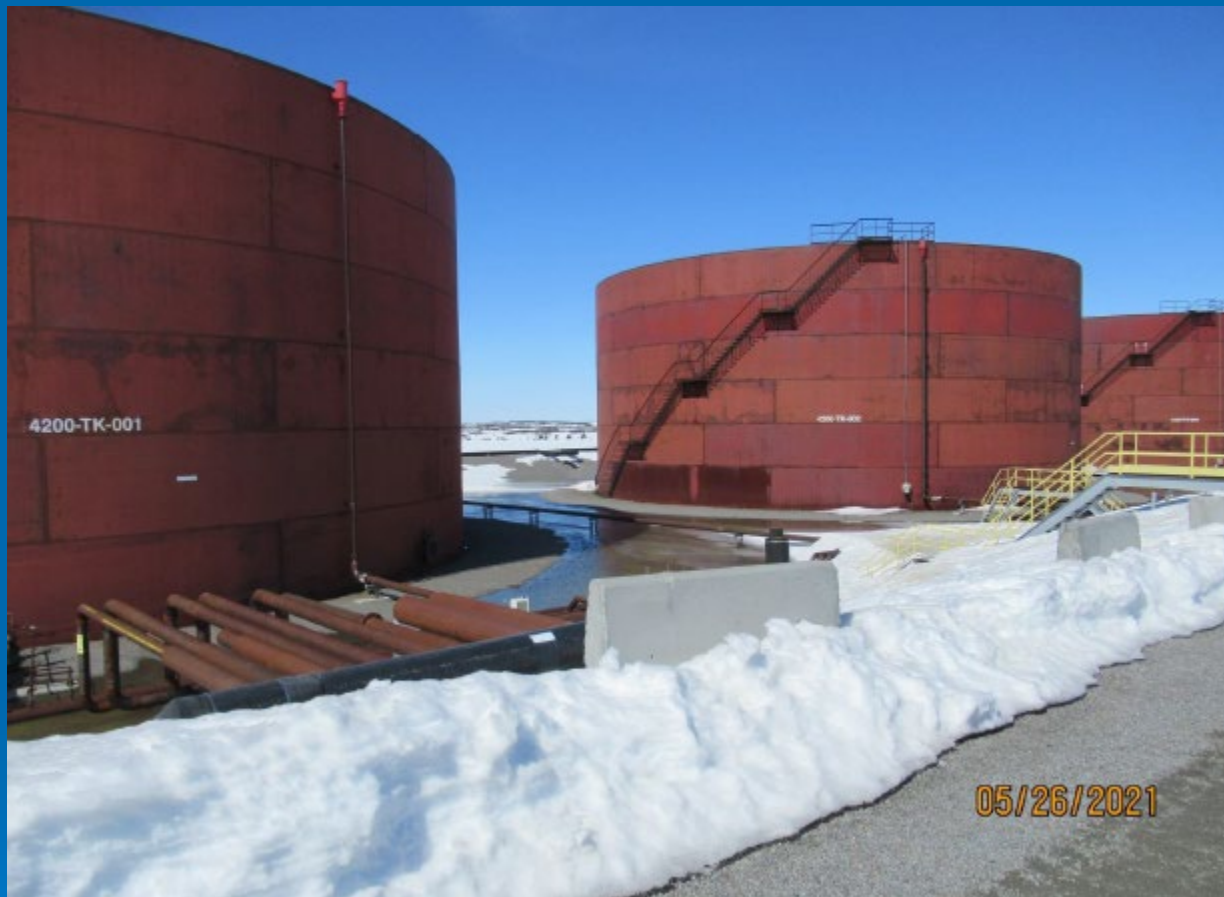
Photo 27: The 12-million L fuel tank farm. Fuel is being kept in the tank on the far right of the photo.

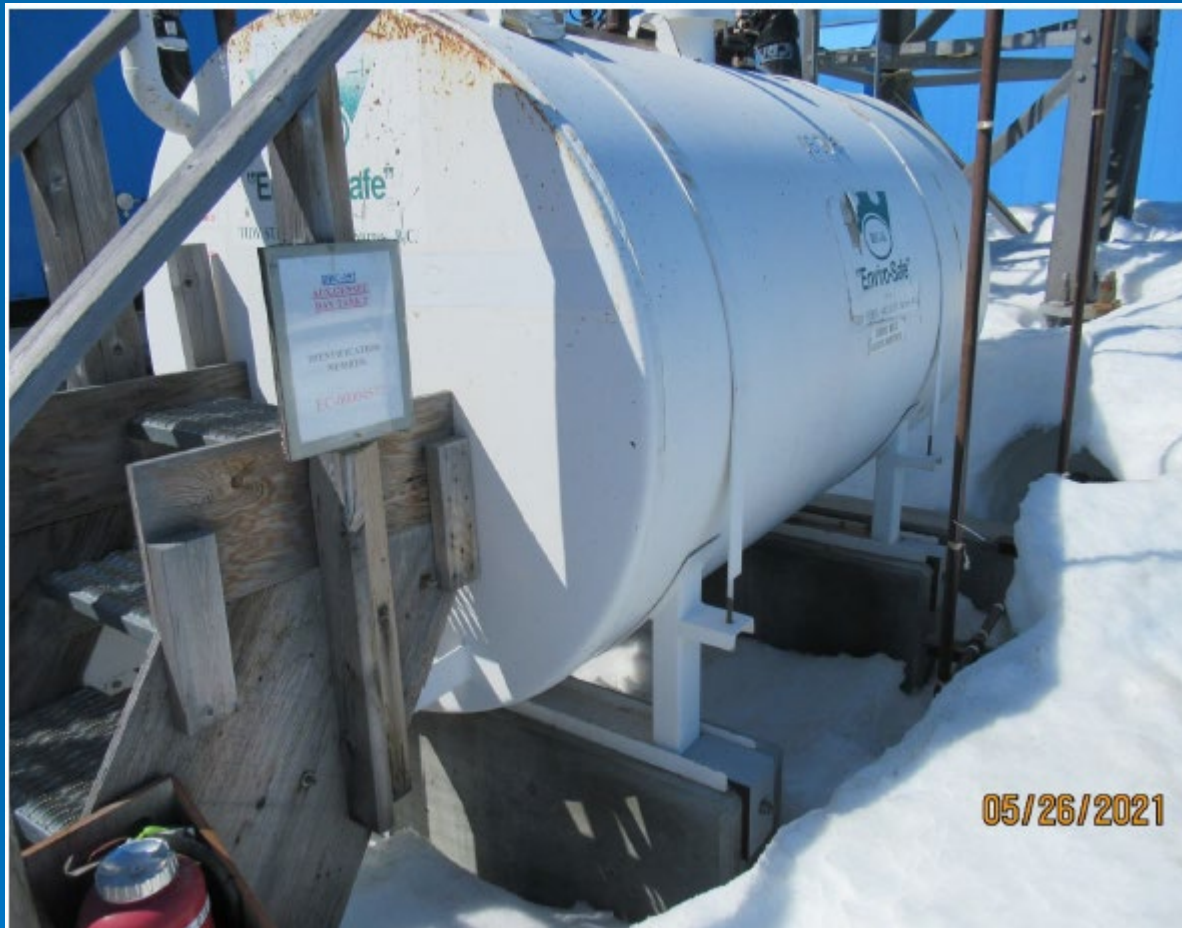
Photo 28: Fuel tank containment around site is being monitored and meltwater removed on an ongoing basis.

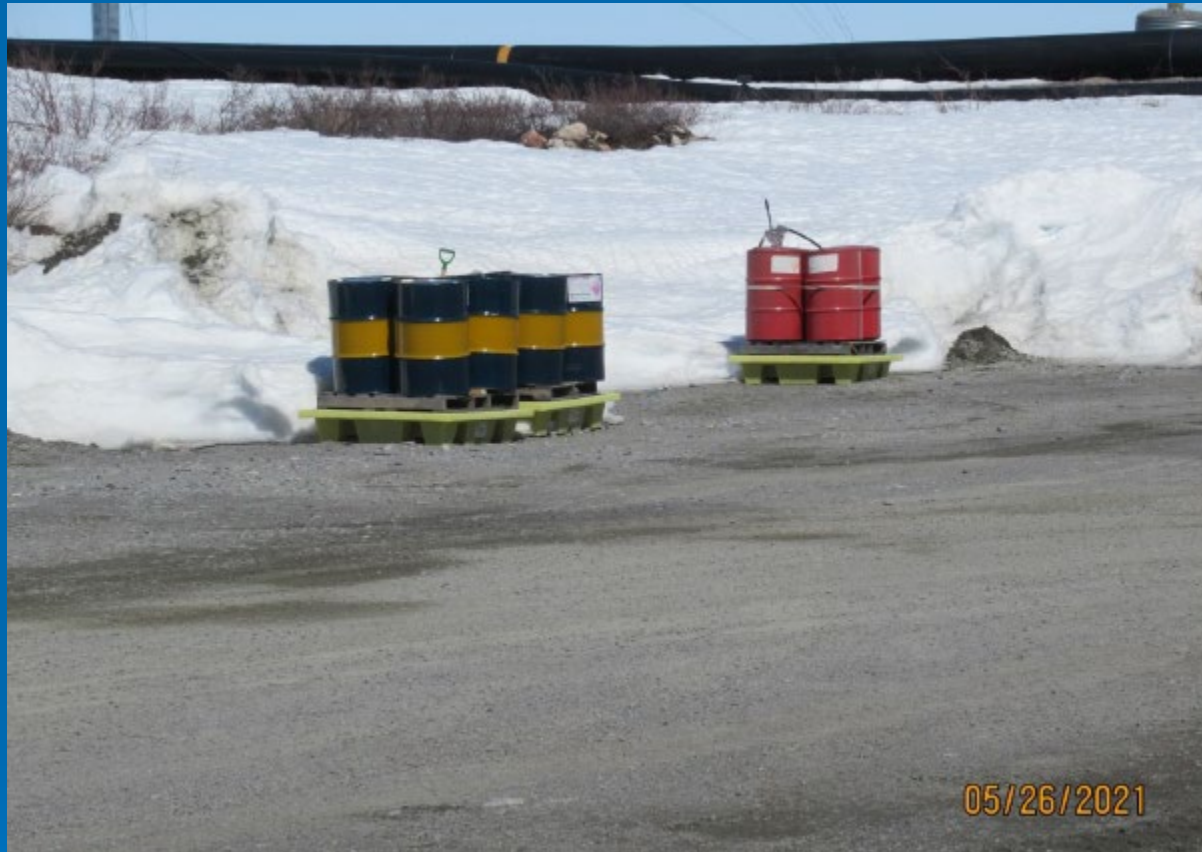
Photo 29: Diesel fuel and gasoline staged within secondary containment in the mine warming shed parking area.

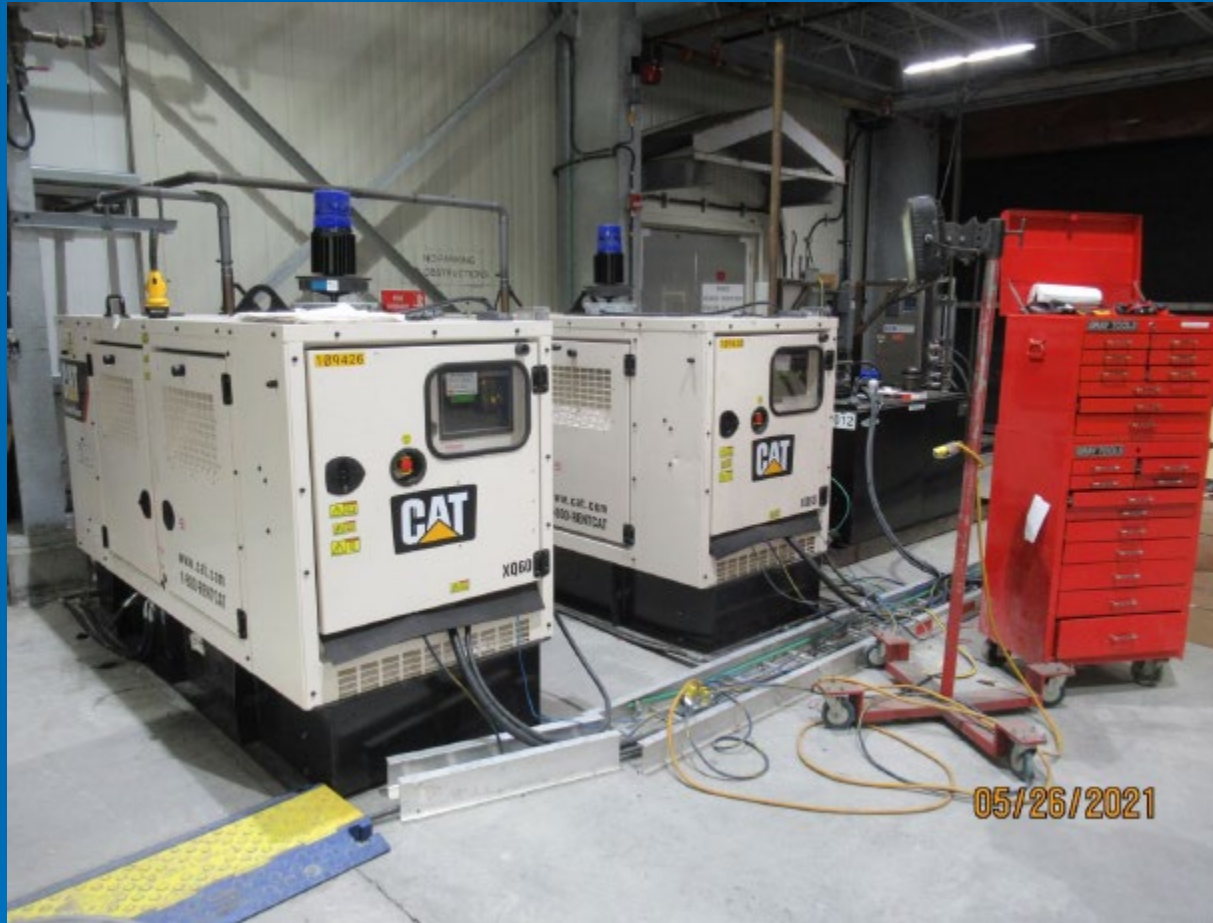
Photo 30: The warming shed generators and diesel feed tank.

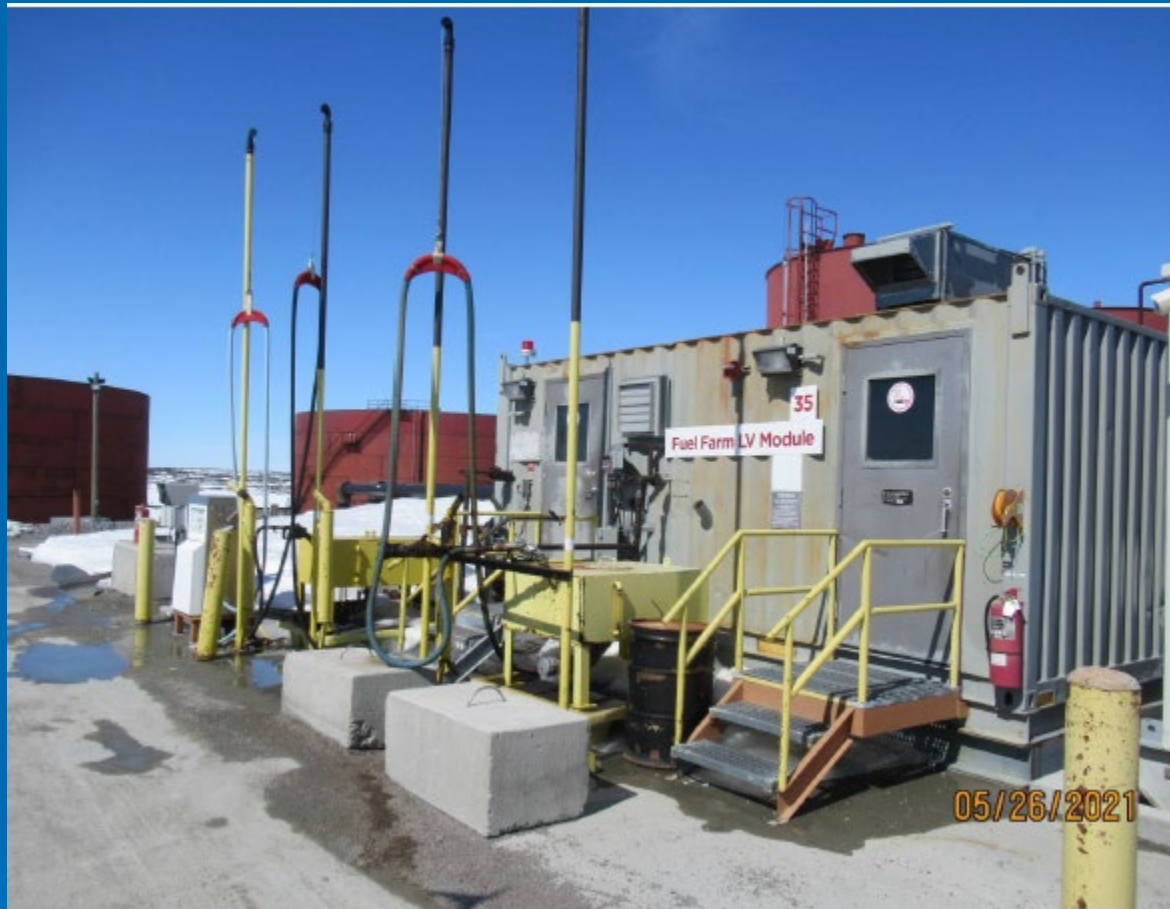
Photo 31: Looking south at the light vehicle fuel transfer station.

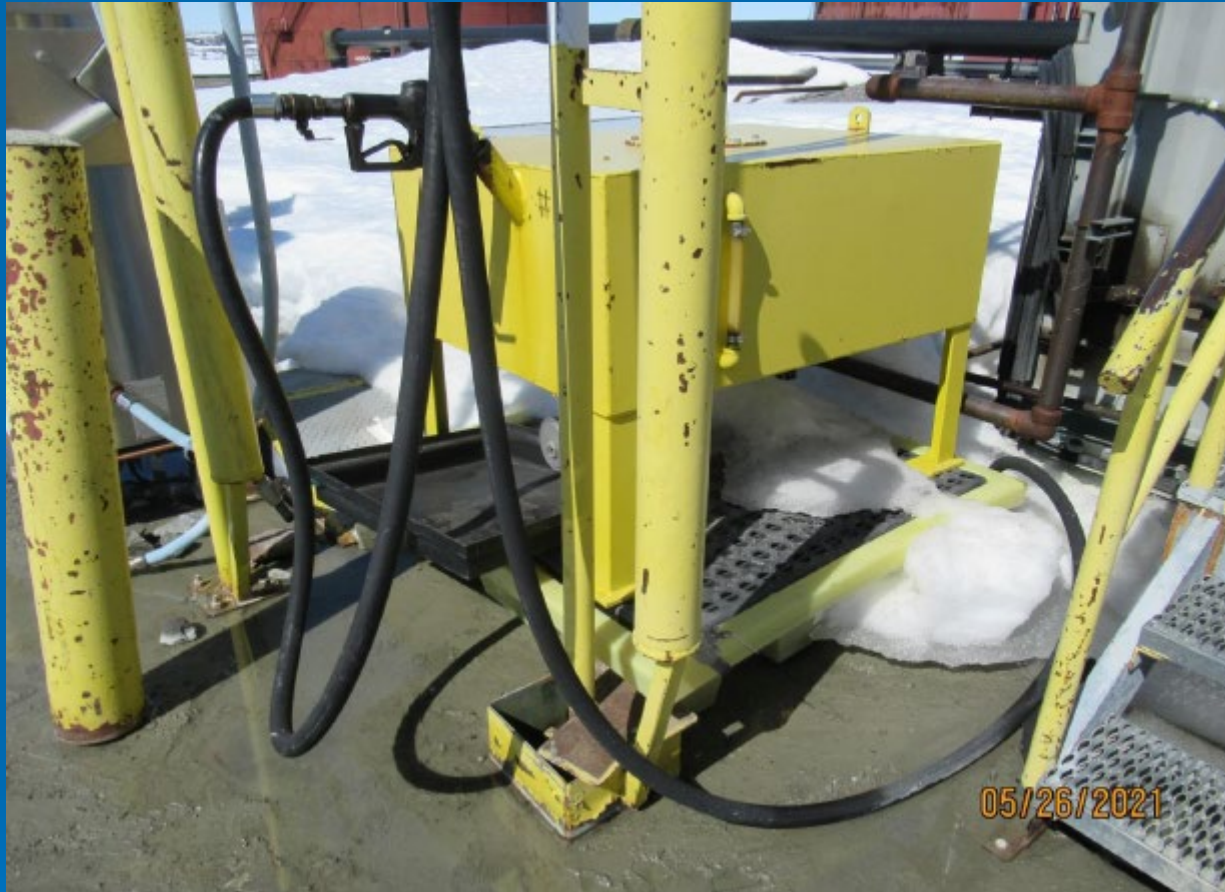
Photo 32: Capacities within secondary containment structures are being monitored and emptied on an ongoing basis.

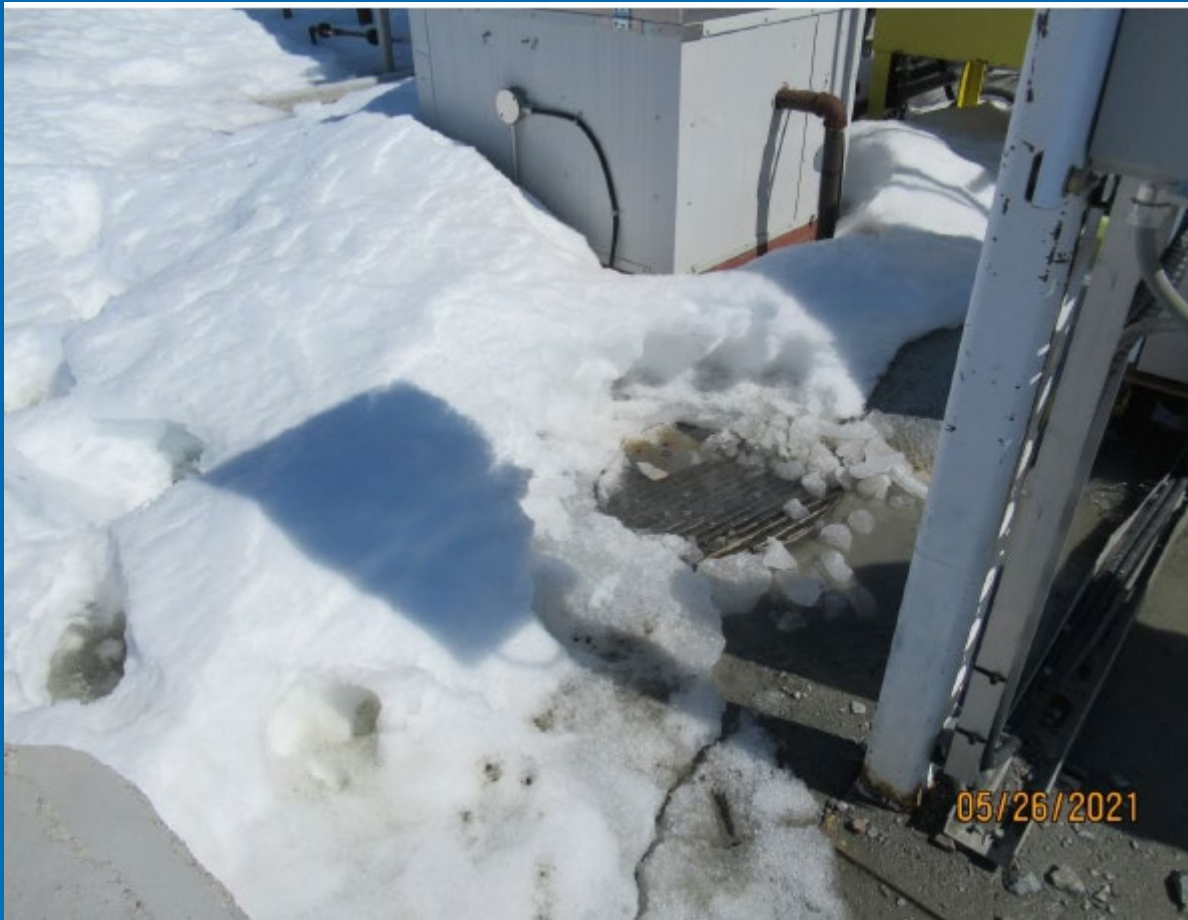
Photo 33: This sump at the light vehicle fueling station is also being monitored and emptied on an ongoing basis.

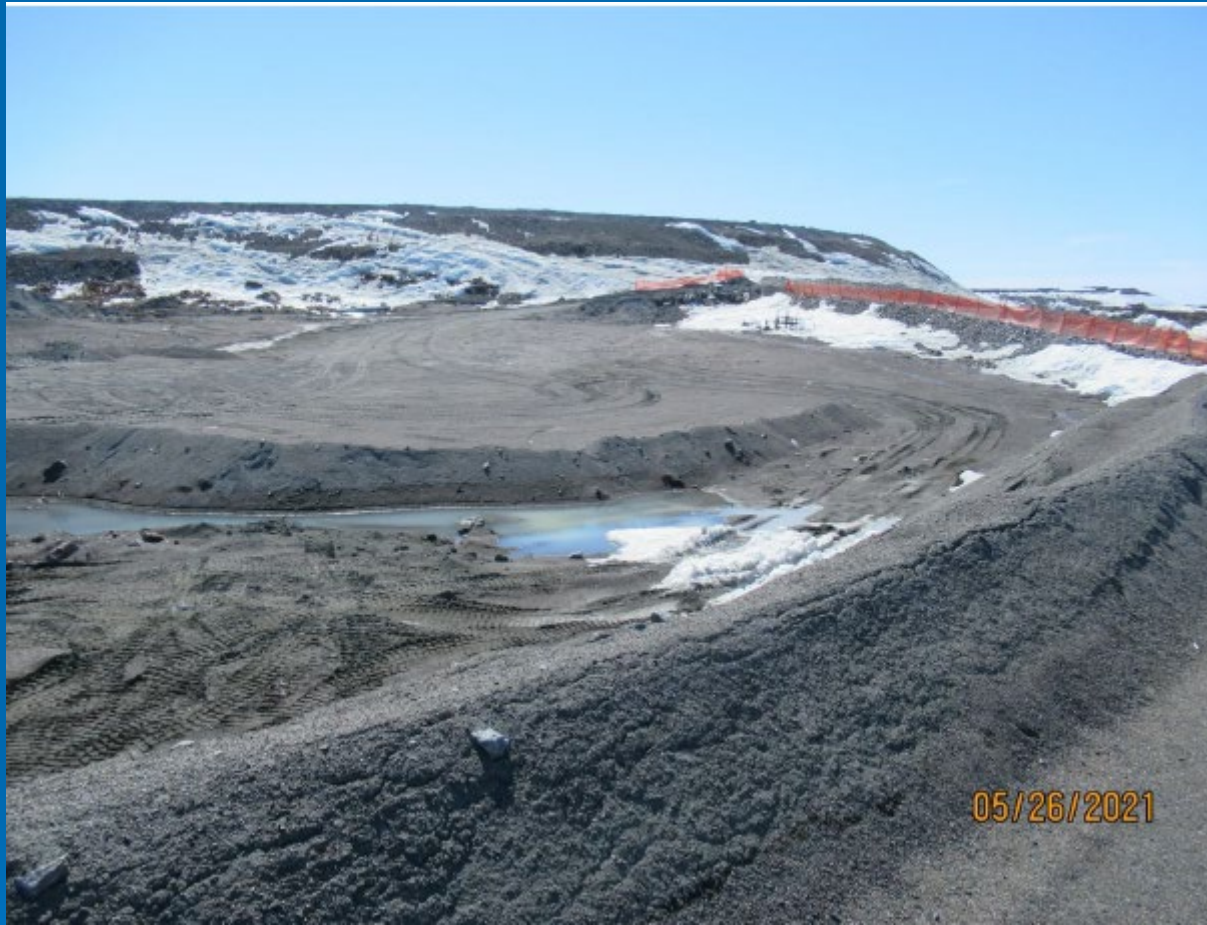
Photo 34: A look at the entrance to the mine landfill located at the North Pile East Cell – Cell #1.

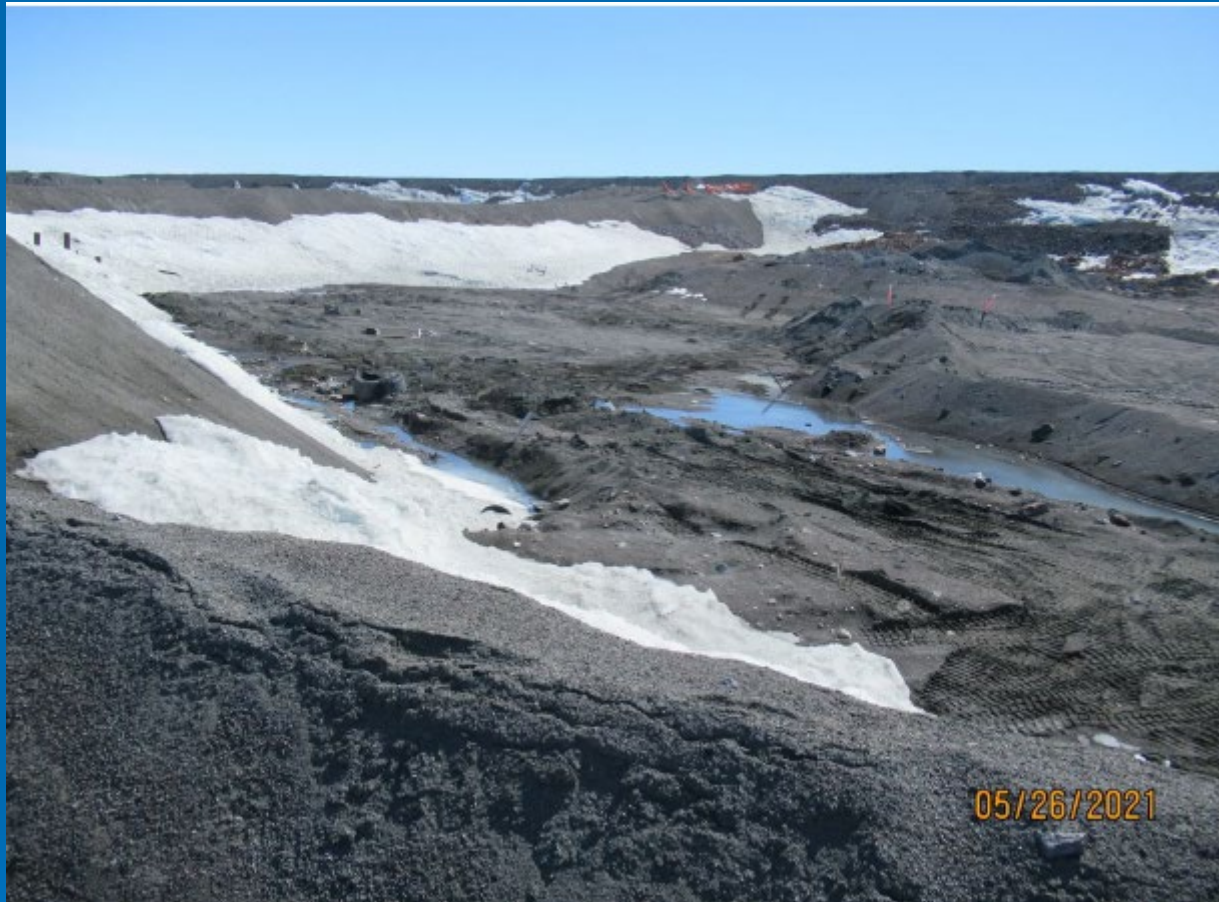
Photo 35: The remainder of the landfill at the North Pile.

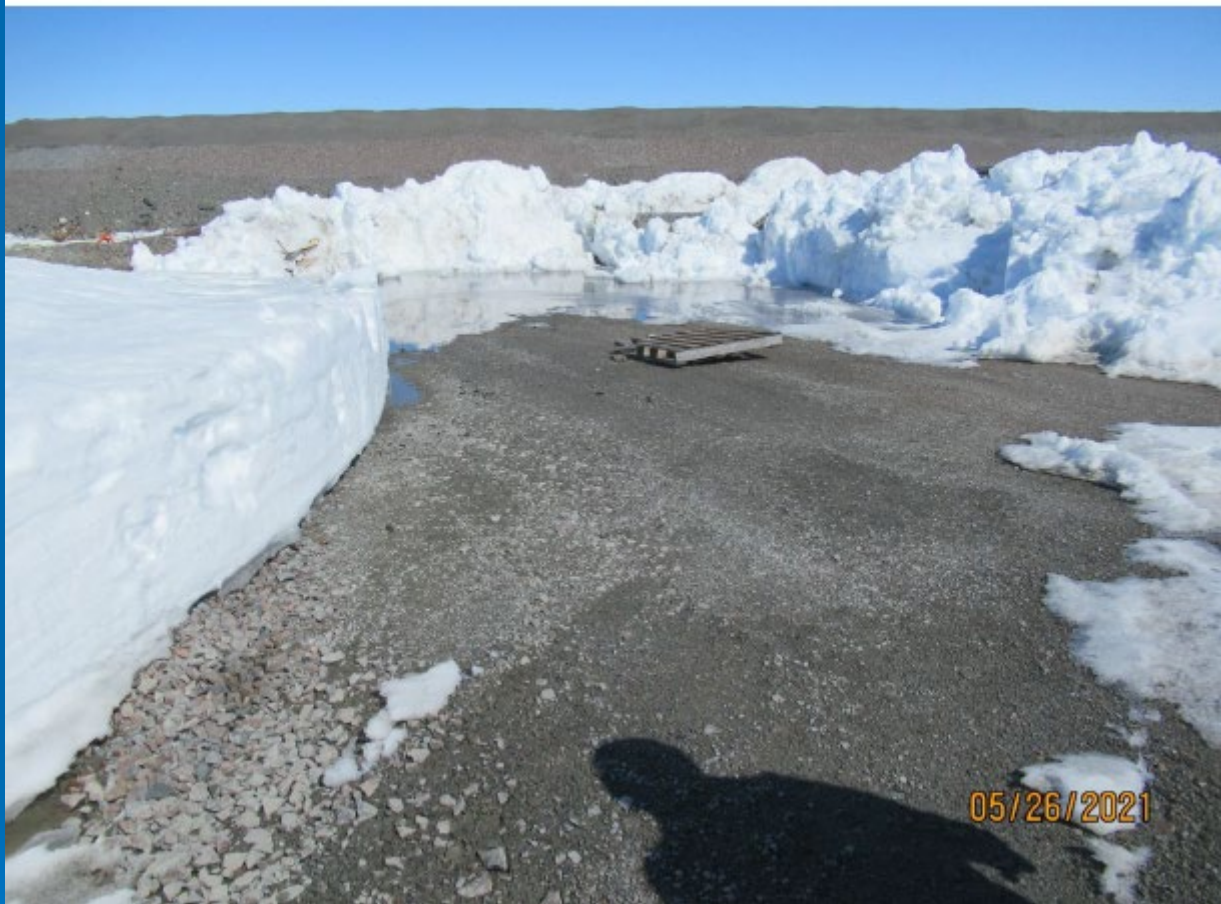
Photo 36: Though no burning has occurred, the mine burn pit has been prepared for use.

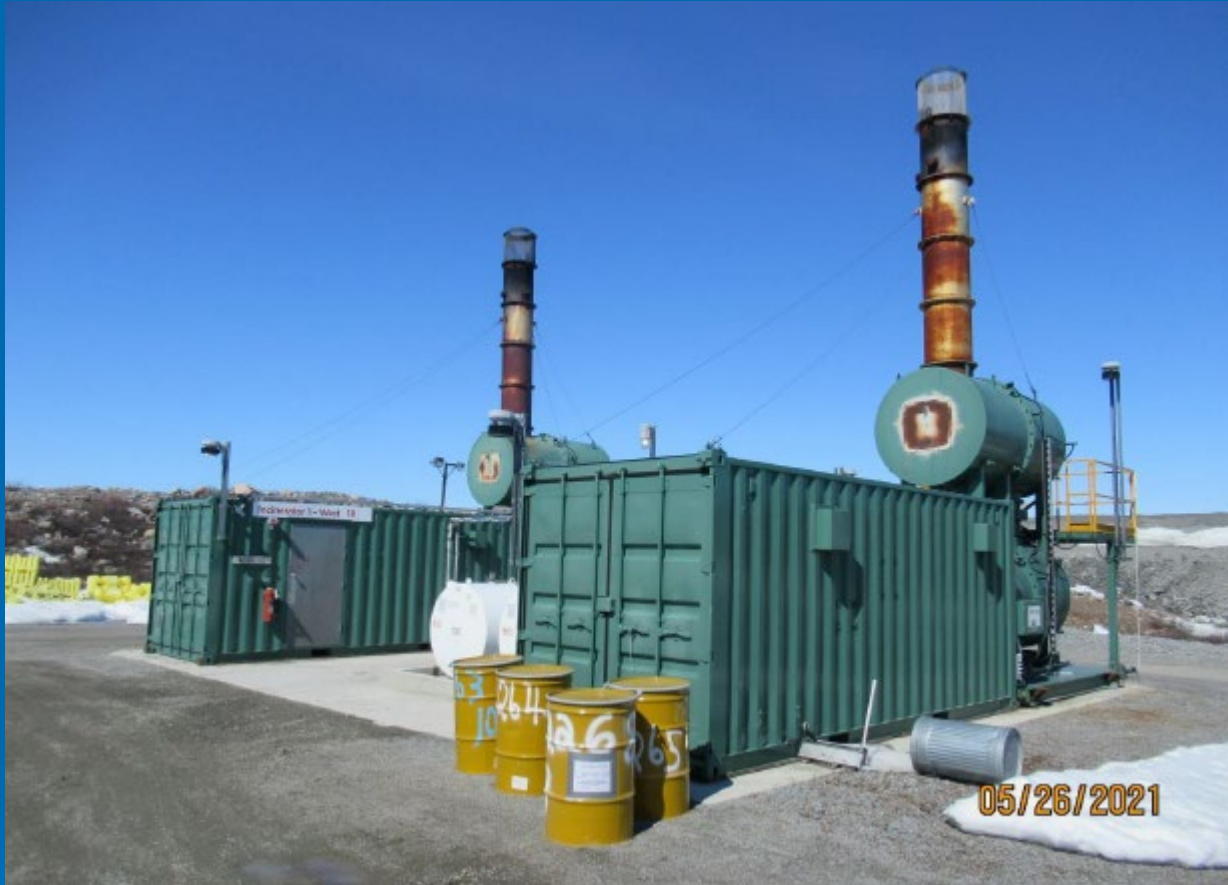
Photo 37: The mine incinerators, fuel tanks and labeled waste in drums.
