May-June 2021 Environmental Update for SLEMA Board

July 8, 2021

➤ Regulatory site inspection was conducted on May 26, 2021, by Inspector Joe Heron.

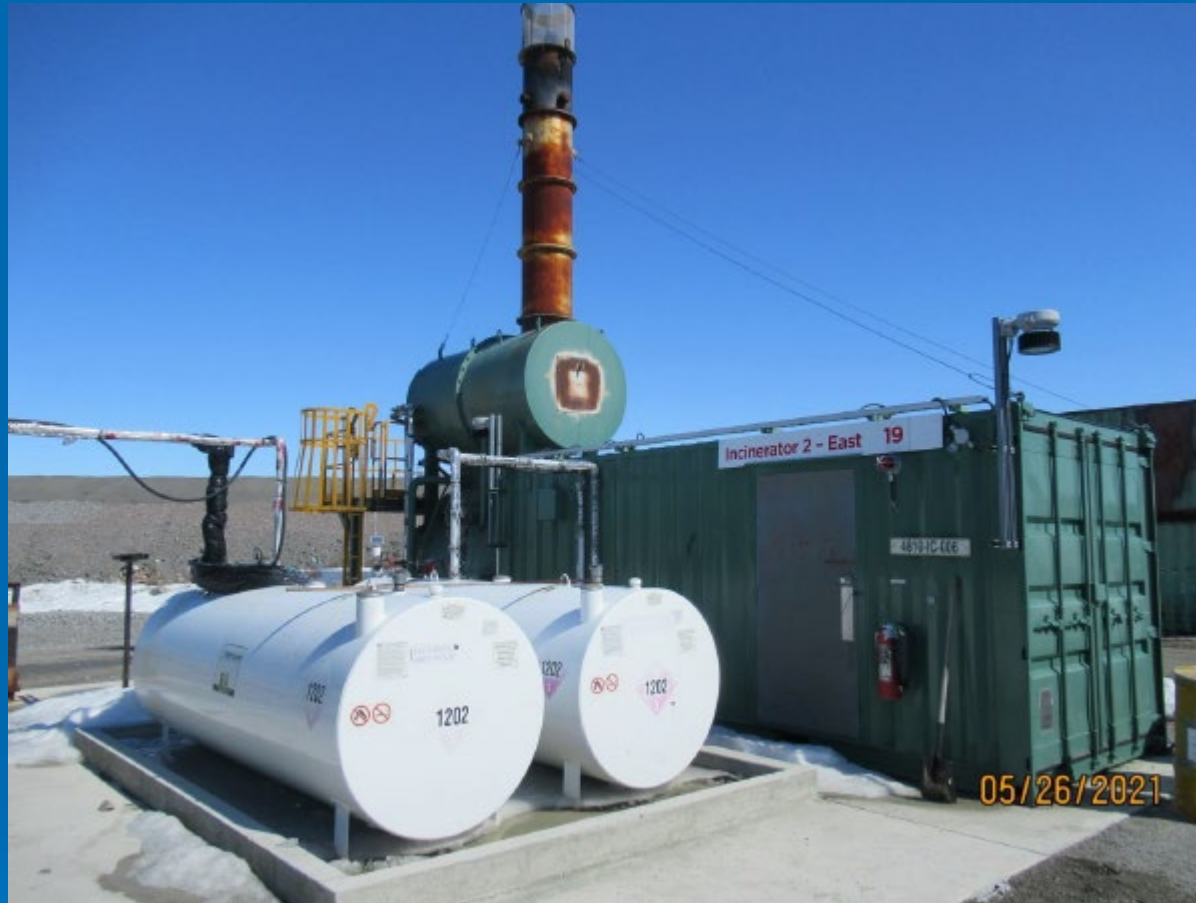
Photo 38: These fuel tanks are used to supply the mine incinerators. Capacity levels are also being monitored in the tank containment and are being emptied out on an ongoing basis.

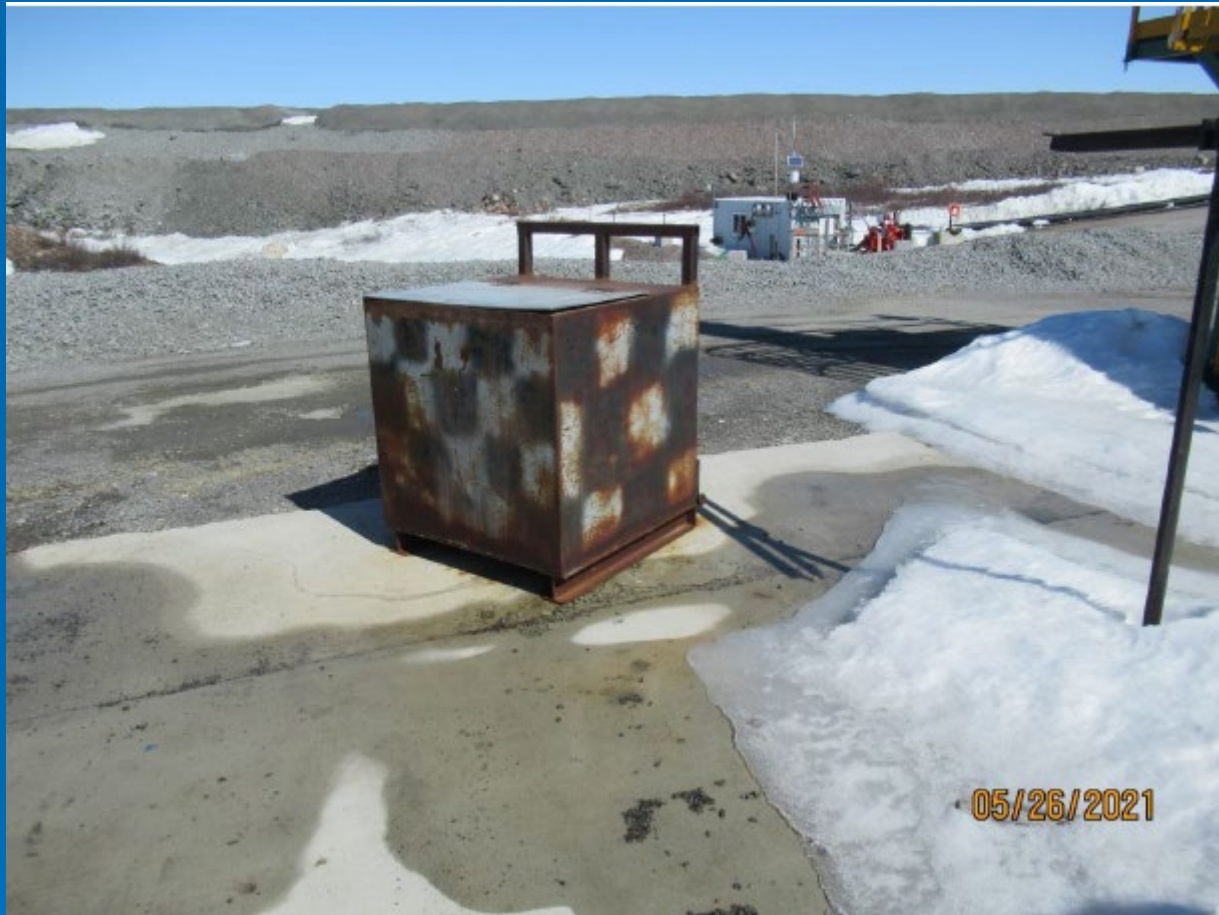
Photo 39: Waste ash and metals from the burn pit and incinerators is placed into this container prior to testing and disposal.

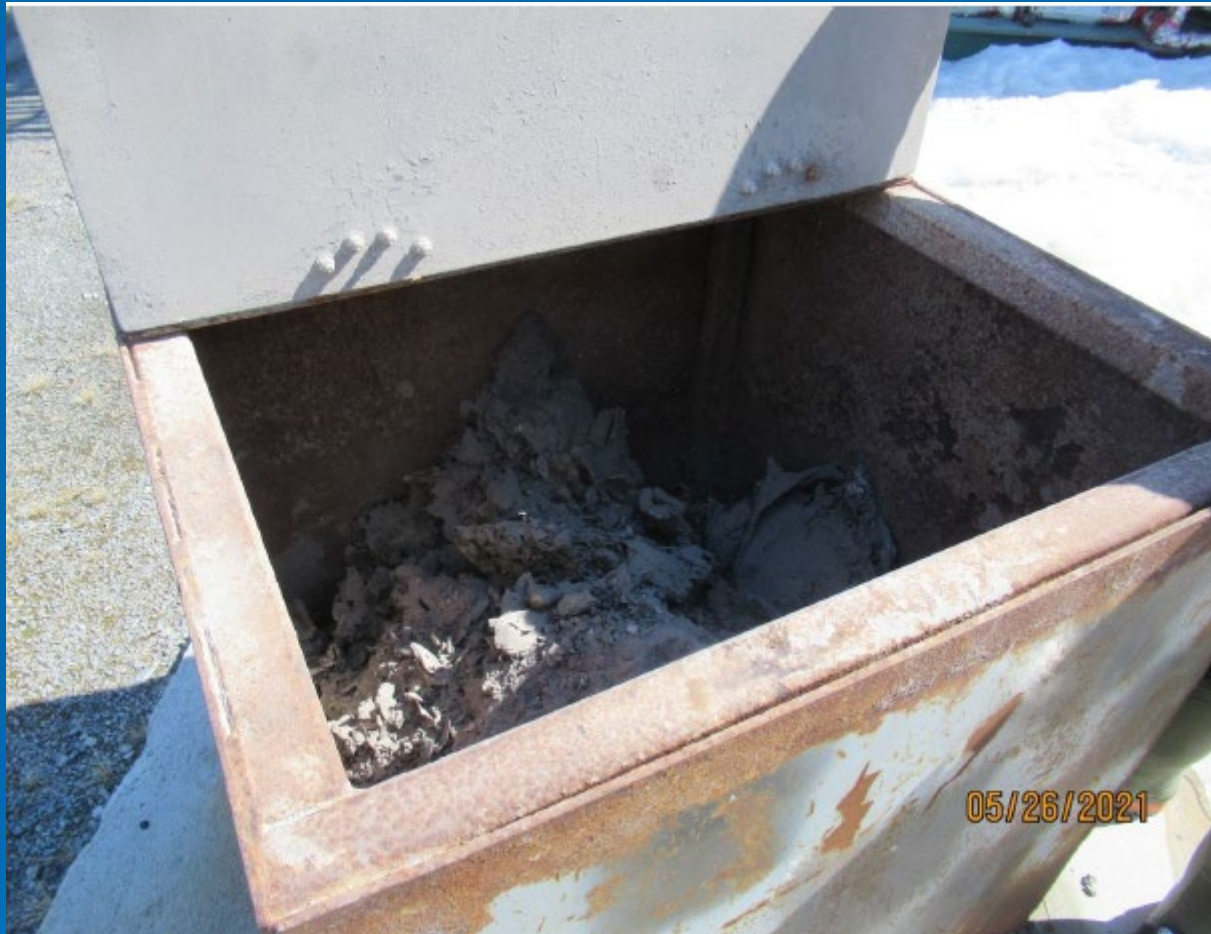
Photo 40: Waste metals and ash within the holding bin.

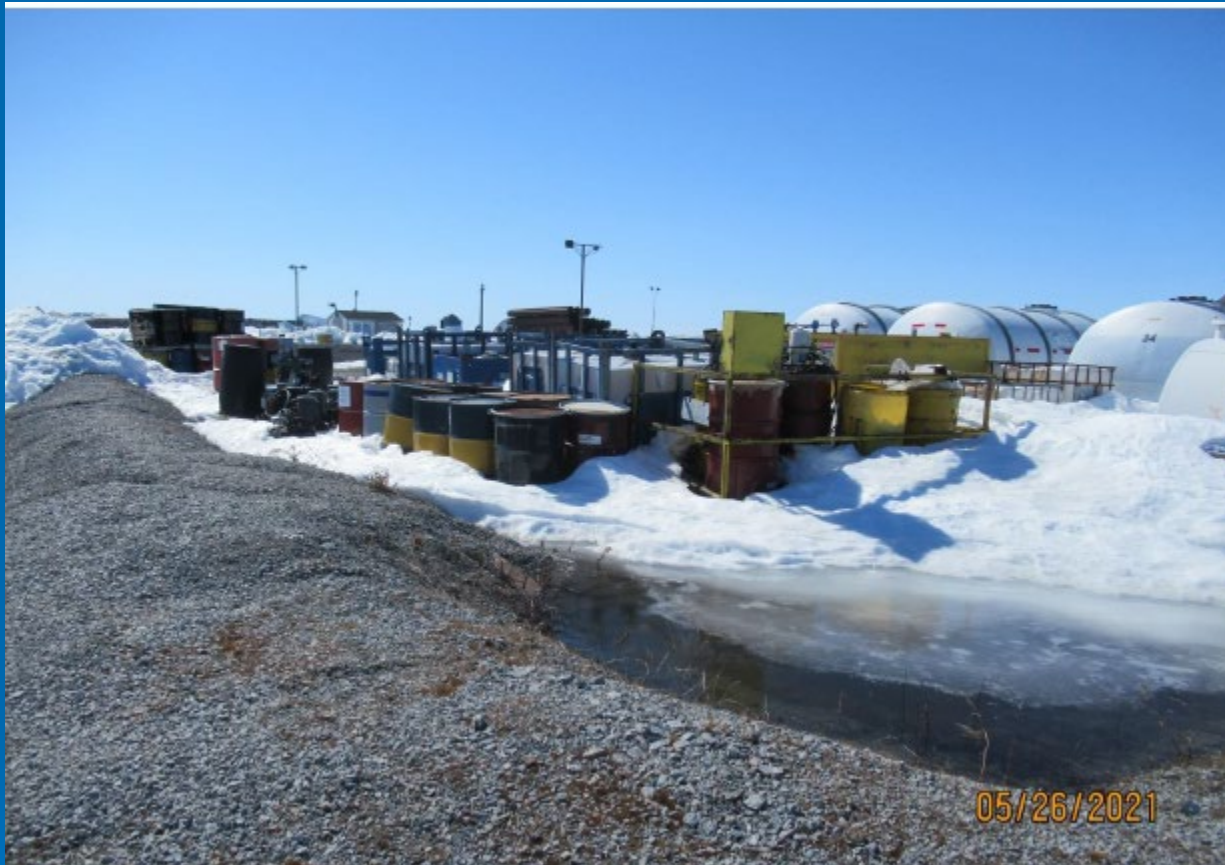
Photo 41: Properly labeled and staged waste within lined containment at the mine WTA.

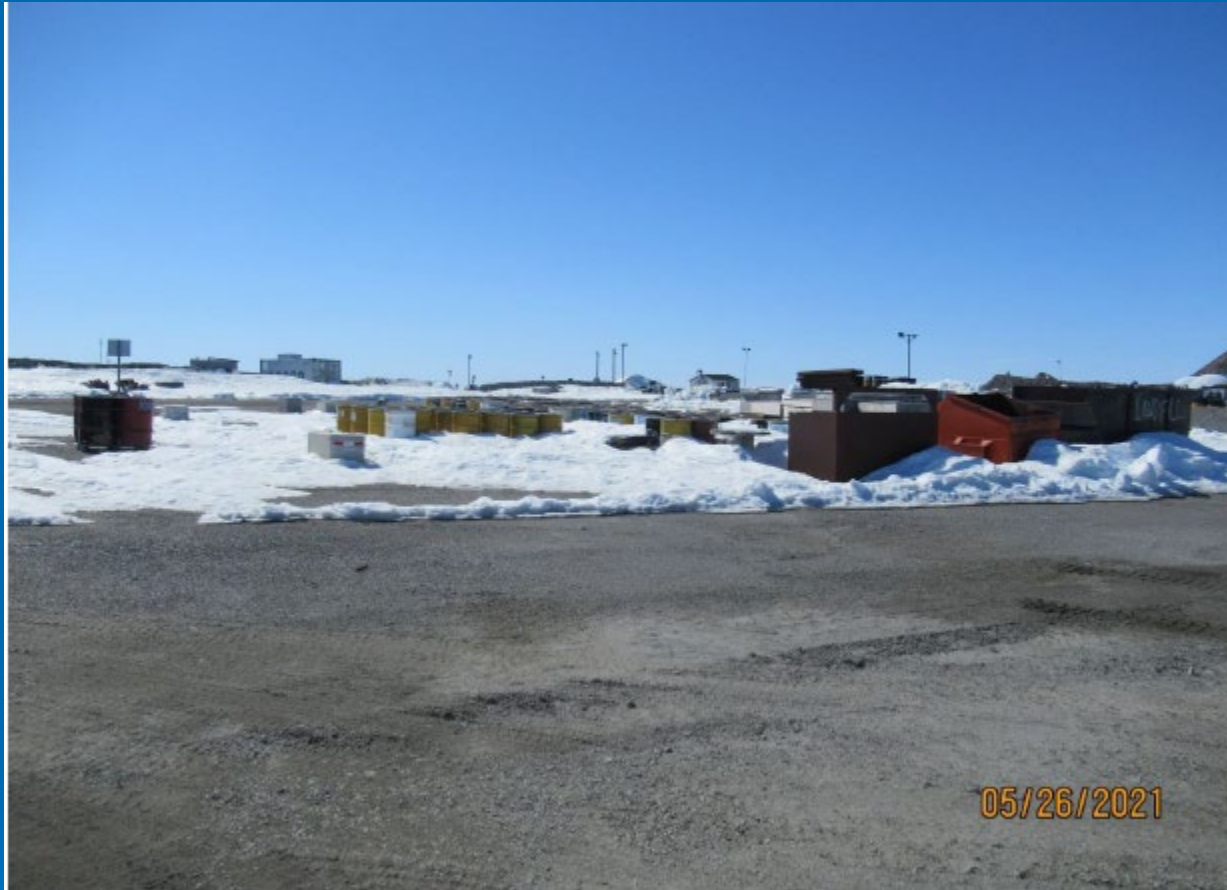
Photo 42: Additional containerized waste at the mine WTA.
