July-August 2021 Environmental Update for SLEMA Board

September 7, 2021

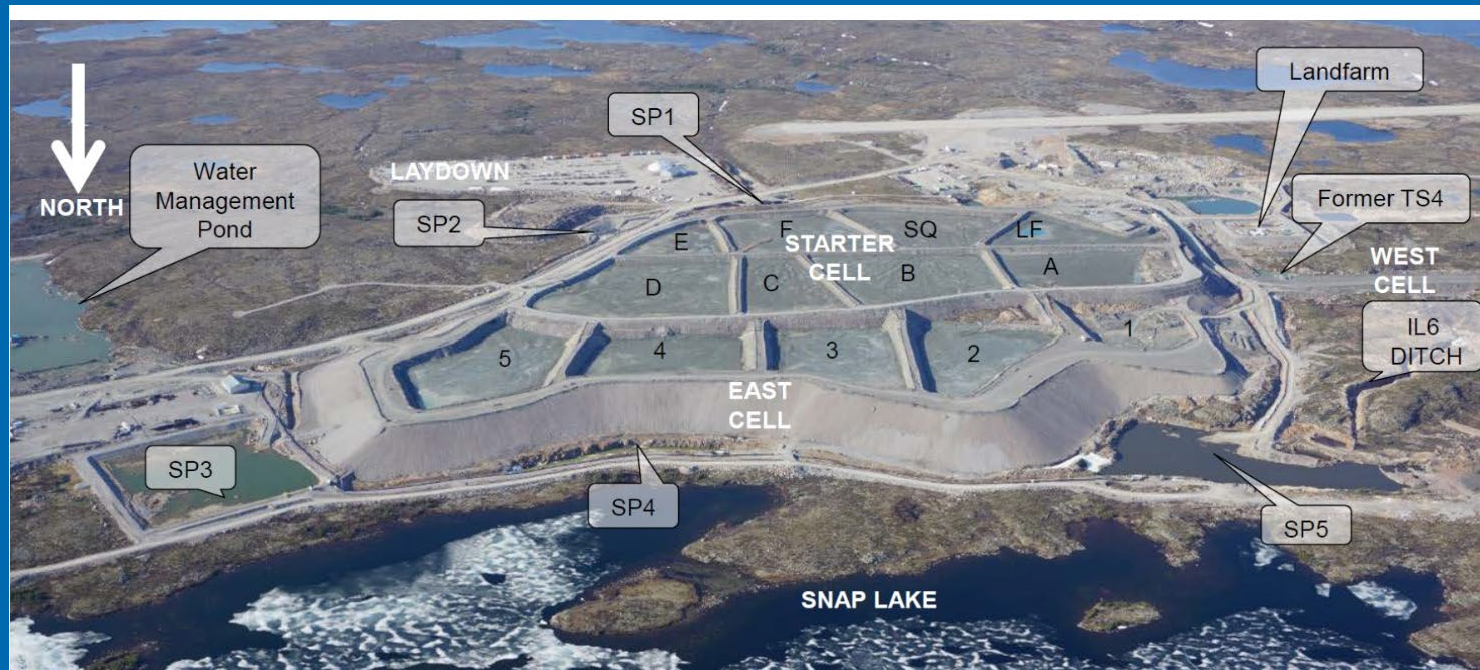
- On July 23 DB communicated SLEMA Tech Advisor of a leak in the liner of the Sump 3 that started in July 2020;
- Sump 3 is one of the sumps that receives the seepage from the North Pile;
- They noticed a decrease in the level of Sump 3;
- The decrease in water level occurred when the Sump was full.

- Part of the water leak was discharging into Snap Lake;
- After analysis, they found that the leak water quality meets the Water Licence's Effluent Quality Criteria (EQC);
- Following that, DeBeers reported the leak to the NT-NU SPILL REPORT: Spill Report # 20211331;
- And submitted a Follow-up Report to the MVLWB;

Fig 1: View of the North Pile. The leak occurred in SP3

- Further measures of response and containment of the leak include:
 - Pumping the remaining PS3 water to the Water Management Pond (WMP) until the surface elevation was below the suspected seepage;
 - Building an interceptor ditch North of PS3 to cut off the flow pathway to Snap Lake.

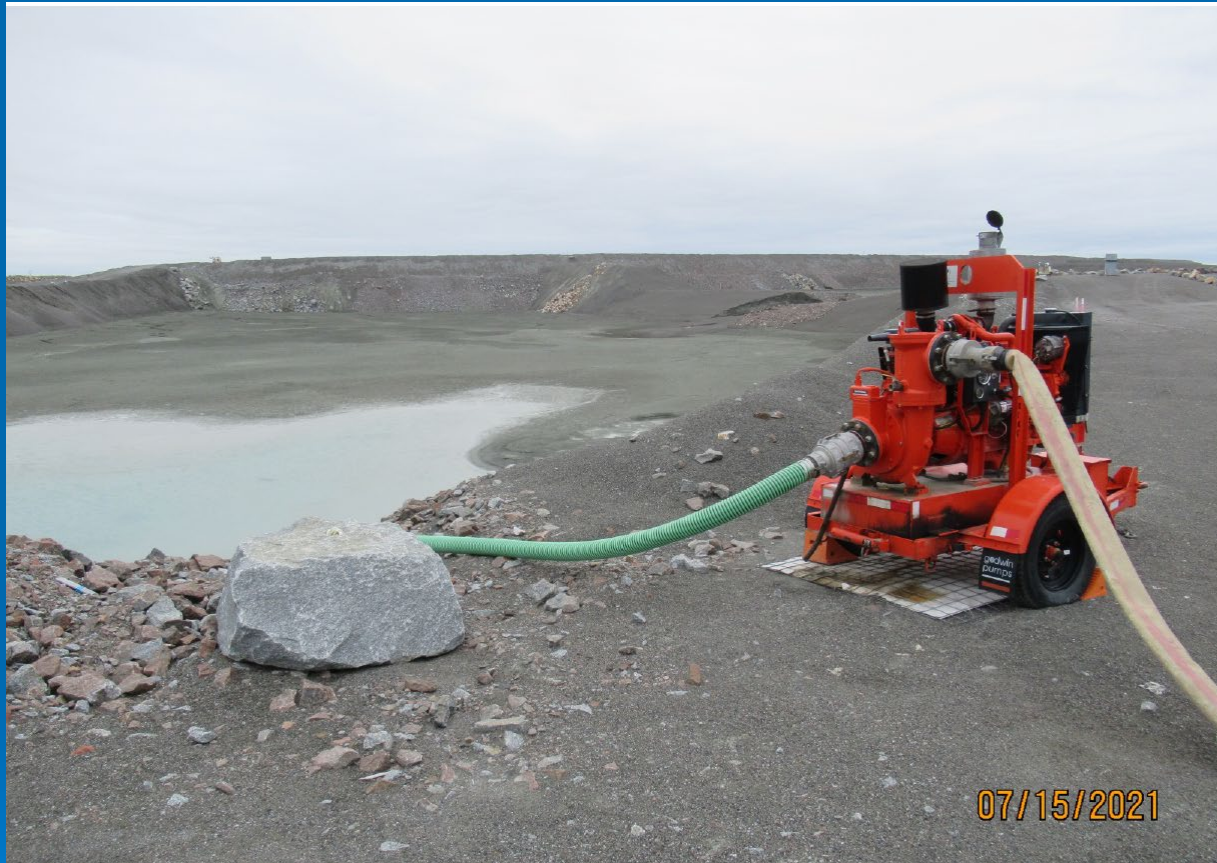
Photo 1: A diesel pump set-up at the North Pile cells. The Licensee must monitor the secondary containment and properly maintain to ensure hydrocarbon spills are being minimized

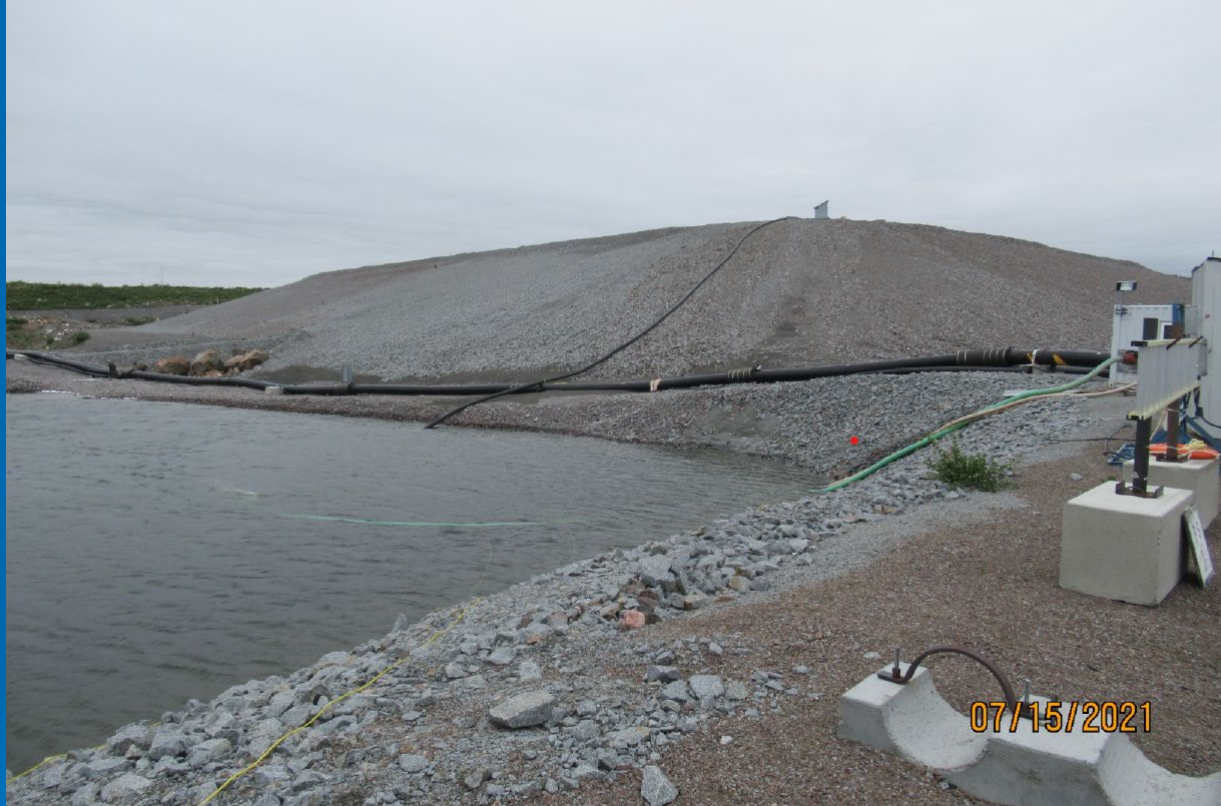
Photo 2: Water from the cell in Photo #1 is pumped down the North Pile and into sump PS3.

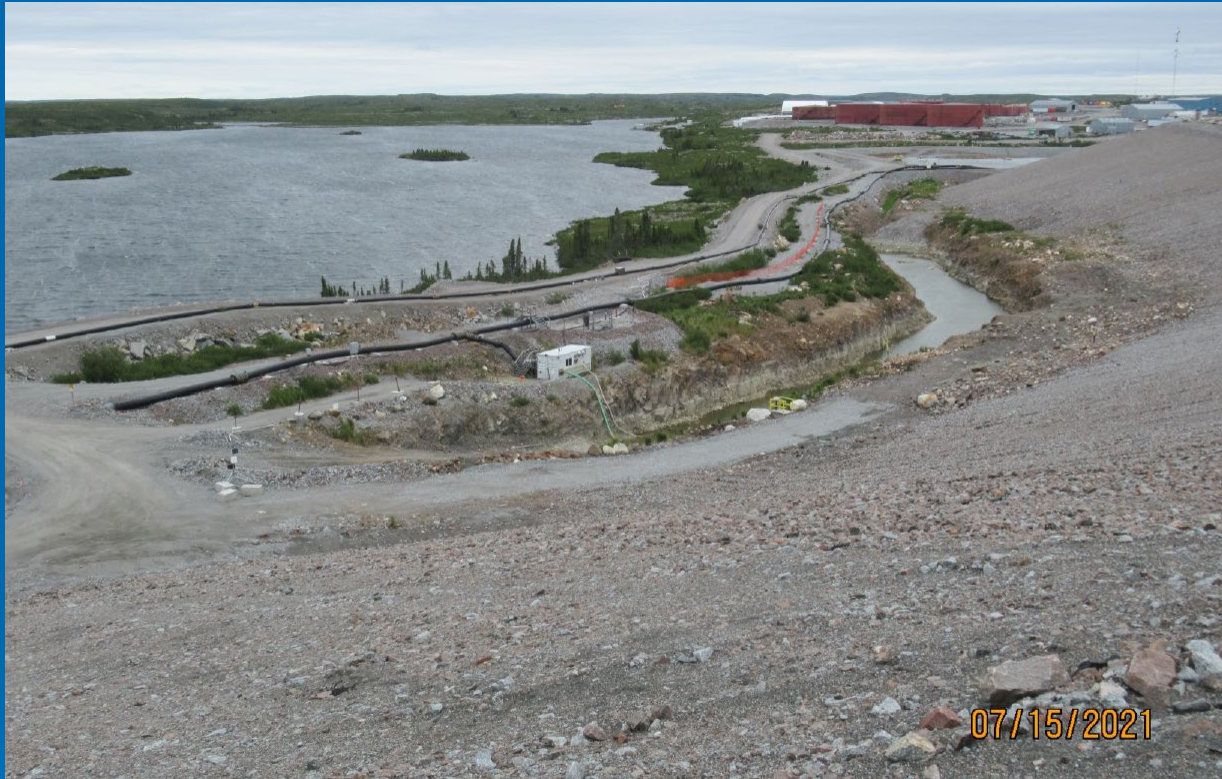
Photo 3: Looking east at the North Pile sump PS4.

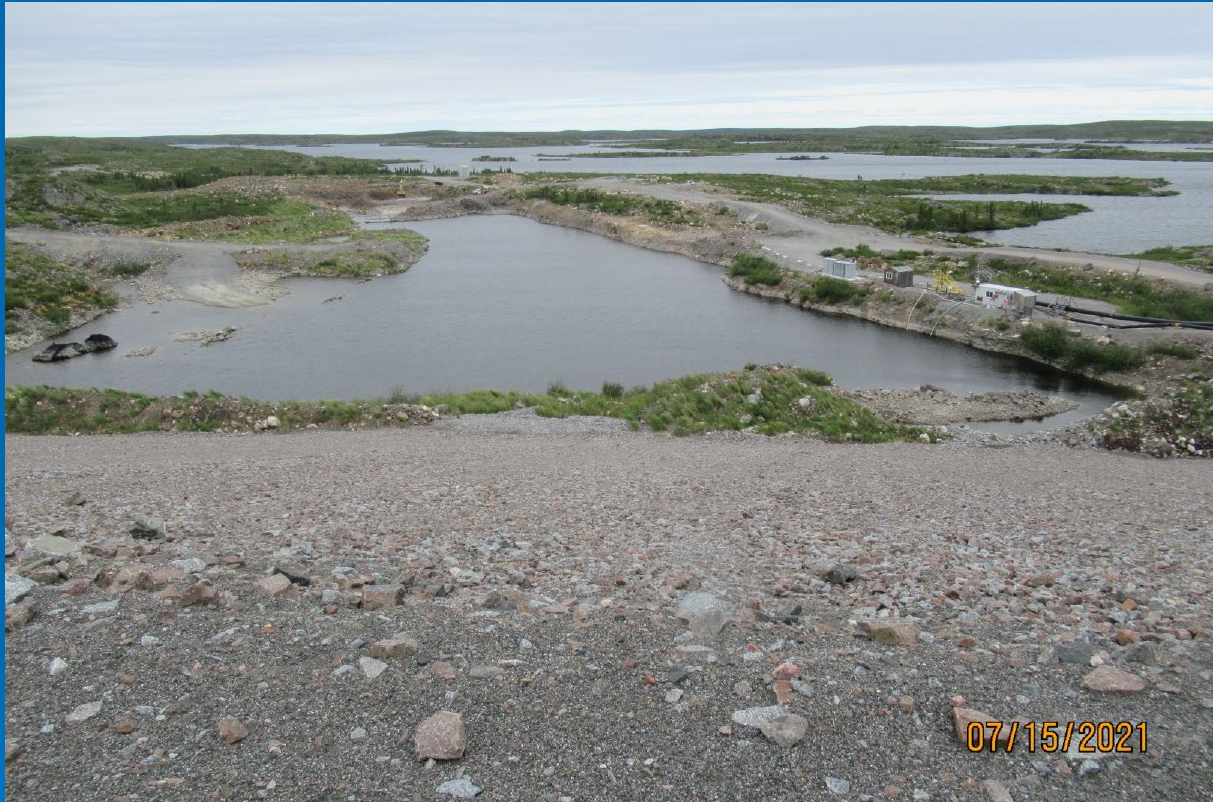
Photo 4: Looking west at the North Pile sump PS5. A staff gauge will be installed and surveyed into place.

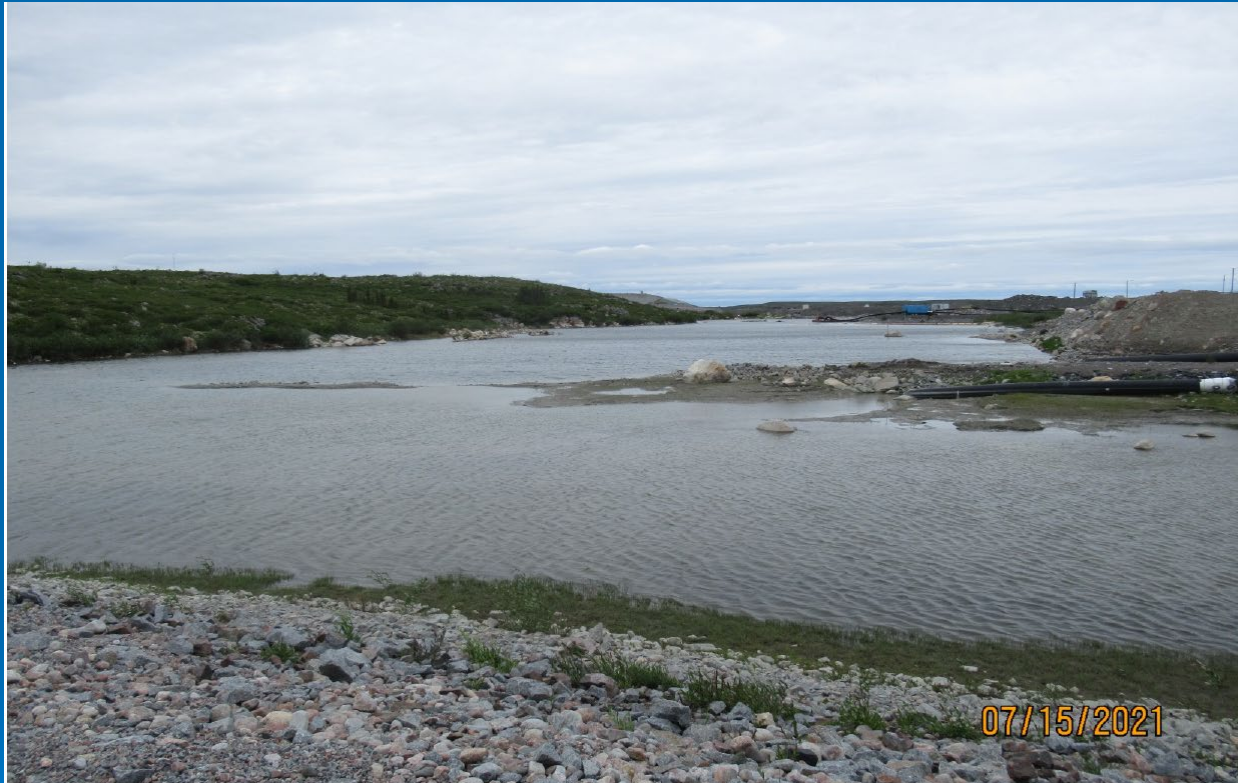
Photo5: Looking north at the Snap Lake Mine Water Management Pond.

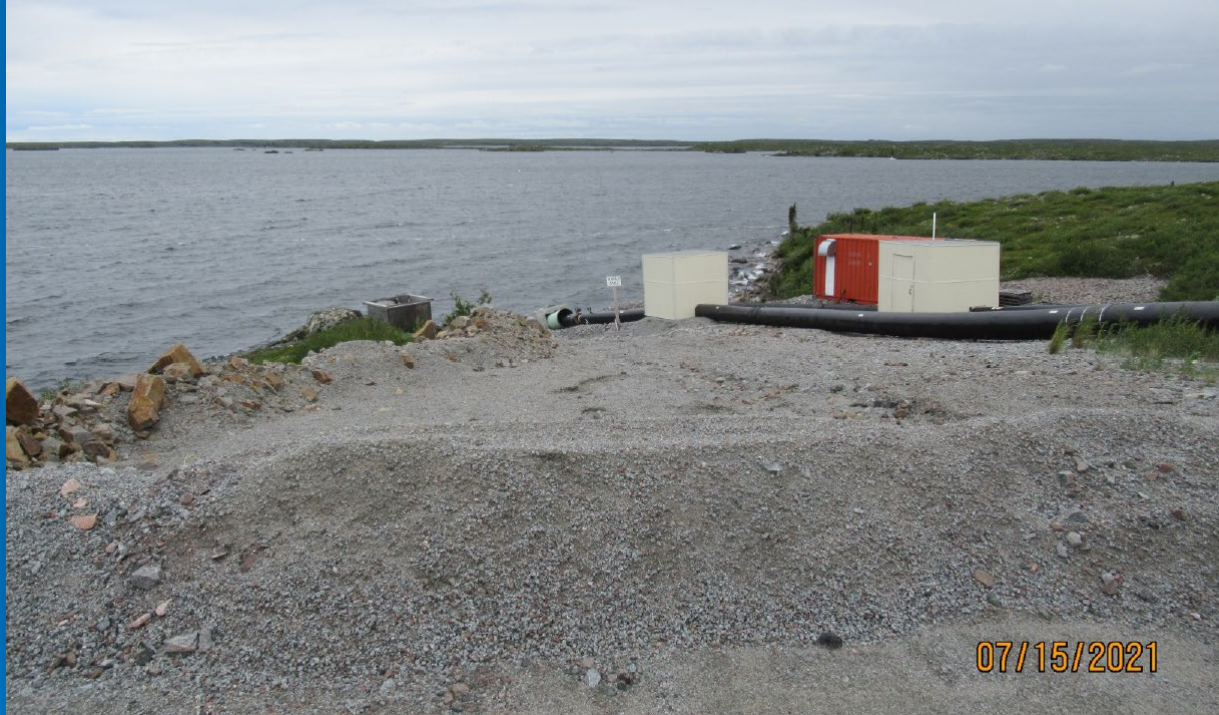
Photo6: Treated water that meets EQC is discharged into Snap Lake via this diffuser

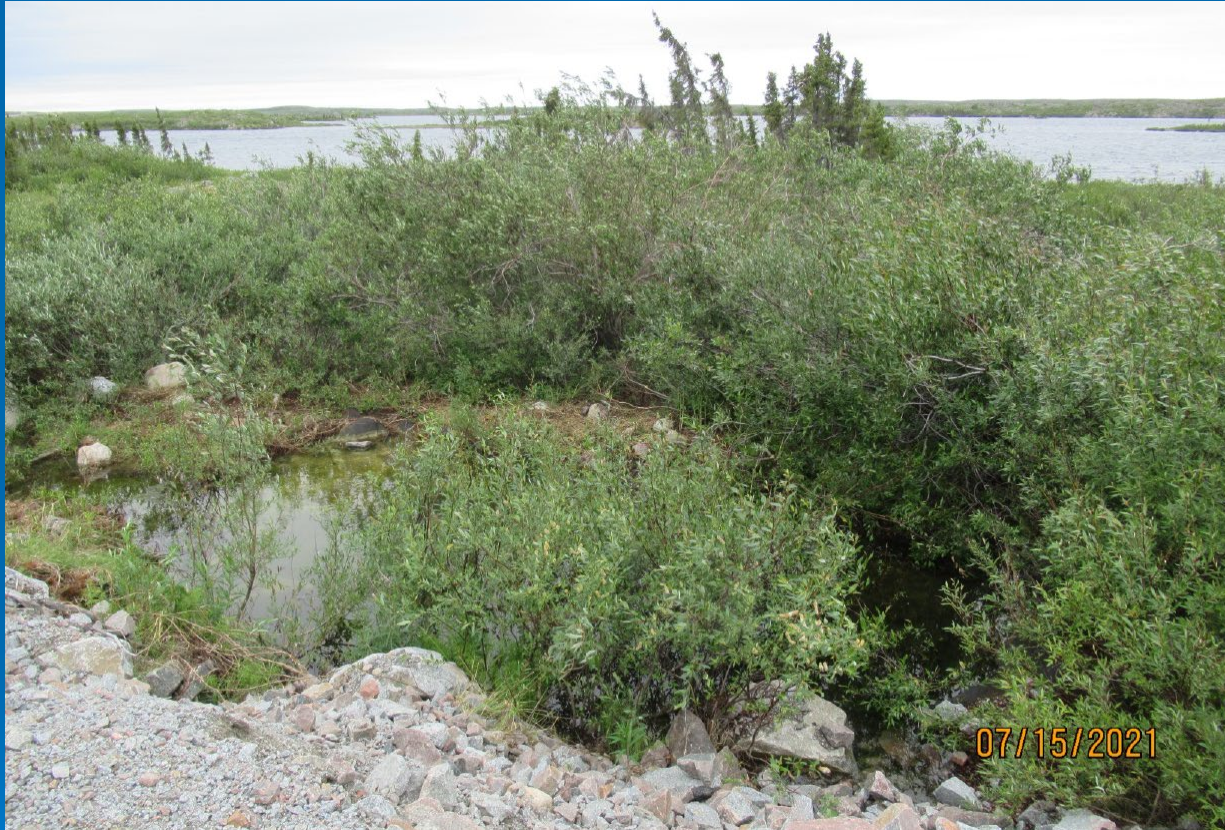
- Upon closer inspection of the site, staff noticed water pooling outside the water containment facility along the North Pile access road.
- Testing showed the source of the pooled water to be from the North Pile Perimeter sump PS3.
- As the seepage meets the Effluent Quality Criteria (EQC) and there was no harm to the receiving environment, no further enforcement action is being considered at this time.

Photo7: Pooled water along the North Pile access road due to seepage from North Pile sump PS3.

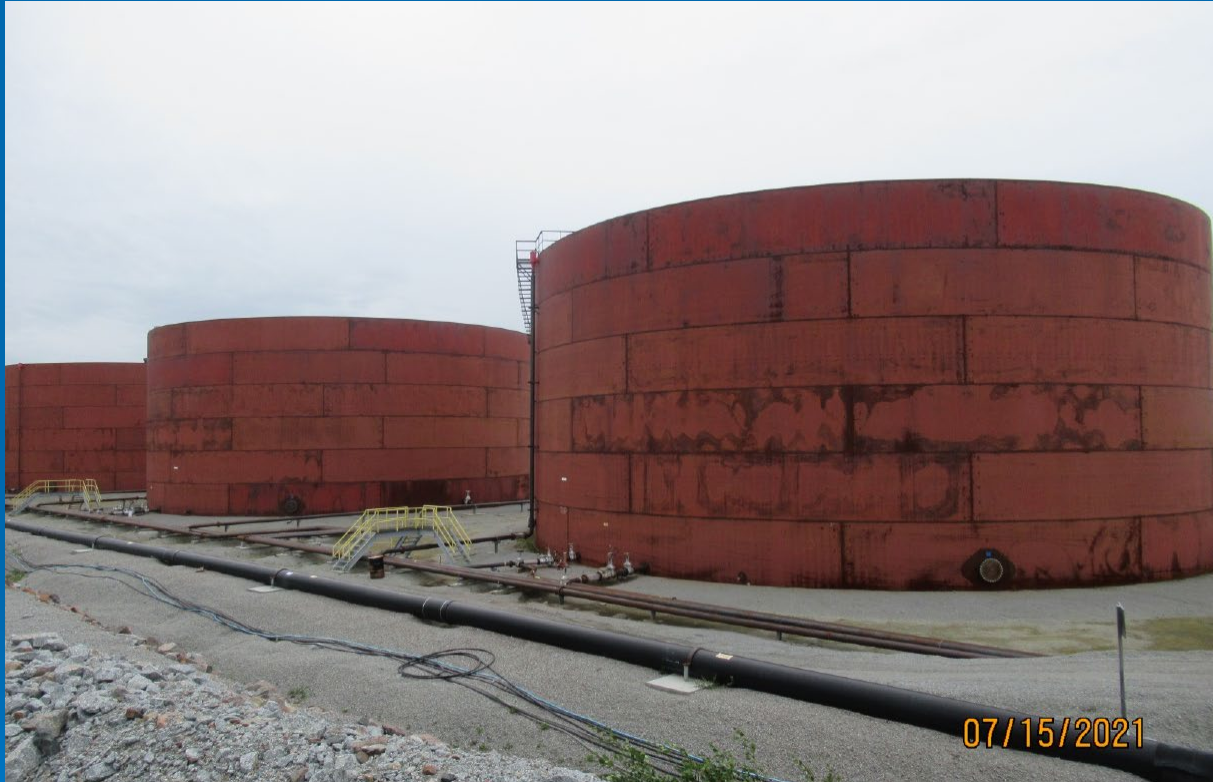
Photo8: Looking west at the 18-million litre bulk fuel storage tanks and pumped-out berm.

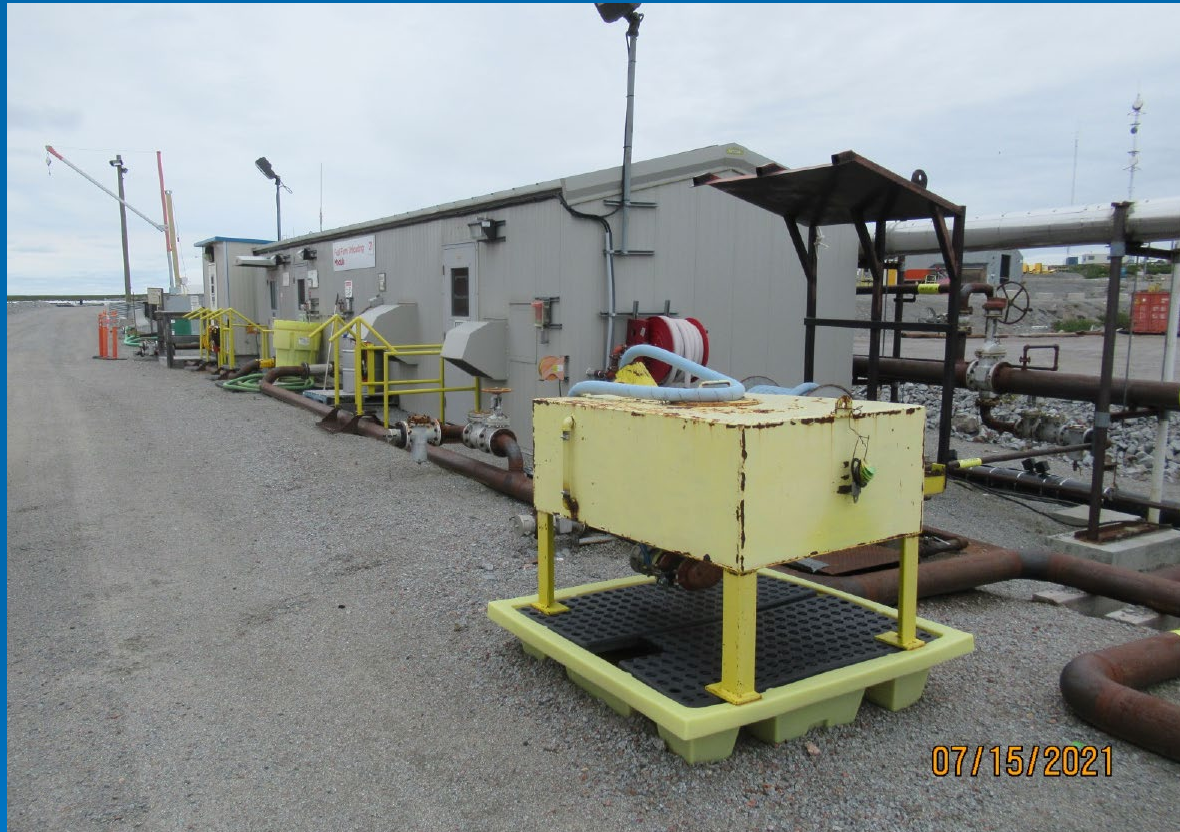
Photo9: The bulk fuel storage facility transfer station.

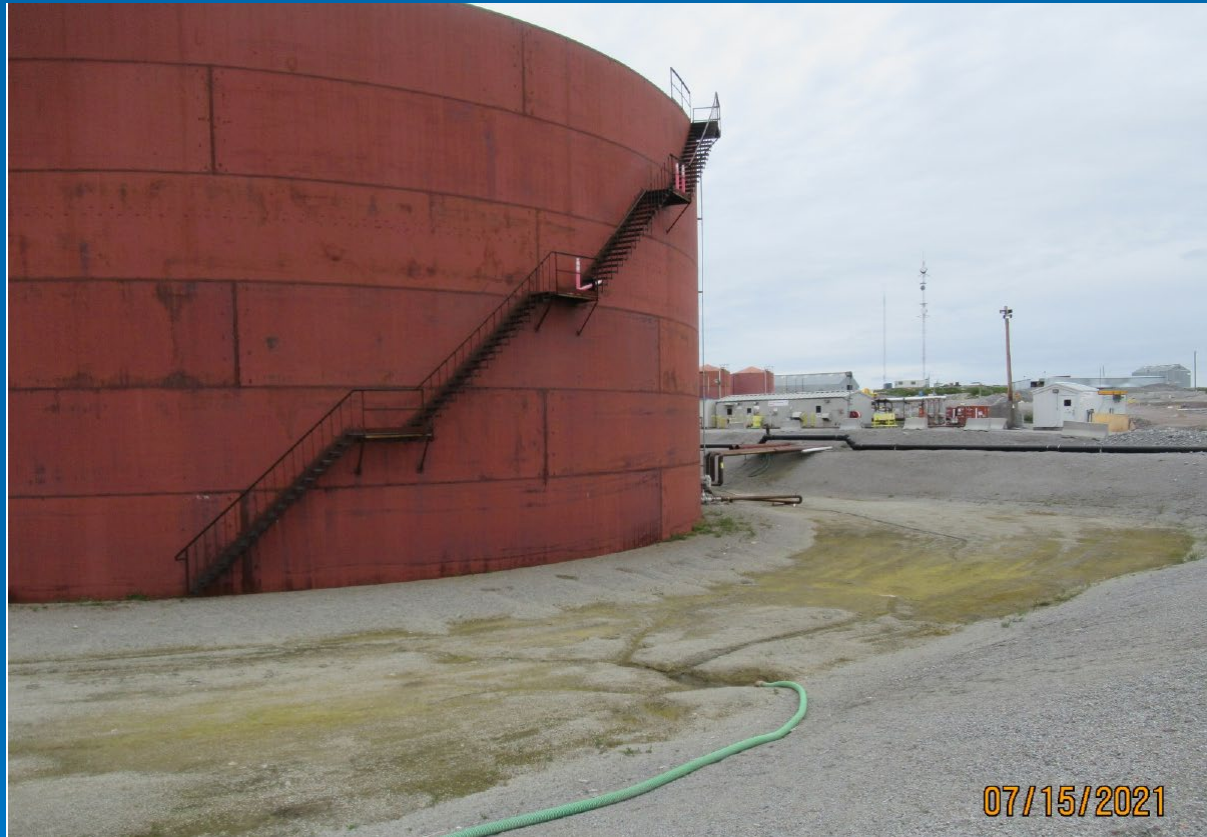
Photo10: As seen, water from the tank berm is pumped out as required.

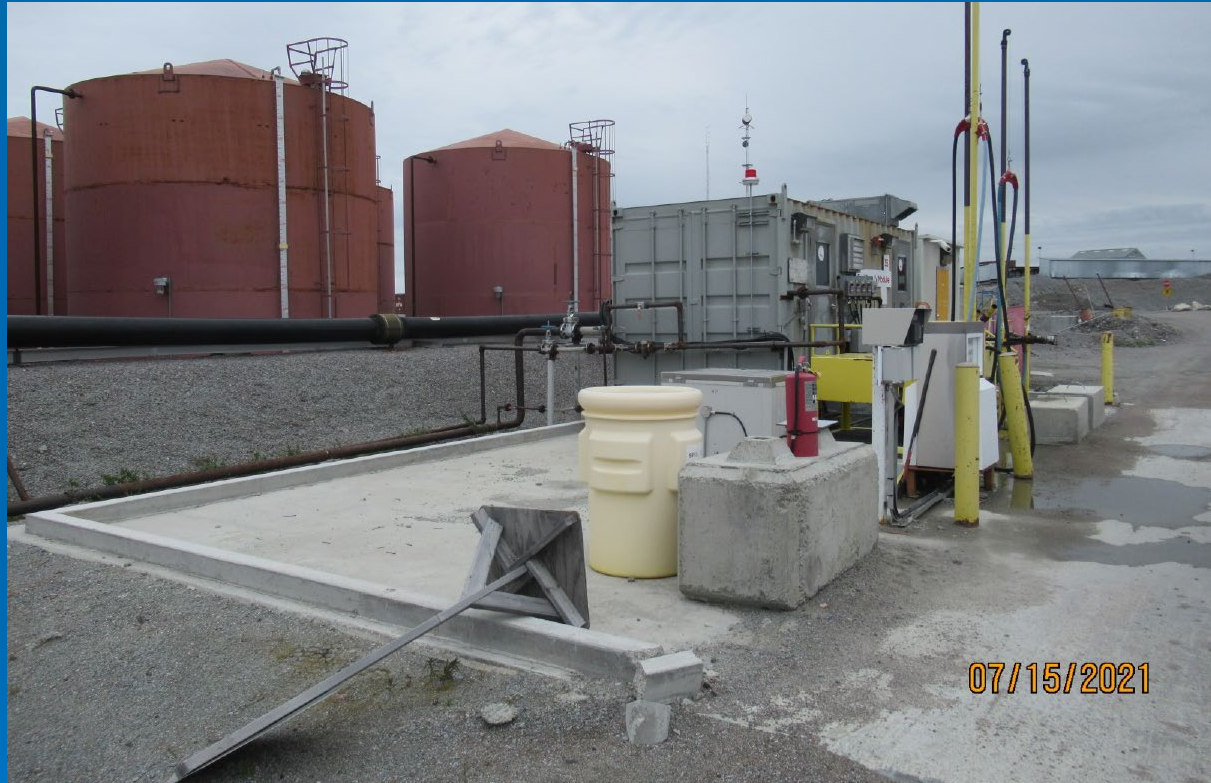
Photo11: The light vehicle fuel transfer station at the Snap Lake Mine.

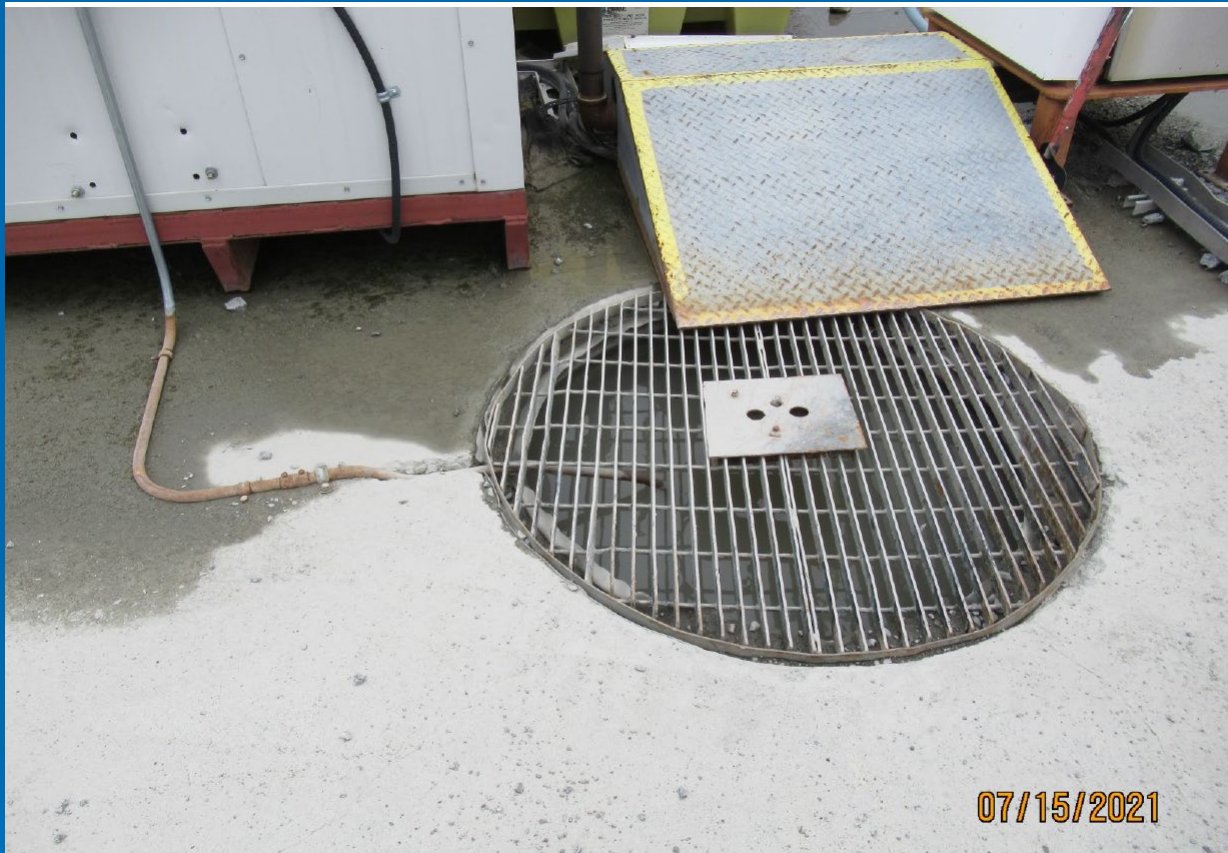
Photo12: This sump at the fuel station in Photo #14 was approaching capacity due to a recent rainfall. The sumps are sucked out with a vacuum truck and the water is deposited into the WMP prior to treatment and discharge.

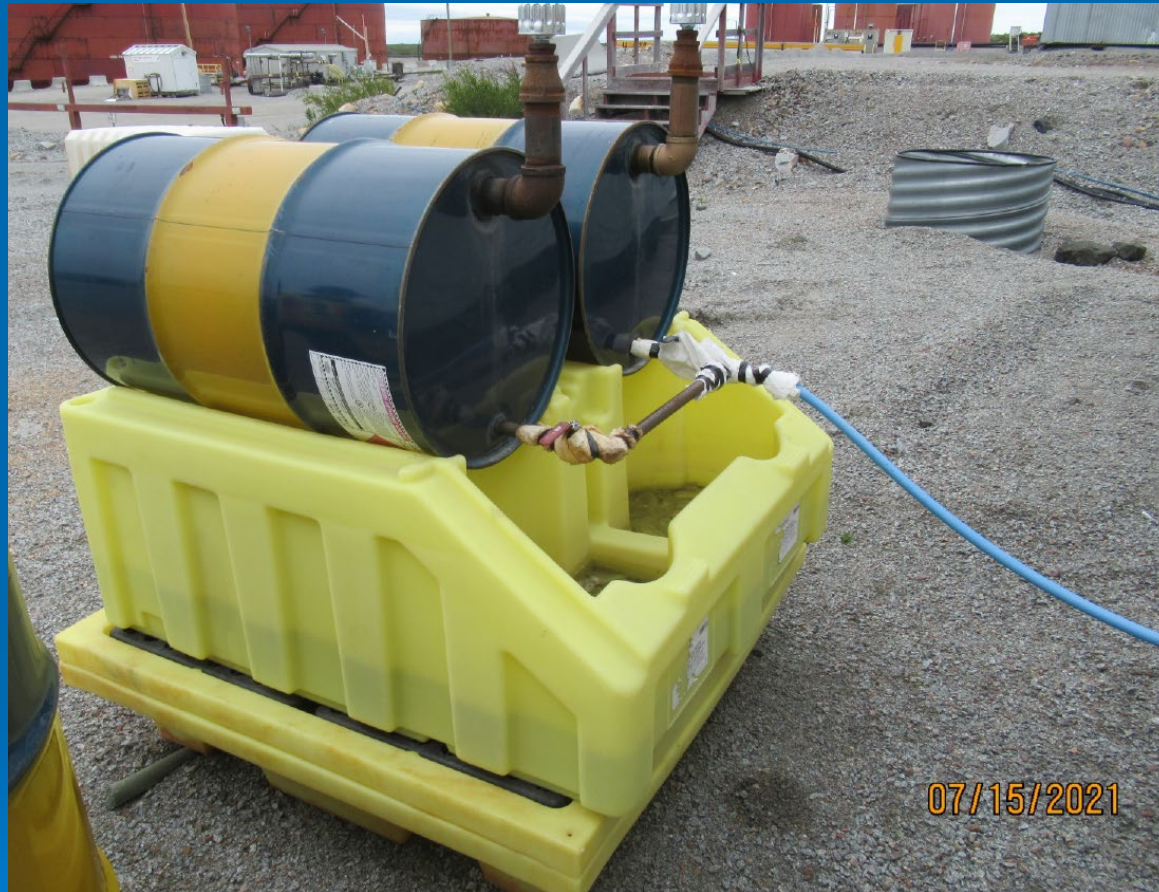
Photo13: The hydrocarbon matting on this fuel spigot was saturated required changing.

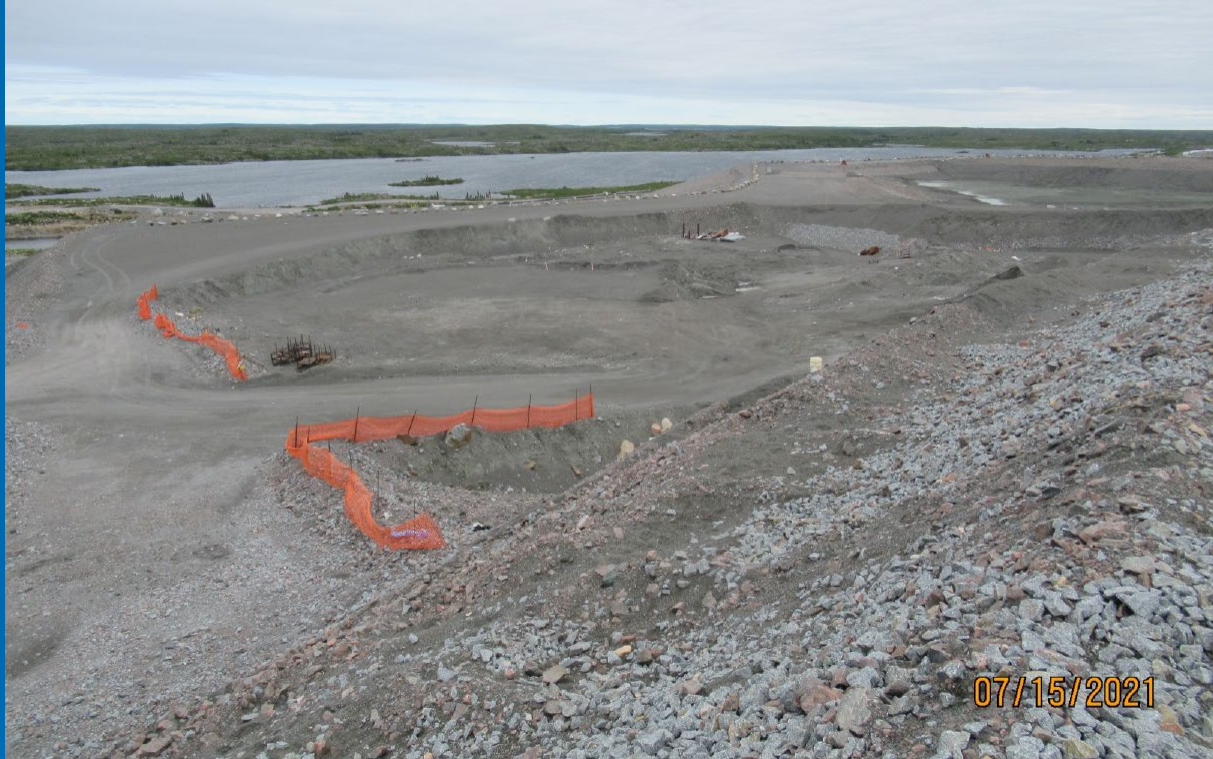
Photo14: Looking north at the mine Landfill.

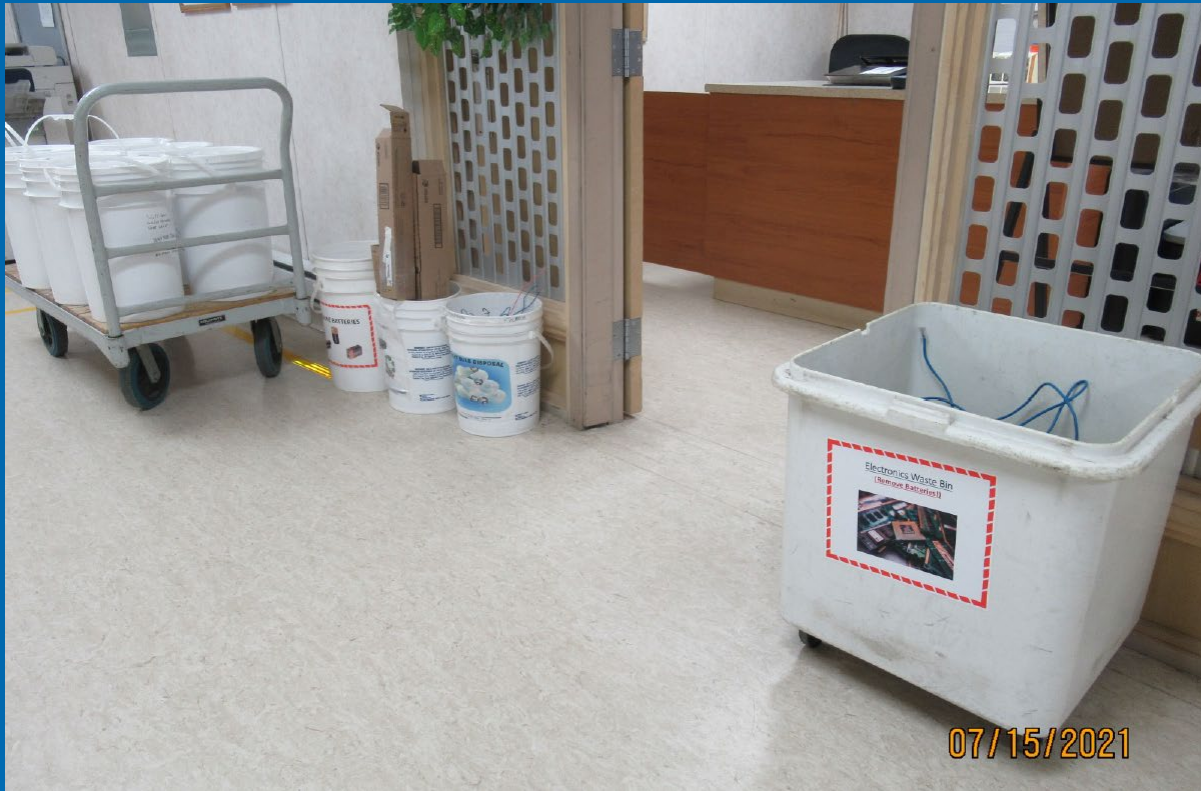
Photo15: Waste is segregated into its proper waste streams prior to disposal.

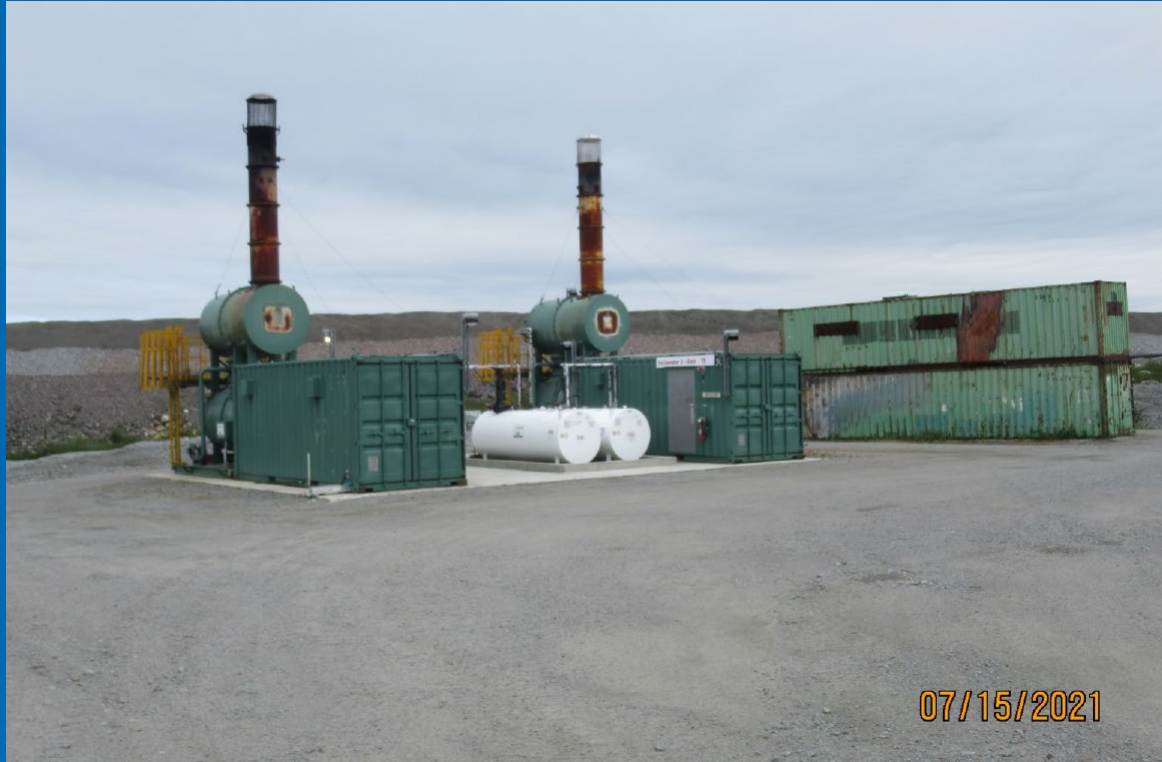
Photo16: The camp incinerators and fuel supply.

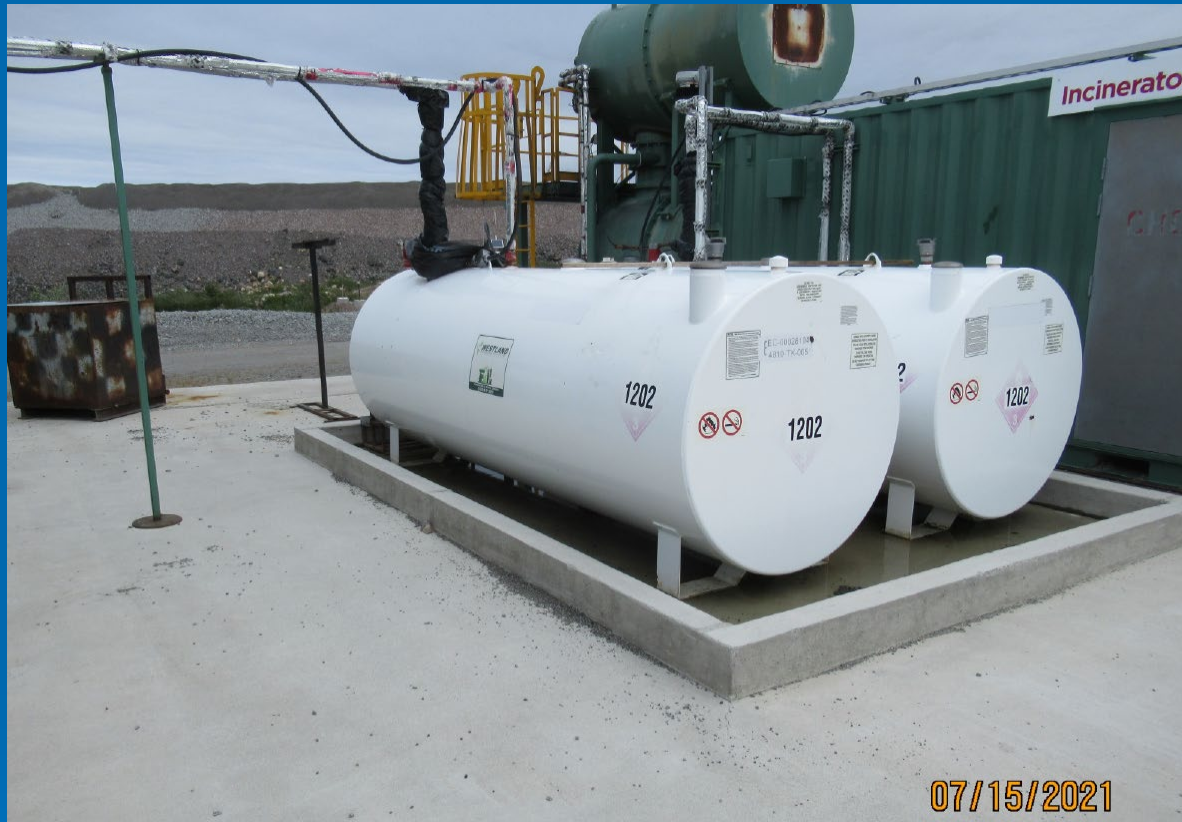
Photo17: Water within the incinerator fuel tank berm is monitored and removed as required to ensure capacity.

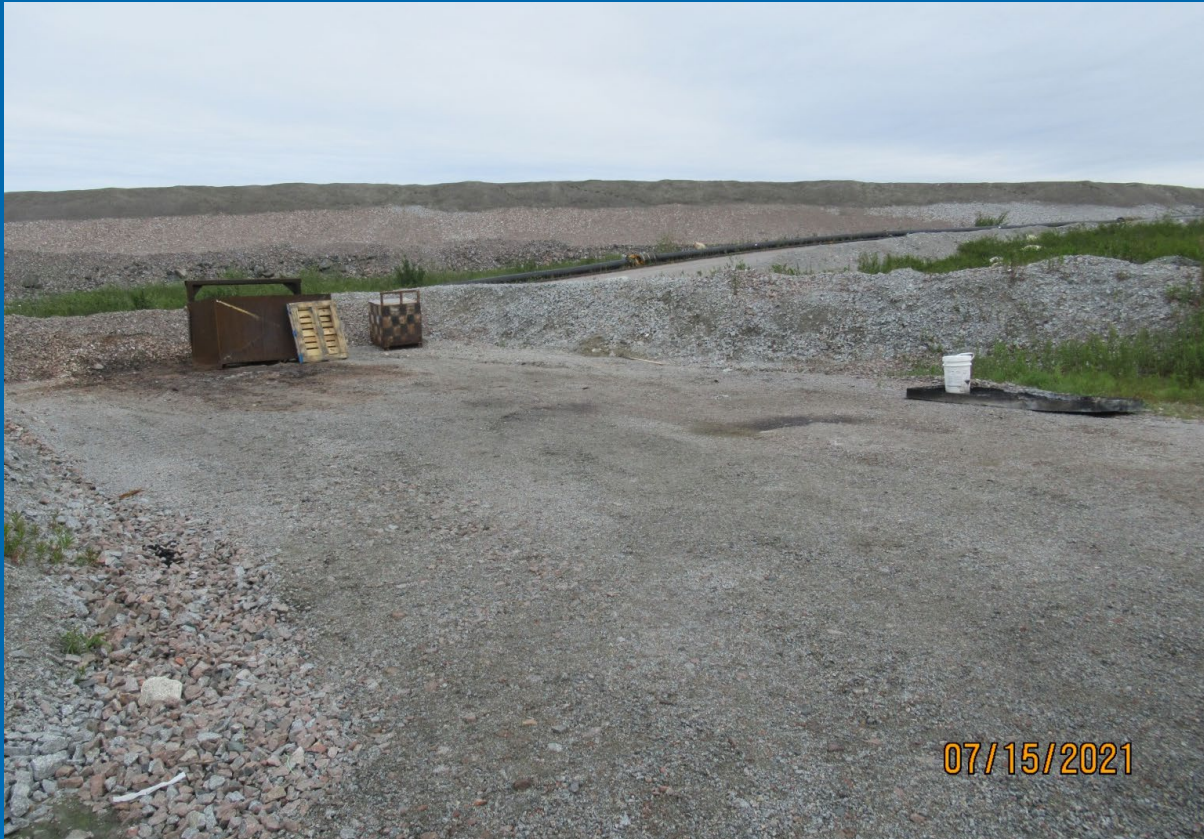
Photo18: The mine burn pit area.

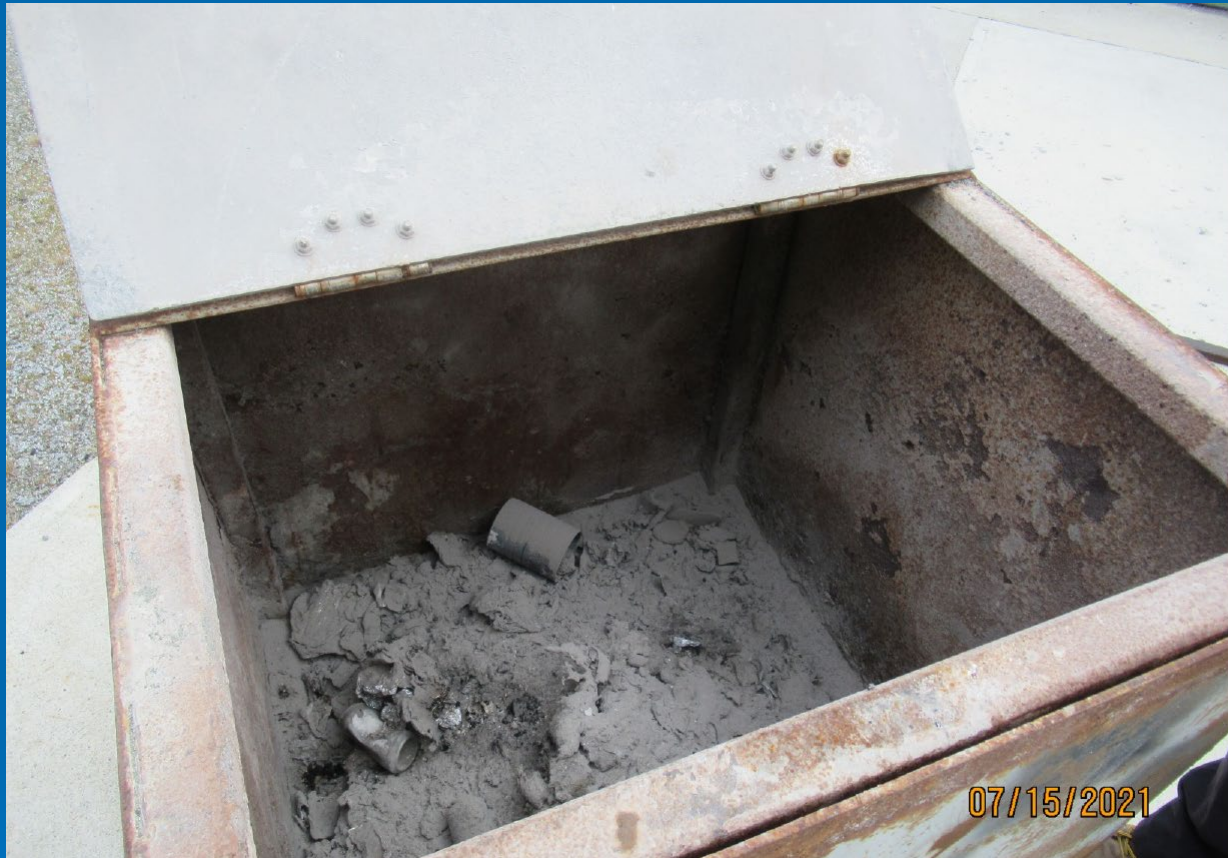
Photo18: Waste metals and ash from the mine waste incinerations are containerized and tested prior to disposal.

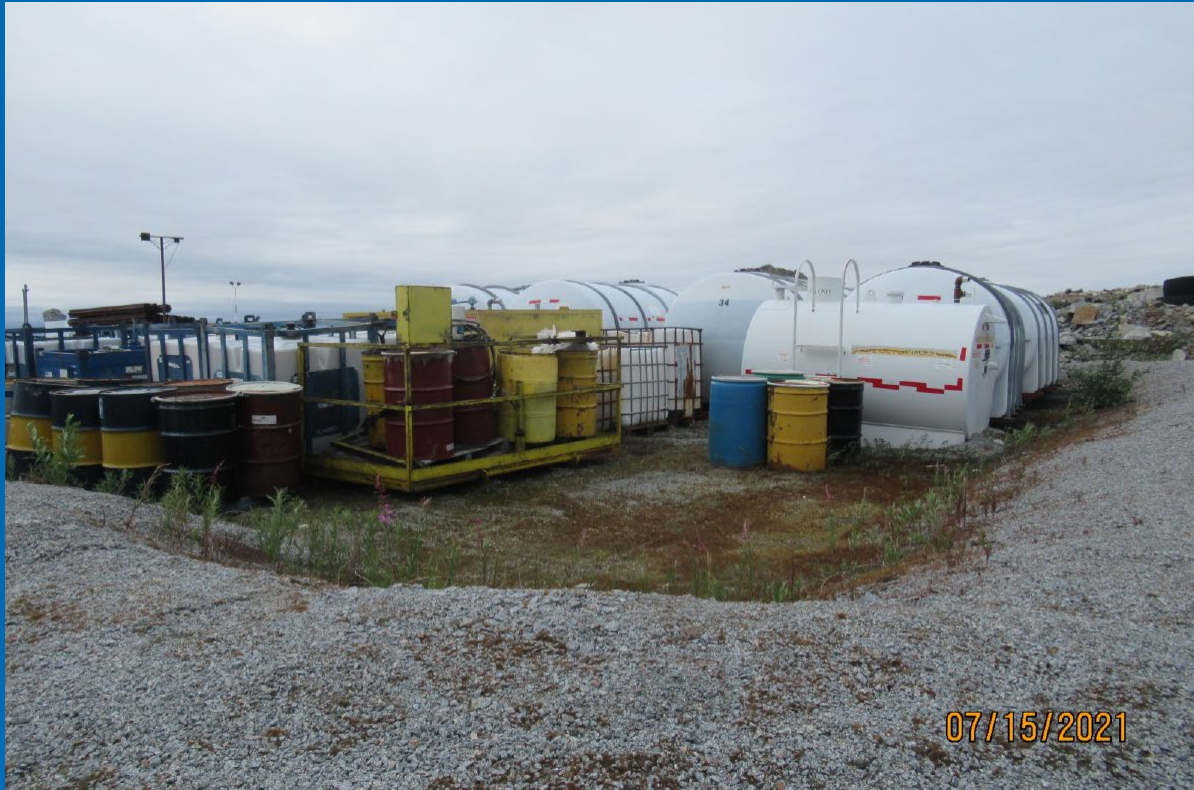
Photo18: Hazardous waste is staged within this lined and bermed area to await disposal offsite.

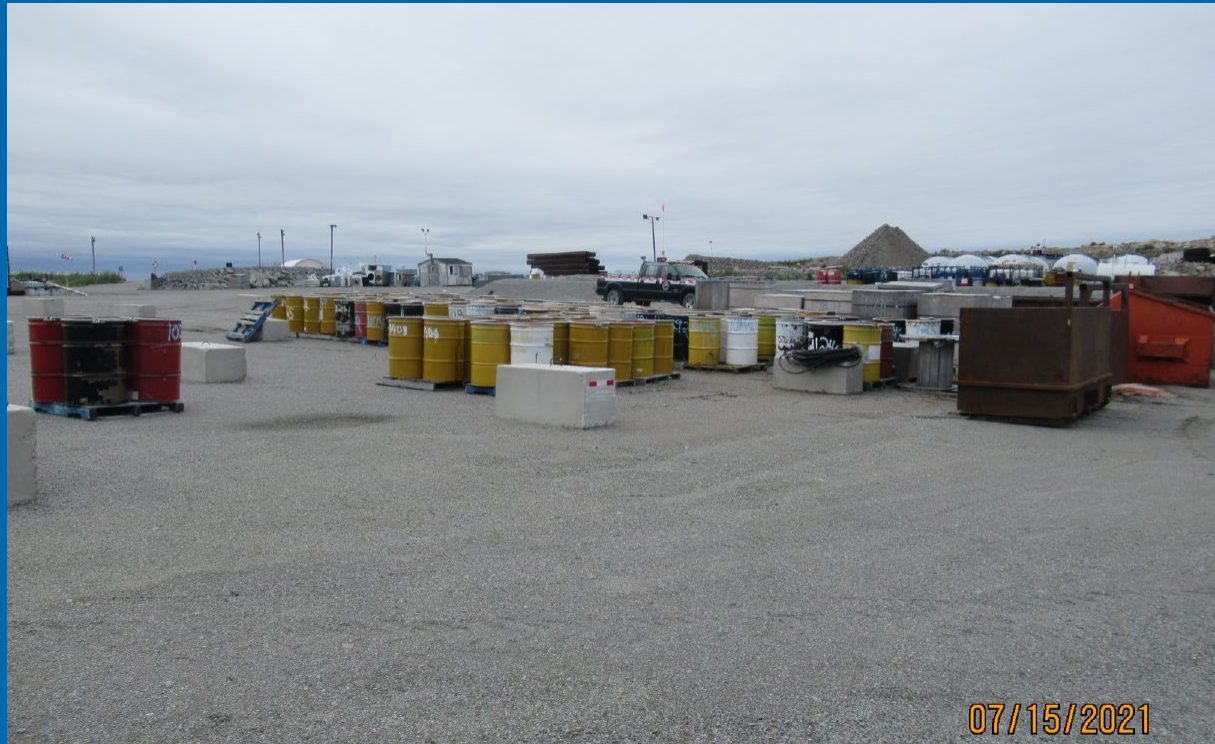
Photo19: Additional hazardous waste is being properly staged and labeled to await offsite disposal at the mine Waste Transfer Area.
