November – December 2021
Environmental Update
for SLEMA Board
January, 2022

5. Site Inspection Nov. 23rd

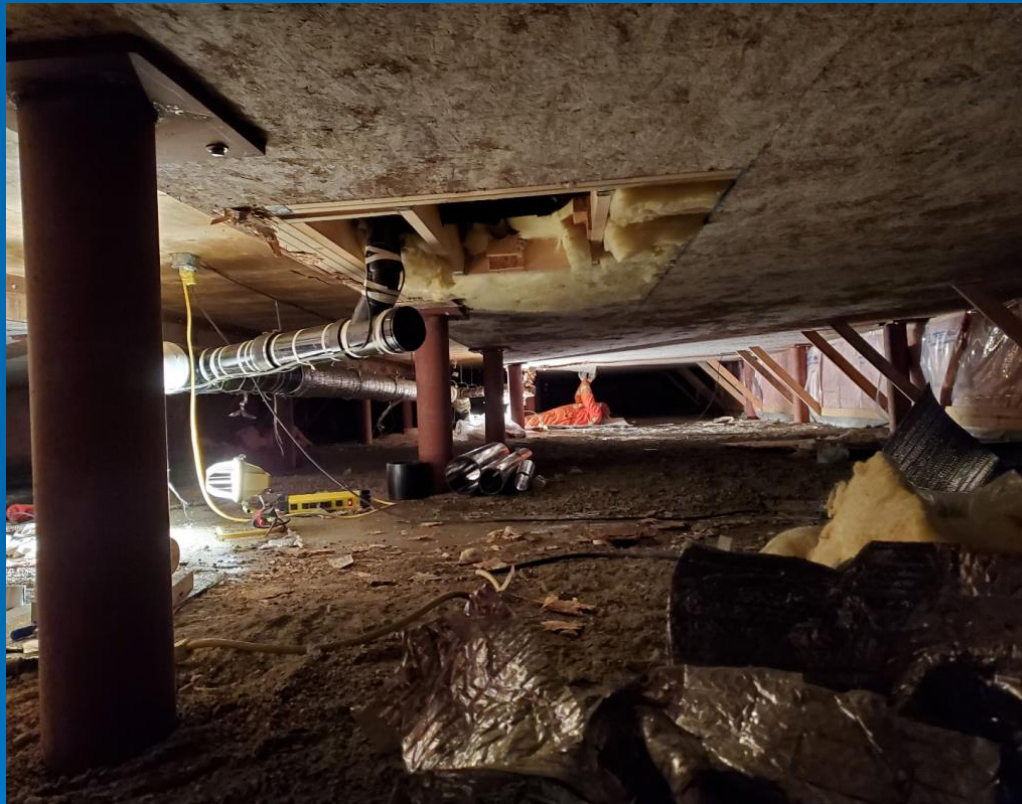
- Spill # 2021487, B-Dorm Sewage Leak on December 4th, 2021
 - A clogged shower drain was reported in room 125 of the B-Dormitory of the main camp.
 - An initial investigation determined the drain had frozen due to extreme cold.
 - Additionally, the 3" drain line feeding the 6" main drain was cracked, and a quantity of black/grey water had leaked out and frozen underneath the dormitory.

- Spill # 2021487, B-Dorm Sewage Leak on December 4th, 2021
 - Further investigation confirmed approximately 200 L of combined black and grey water had leaked from the pipe and frozen on the ground beneath the B Dorm wing of the main camp accommodations complex.
 - The affected washroom was taken out of service to prevent more leakage and staff from the affected rooms were assigned new rooms.

FIG. 1 FROZEN SEWAGE AND DAMAGED PIPES

- Spill # 2021487, B-Dorm Sewage Leak on December 4th, 2021
- Following the incident, the water supply to the washroom was shut off and isolated to prevent additional leakage.
- An initial report was submitted to the NT-NU 24-Hour Spill Report Line.
- The Area was cleaned, and preventative repairs and maintenance were completed as necessary.

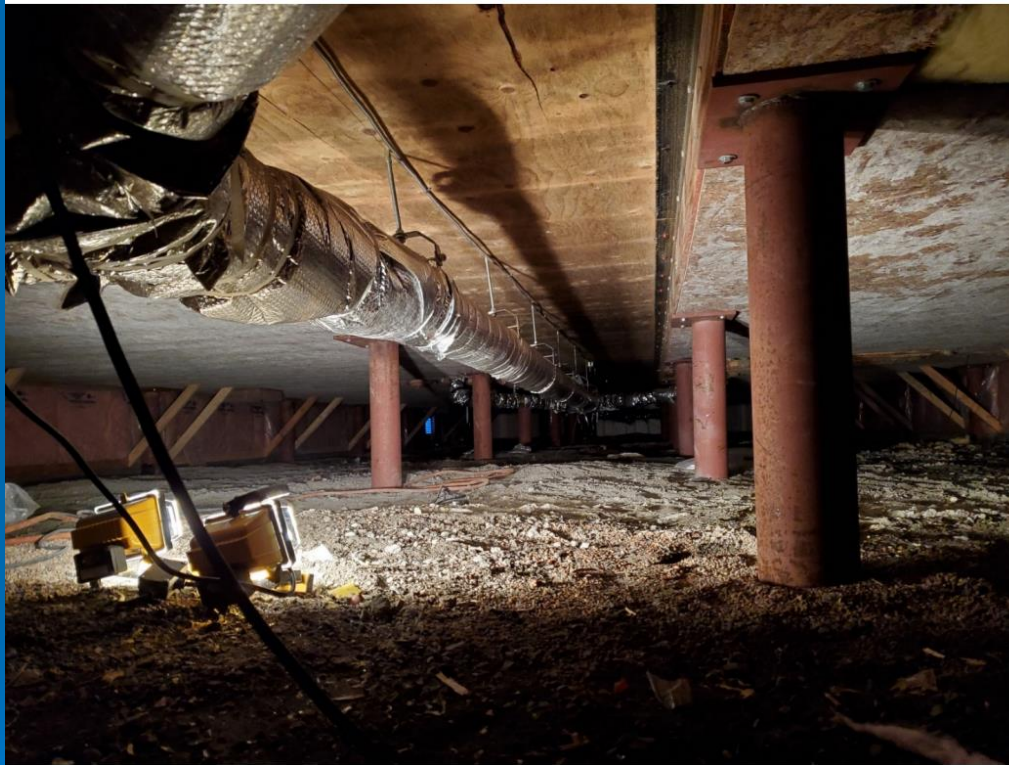
FIG. 2 COMPLETED REPAIRS

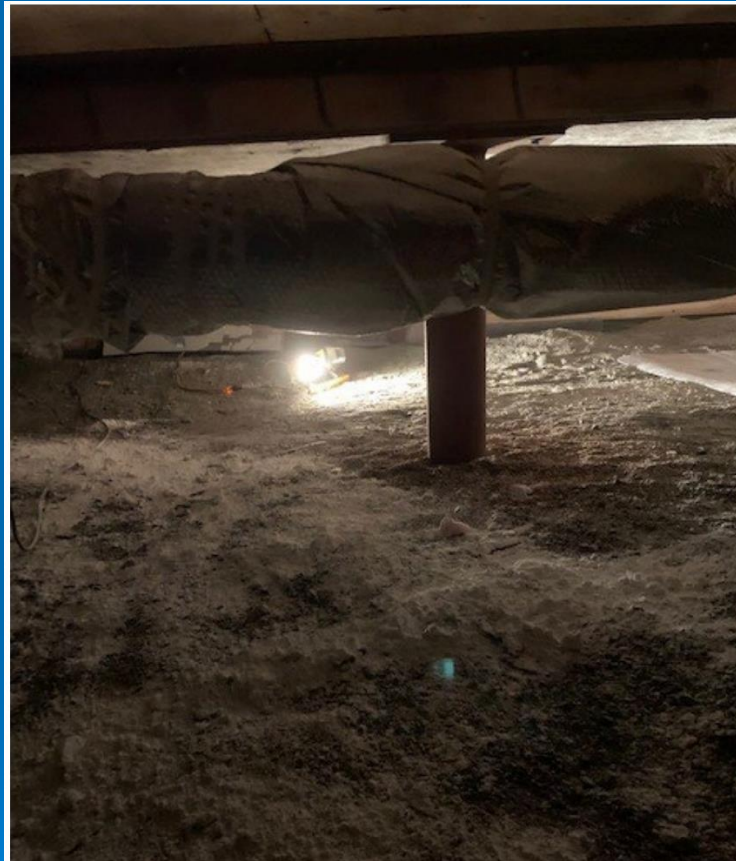
FIG. 3 APPLICATION OF HYDRATED LIME

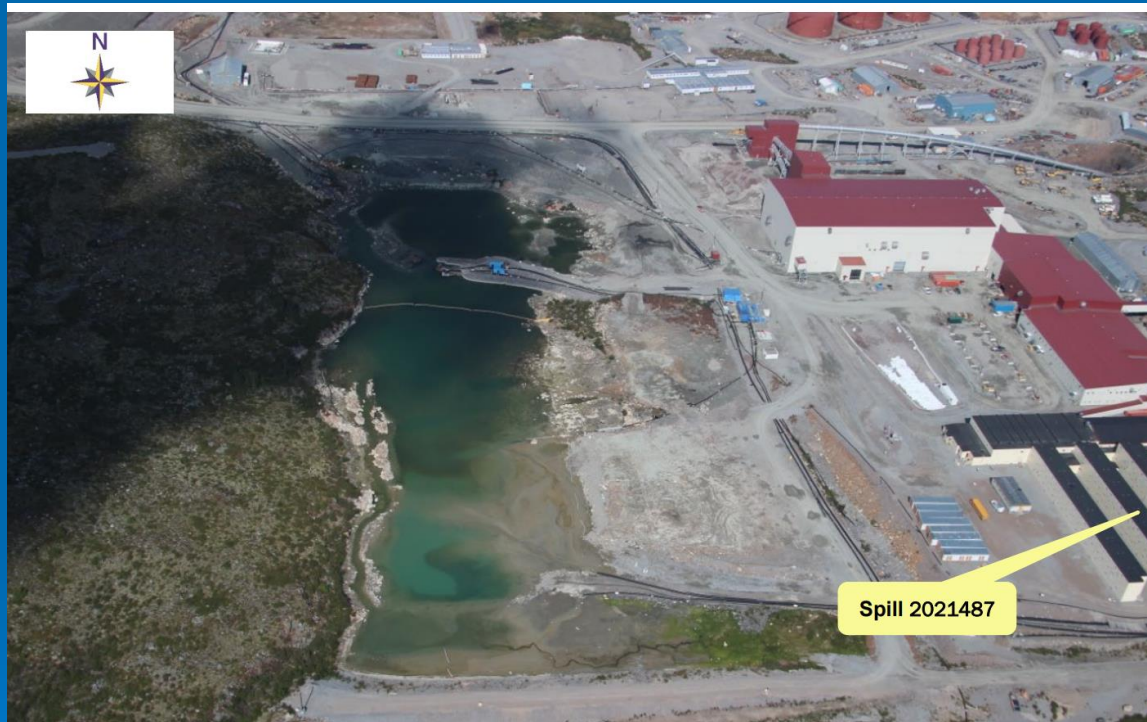
FIG. 4 SITE VIEW

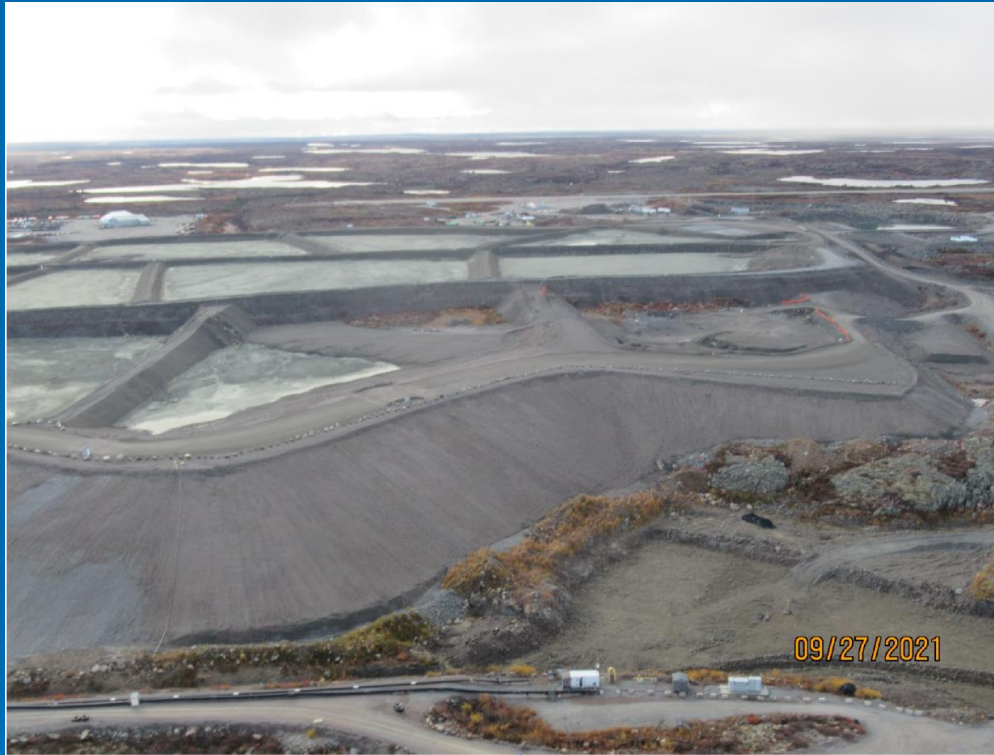
Photo 1: Looking south at the North Pile the landfill is in the centre-right of the photo and Sump #5 can be seen in the bottom-right.

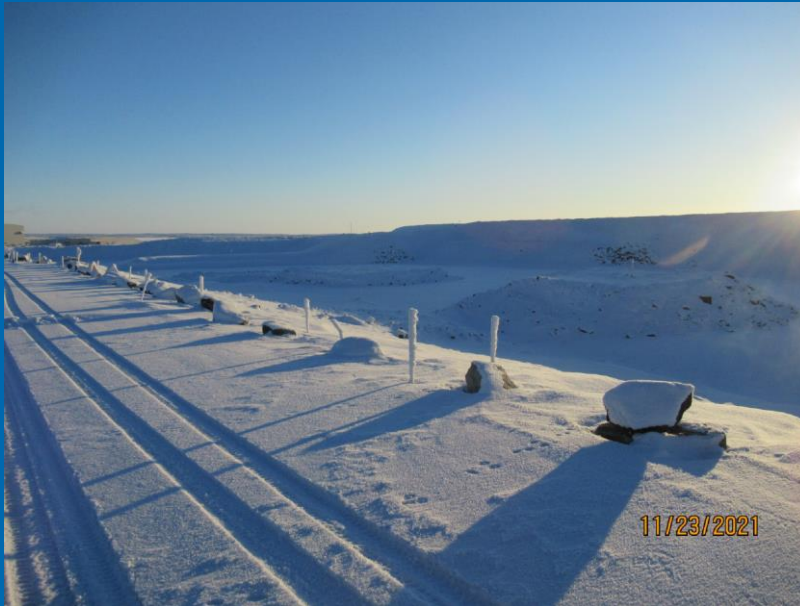
Photo 2: Looking at the snow-covered North Pile East Cell-Cell 4.

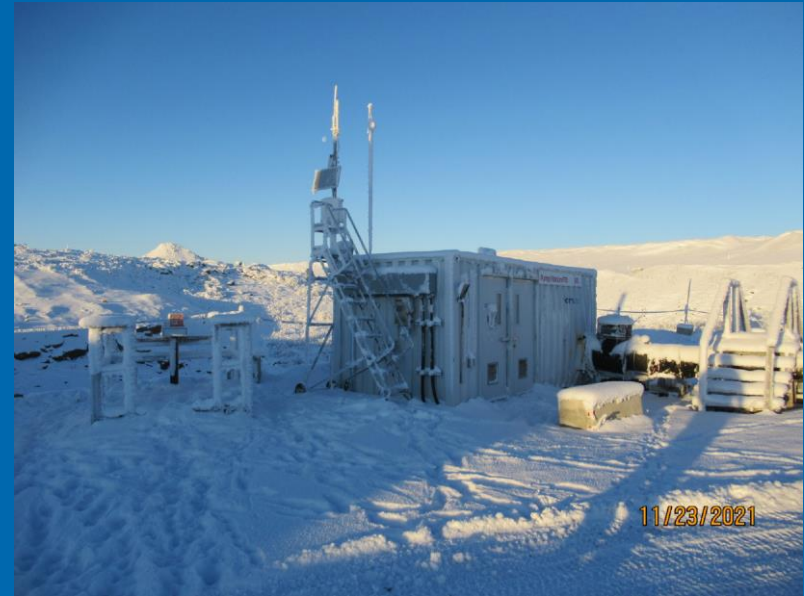
Photo 3: The Godwin previously staged at the North Pile Sump #1 pumphouse has been put away for the winter.

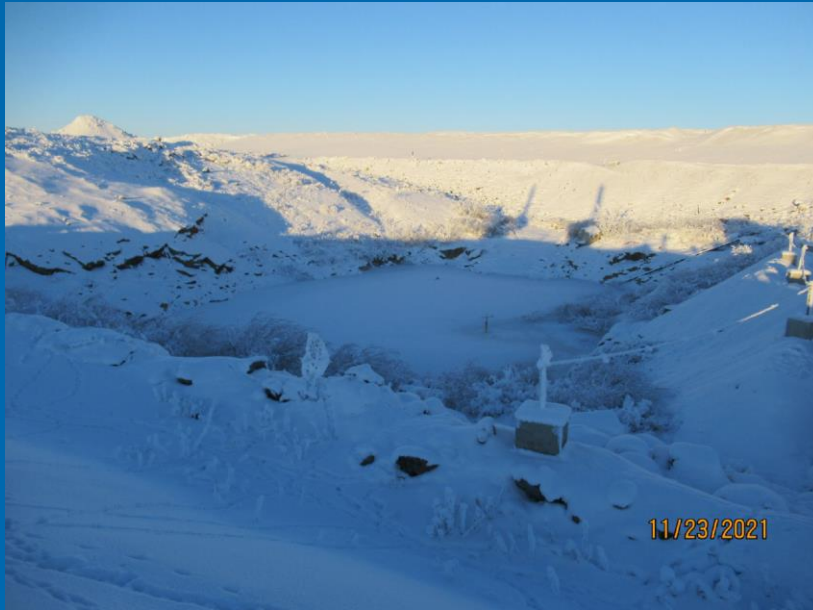
Photo 4: Looking north at the North Pile Sump #1.

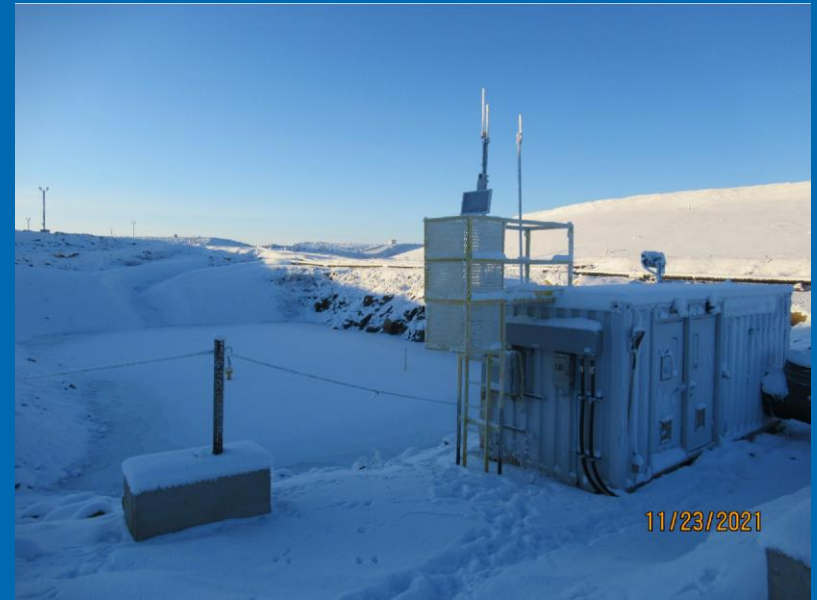
Photo 5: Looking west at Sump #2 and the shut-down pumphouse. A staff gauge has been installed at the sump to assist with the surveyed elevations.

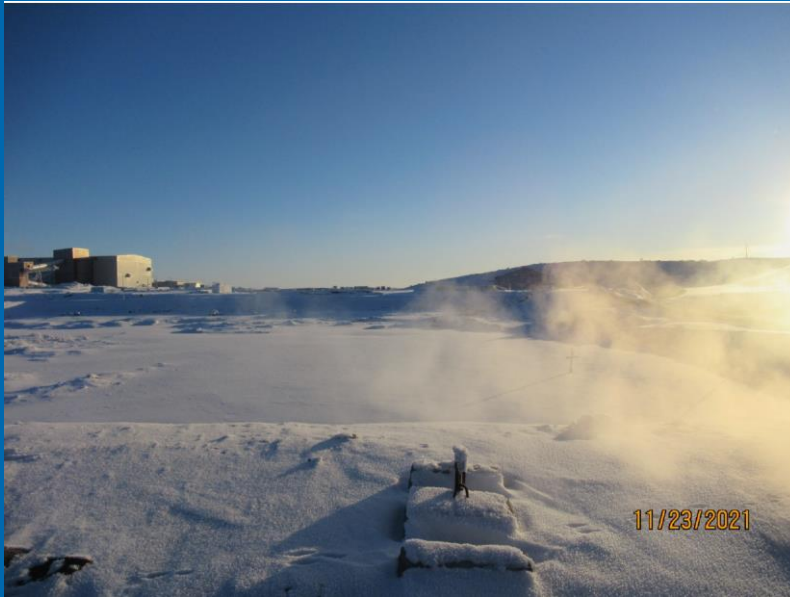
Photo 6: Looking south at the pump-out and frozen North Pile Sump #3.

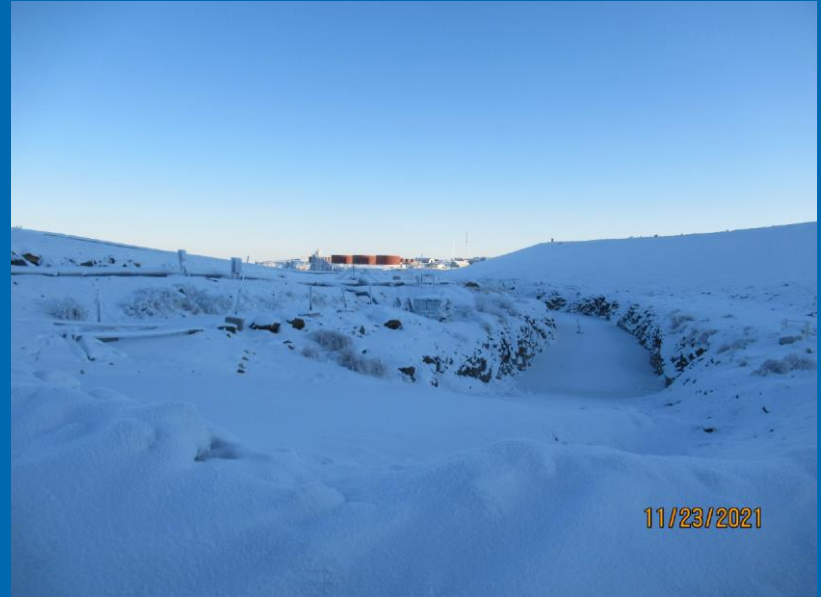
Photo 7: Looking east at the North Pile trench Sump #4 and pumping infrastructure.

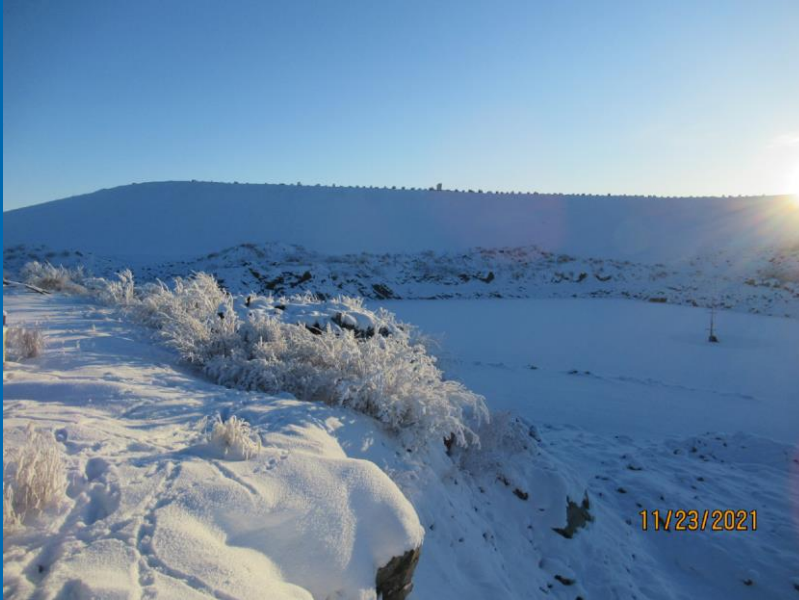
Photo 8: Looking at the east side of Sump #5, located north and adjacent to the North Pile.

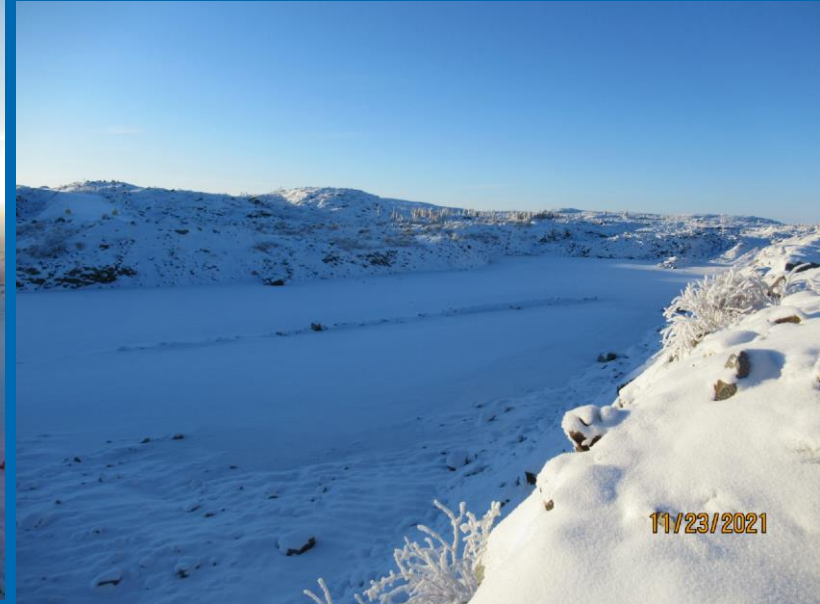
Photo 9: Looking at the west side of Sump #5 just south of the IL6 Ditch

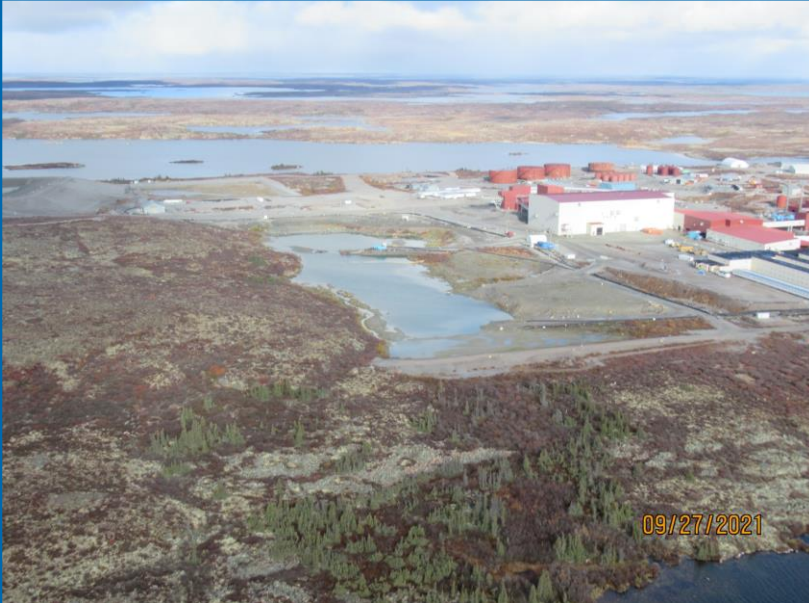
Photo 10: Looking north at the mine Water Management Pond prior to freeze-up

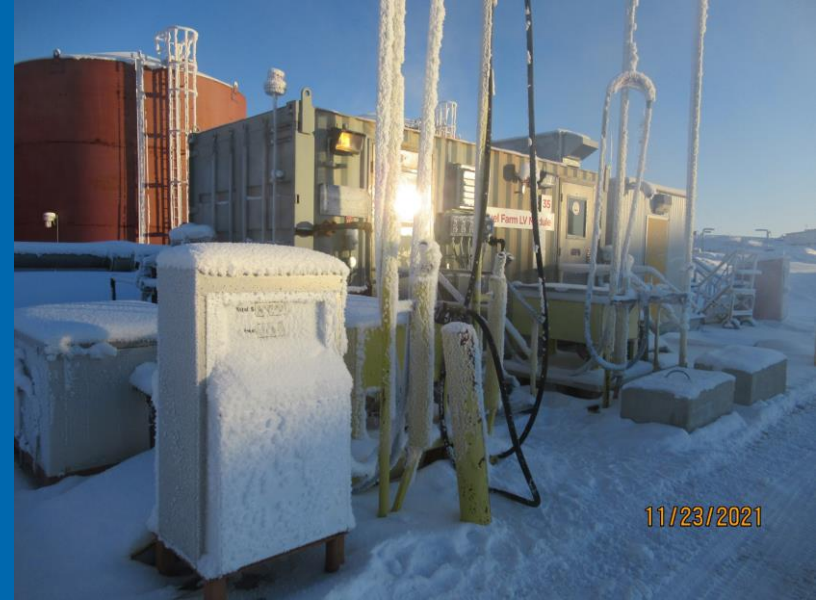
Photo 11: The mine Light Vehicle fueling station is active and in use.

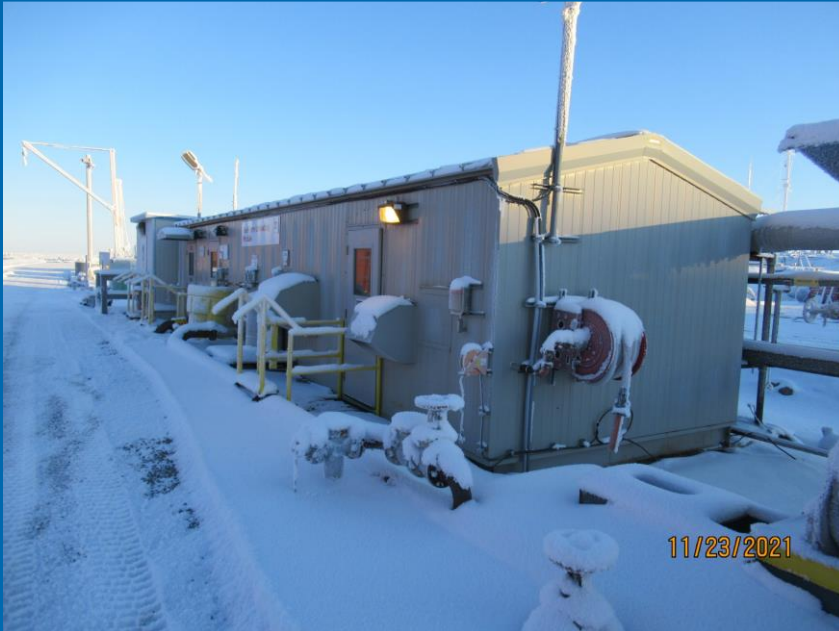
Photo 12: Looking east at the bulk fuel offload station. Approximately 3 million litres of fuel will be delivered to the Snap Lake Mine via winter road during the Winter 2022.

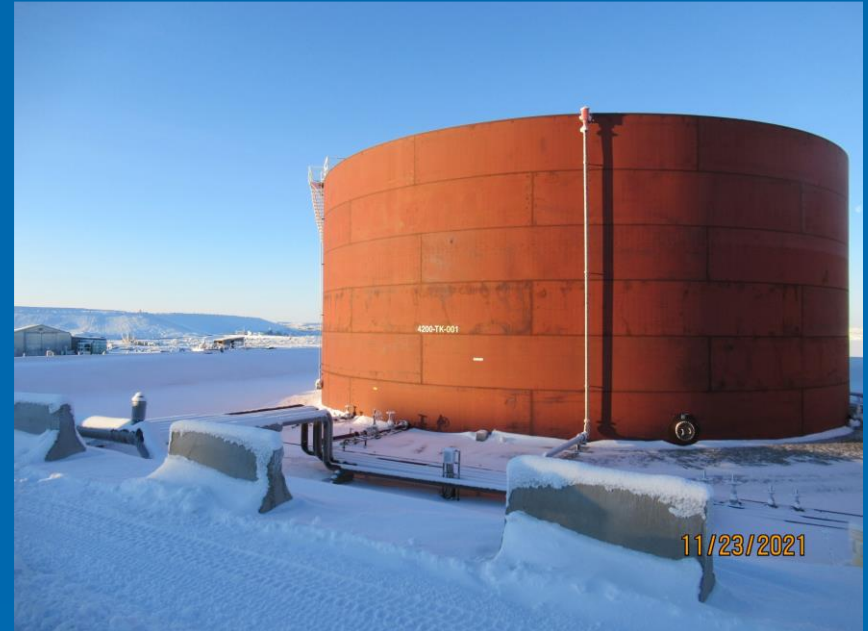
Photo 13: Looking north at the TK-001 12 million litre bulk fuel holding tank.

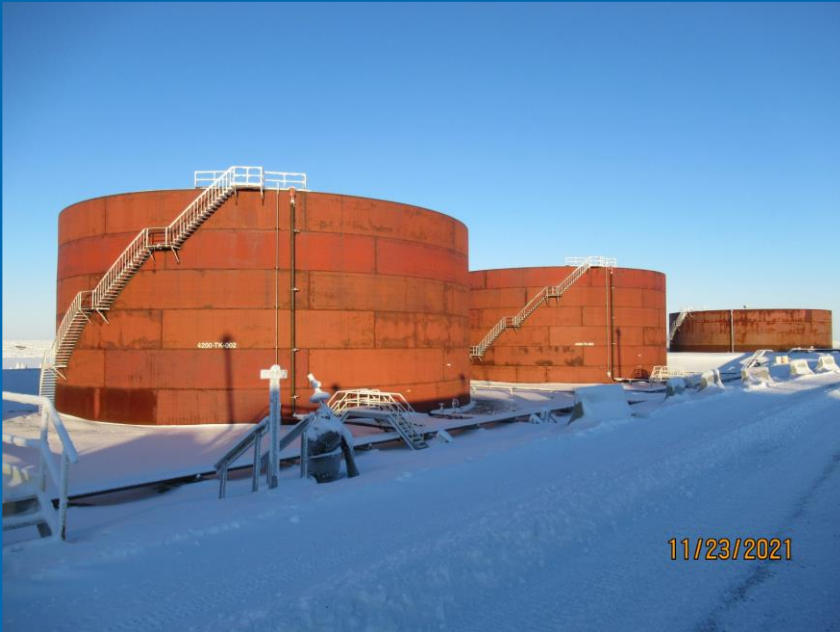
Photo 14: Looking east at tanks TK-002 and TK-003. The decommissioned 10 million litre holding tank can be seen in the background.

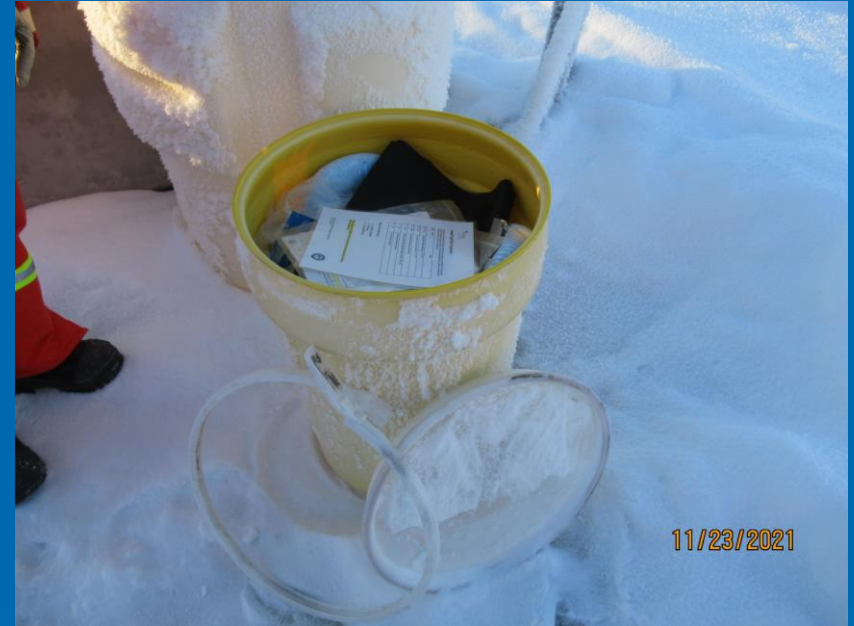
Photo 15: An example of a fully stocked and labeled spill kit at the Snap Lake Mine.

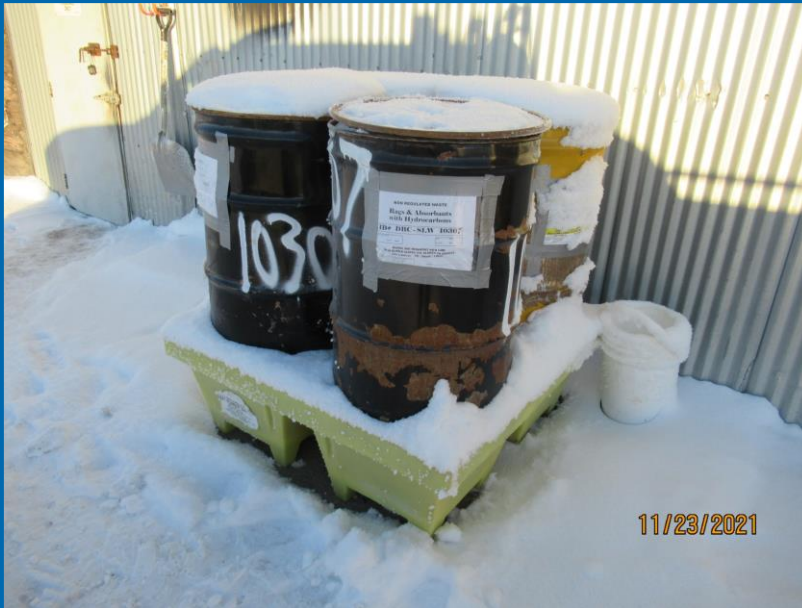
Photo 16: Waste onsite was being segregated, labeled and staged prior to its transfer to the mine Waste Transfer Area.

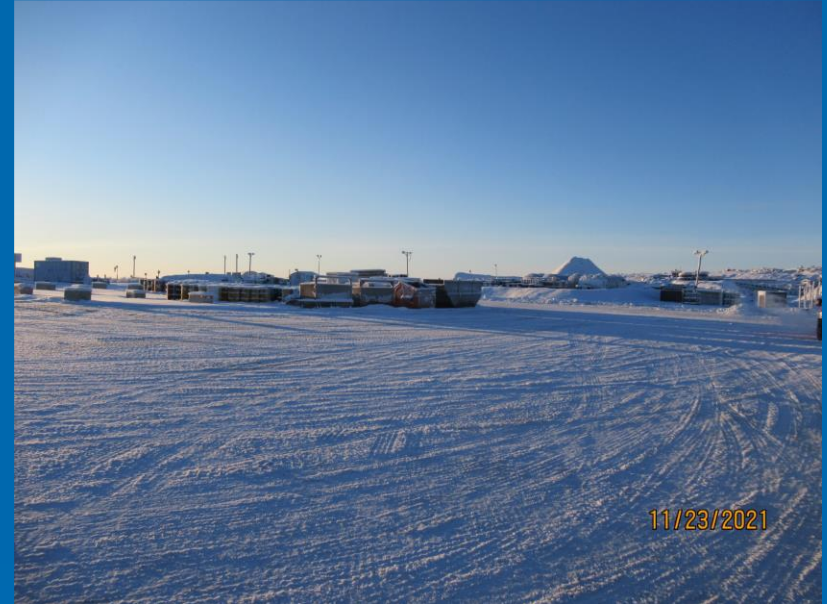
Photo 17: Looking at properly staged, labeled and containerized waste at the mine WTA.

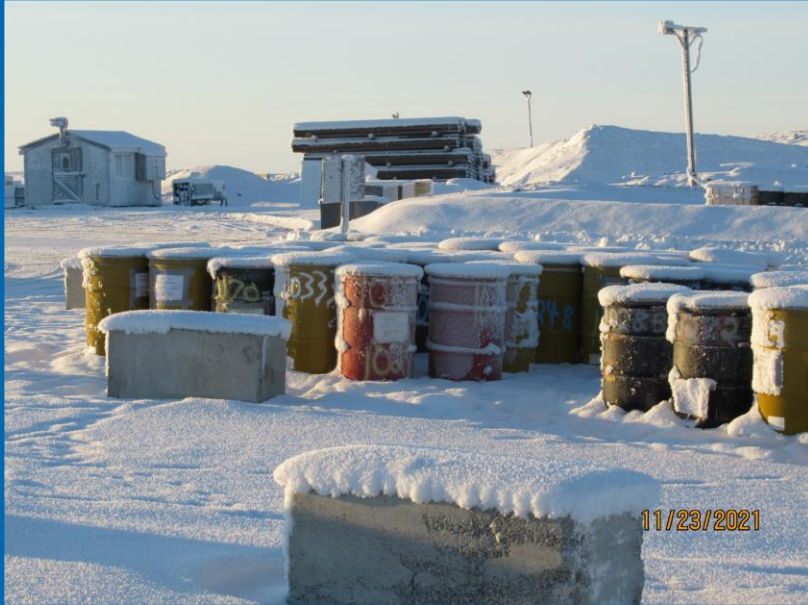
Photo 18: The mine maintains a labeling program to ensure waste is easily identified prior to processing and disposal.

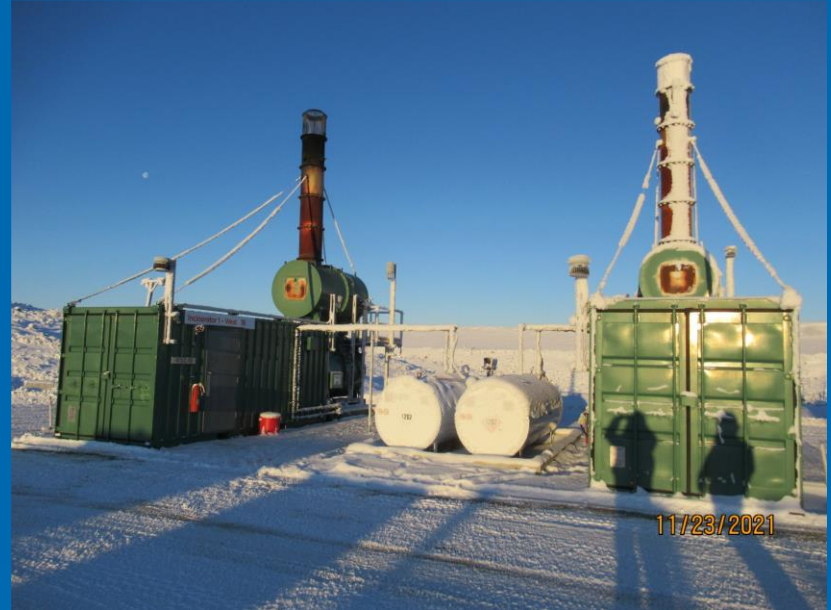
Photo 19: Looking north at the mine incinerators and fuel tanks.

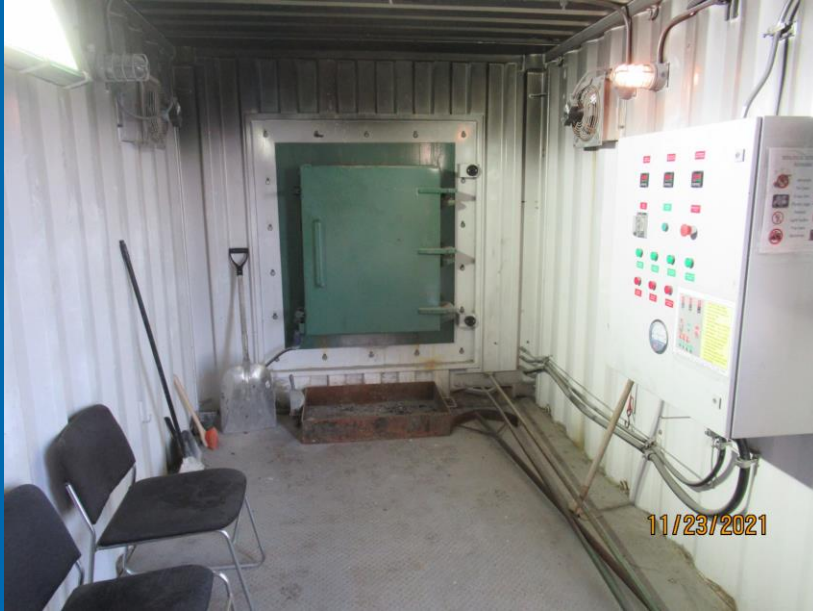
Photo 20: This incinerator access hatch is used to remove incinerated materials

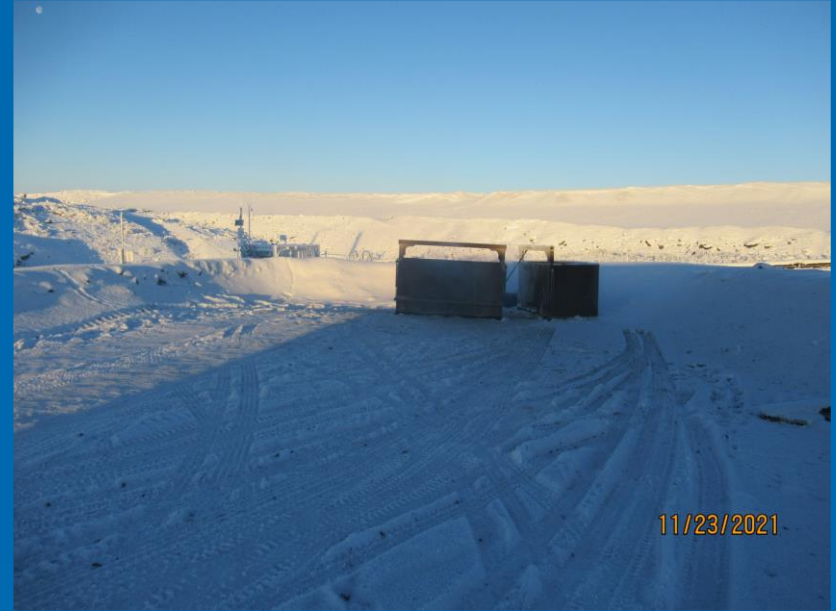
Photo 21: Looking north at an active burn bin and a holding bin. The Licensee must ensure only approved waste is burned in the bins.

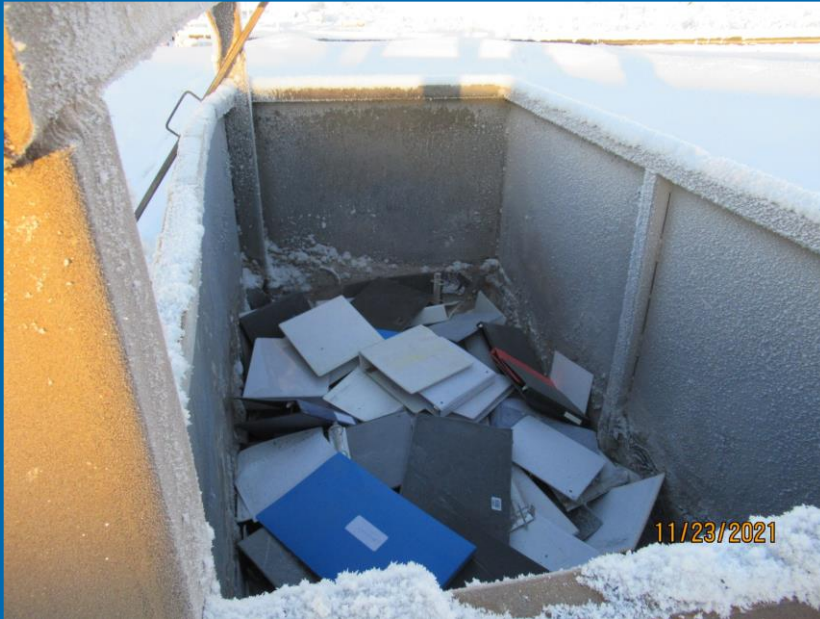
Photo 22: Materials awaiting incineration are separated prior to burning at the mine burn area.

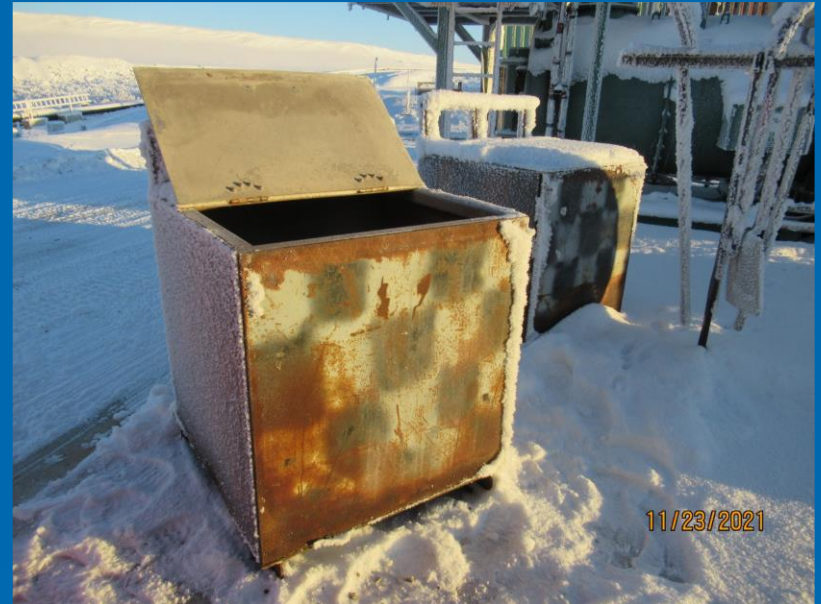
Photo 23: Waste metals and ash from the mine incinerators and burn bins are placed in this holding container.

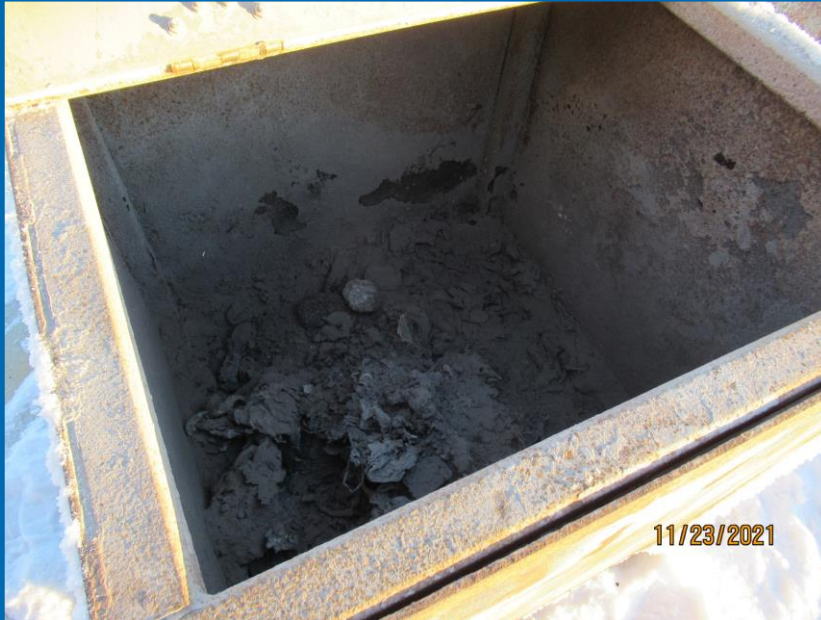
Photo 24: The waste metal and ashes are tested prior to disposal.

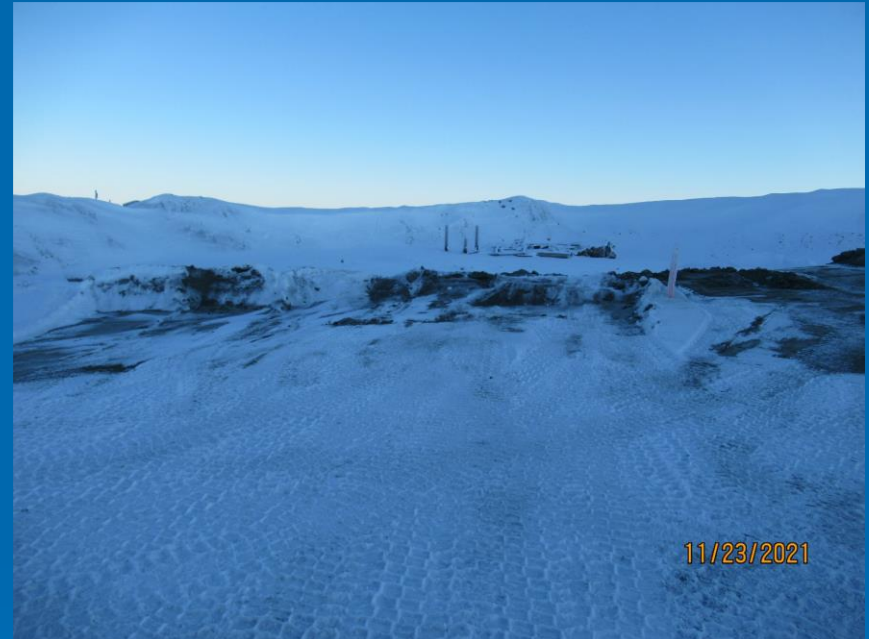
Photo 25: Looking east at recently pushed up waste at the mine landfill.

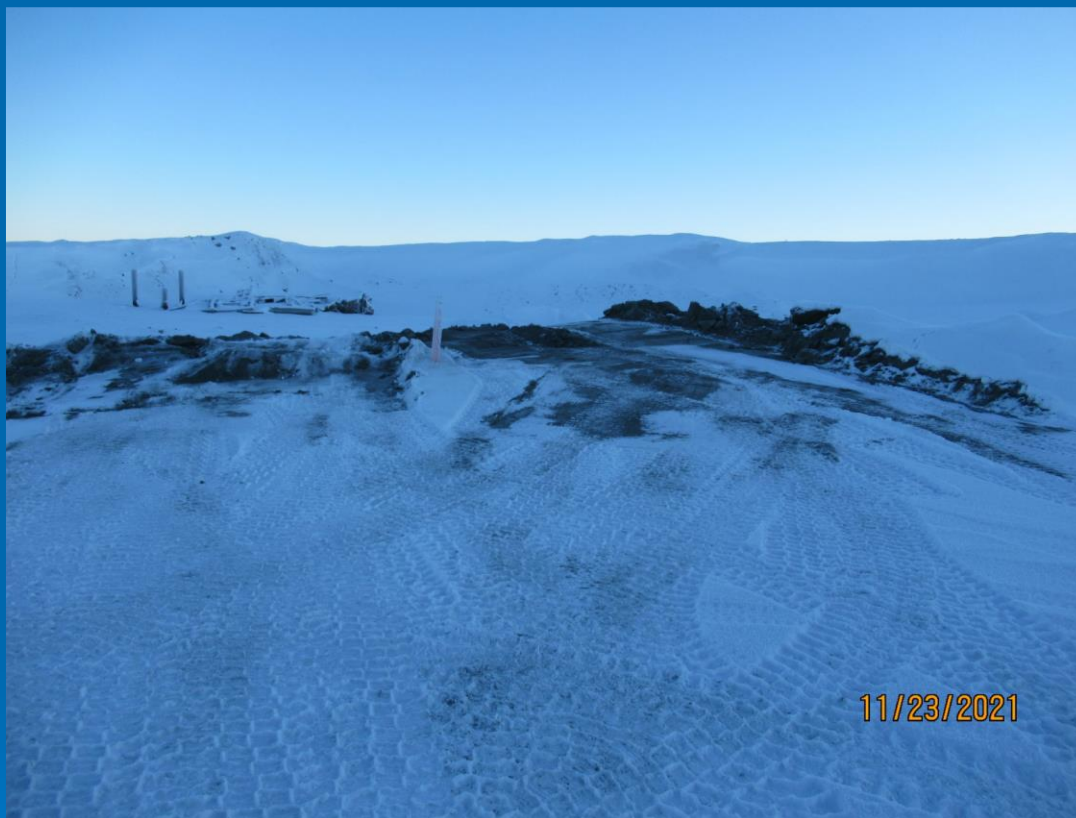
Photo 26: The waste metal and ashes are tested prior to disposal.
