JULY, AUGUST 2022 Environmental Update for SLEMA Board October, 2022

- On June 6, 2022 a water licence inspection was conducted at Site by Tom Bradbury, Resource Management Officer III
- The following areas were inspected
- Ammonium Nitrate Storage Area/Temporary Hazardous Waste Storage Area
- Old Emulsion Plant Area
- Landfarm
- Landfill/Cell 1
- Perimeter Sumps/North Pile
- Powerhouse
- Modular Water Treatment Plant

- On July 18, 2022, a Water Licence inspection was conducted at the Site by Tom Bradbury, Resource Management Officer III
 The following resource is a set of
 - The following areas were inspected
- Waste Management Area
- Perimeter Sump Construction
- Materials Demolition
- Temporary Hazardous Waste Storage
- Spills

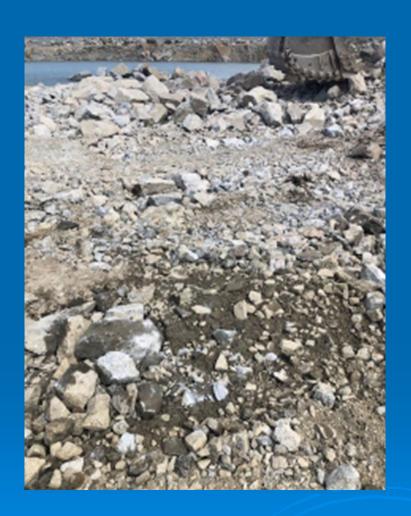
On June 19th, 2022, a Komatsu 650 Excavator was loading material in the Quarry (adjacent to the Crusher). While in operation, a hydraulic line connected to the main boom cylinder failed, causing a spill of approximately 250L of Hydraulic Fluid on the rock floor below.

The floor level the Excavator was working on where the spill took place, sat just above the water table; no hydraulic fluid escaped into the main water body nearby.

Location of spill nearby water

Spill pads and containment devices were used to isolate the area and protect the nearby water body. The hose on the Excavator was fixed and replaced.

The plan is to ensure that the any equipment that may incur potential leaks, either be swapped out of the location or the part is replaced prior to any further work taking place

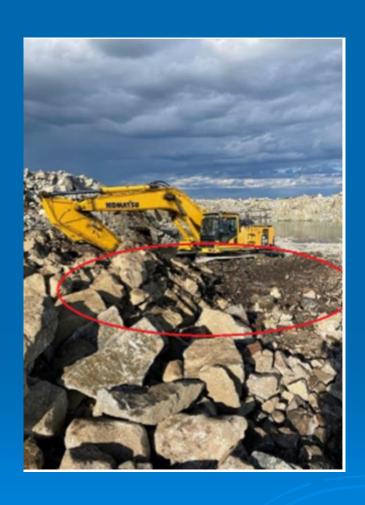
Komatsu excavator

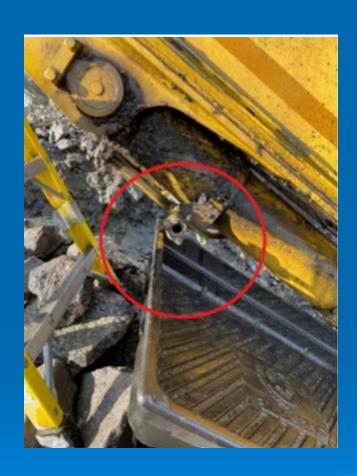
The failure in the hydraulic hose was most likely due to the condition of the hose, which appeared to be subject to wear and tear

Hydraulic line connected to the main boom cylinder failure

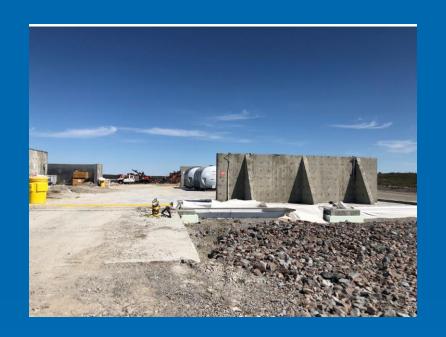
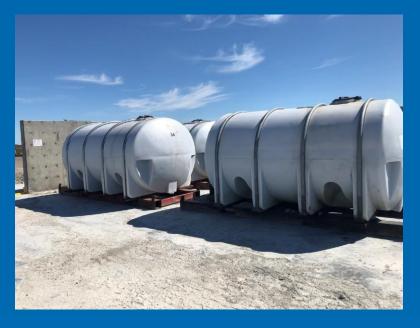
- 1)Temporary Hazardous Waste Storage Secondary containment in place
- 2) Temporary Hazardous Waste Storage – 3000 litre totes

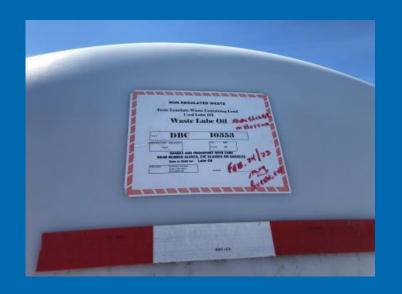
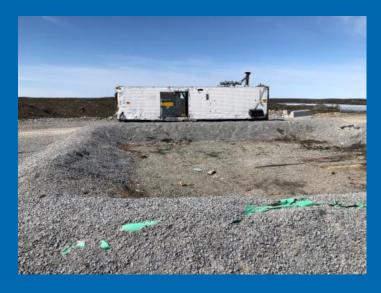
3) Temporary Hazardous Waste Storage – 3000 Litre Totes – Proper labelling 4)Old Emulsion Plant Area – Trailer to be removed

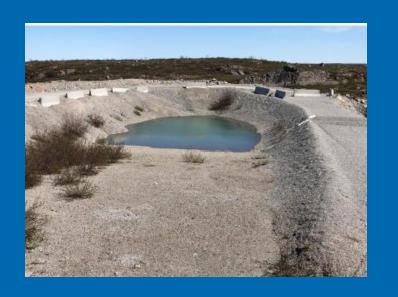
5) Old Emulsion Plant Area – Sump yet to be removed

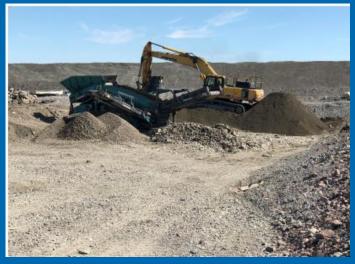
6) Landfarm – Hydrocarbon impacted soil

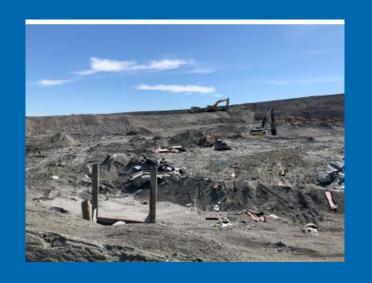
7) Cell 1 – Former landfill.

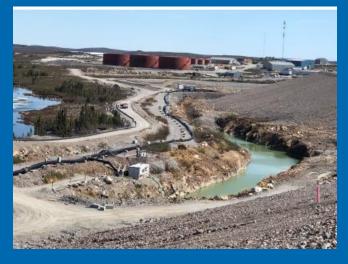
8) Overlooking Perimeter Sump 4.

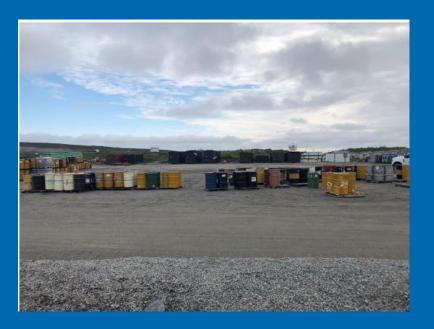
2) Waste Transfer Area – Drums on pallets and strapped when full

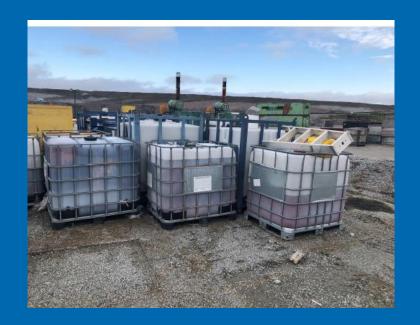
3) Waste Transfer Area – Containers in lined area of WTA

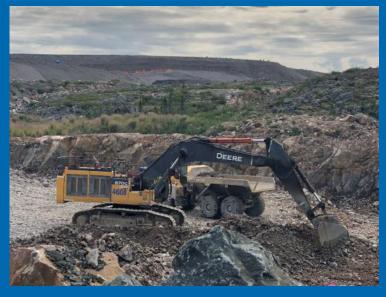
4) Perimeter Sump 5 – Excavation for increased capacity

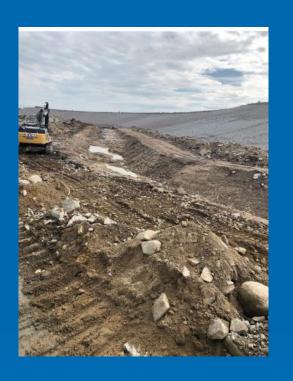
5) Area Between Perimeter Sumps 4 and 5 – Exposing bedrock for concrete placement

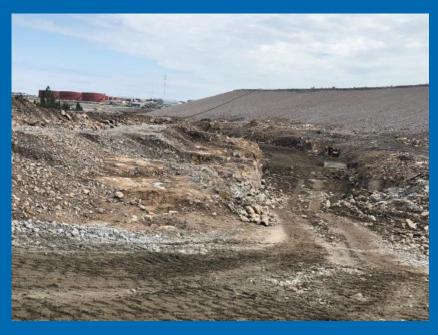
6) Perimeter Sump 4 – Construction for infilling

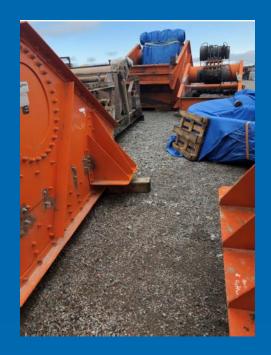
7) Spill 2022121 – Post clean-up

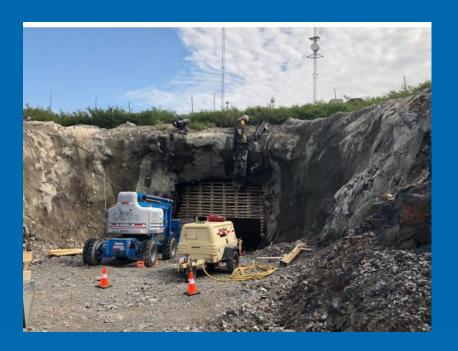
8) Main Portal – Concrete team on site to cap entryways to underground

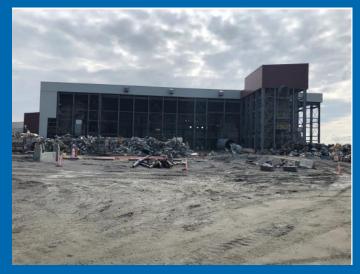
9) Process Plant – Dismantling of the Process Plant underway

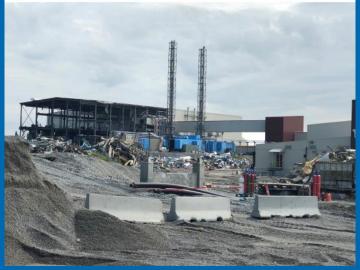
10) Powerhouse – Dismantling of the Powerhouse underway

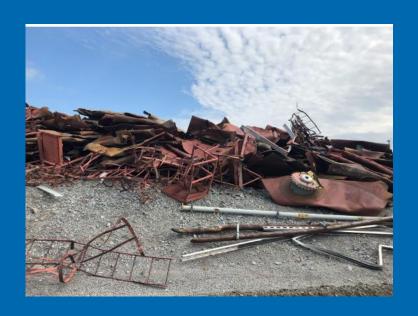
11) Tank Farm – Dismantling of the 500,000L tank farm

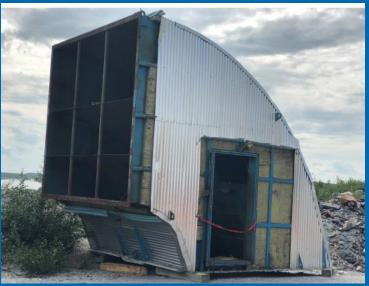
12) Fresh Air Raise – Removal of Fresh Air Raise for purpose of capping and covering

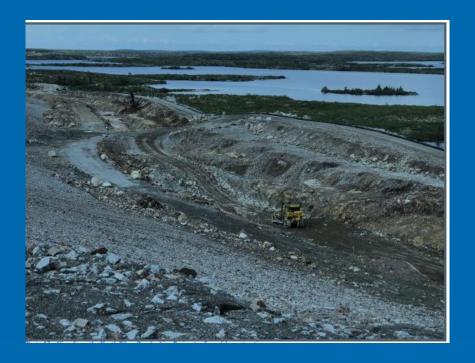
13) View from the North Pile –Overlooking Perimeter Sump(s) construction
