JAN – FEB 2023
Snap Lake Closure Activities
Update
for SLEMA Board
March 2023

5.1 Jan 30 Water Licence Inspection

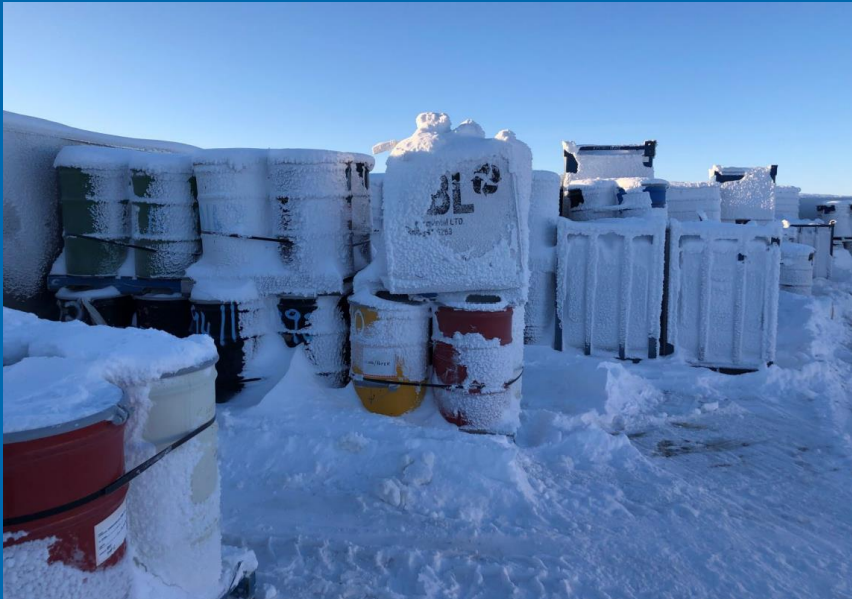
- No leaks or hydrocarbon staining were observed during inspection of the area
- All material will be removed via the winter road in March

1 – Temporary Waste Management Area – Materials are well organized

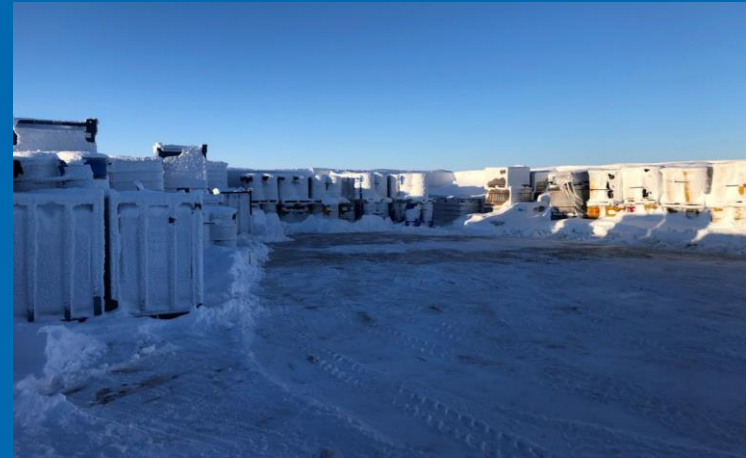
- All material will be removed via the winter road in March
- Totes and drums continue to be well organized with proper labels
- The previously identified drum that was leaking was removed and there is no further evidence of staining in the location.
- No issues noted during the inspection

2 – Temporary WMA – All materials stored in this location are awaiting removal via winter road

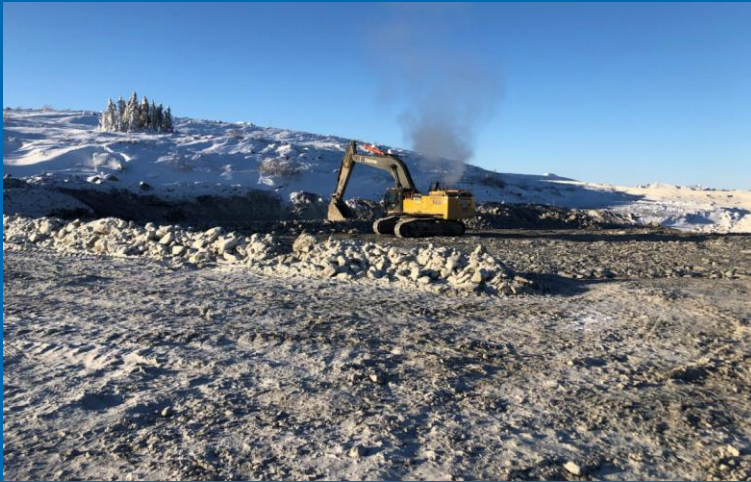
- Construction at the WMP (Photo 3) involved sediment removal as part of the redesign for the east Influence Storage Pond (ISP). There was a much larger volume of sediment to be removed than originally anticipated
- Sediment removal created holes which are being in-filled
- Channel is being sloped as per design (7:1)
- The floor of the channel is approximately 15 metres in width (Photo 4)

3 – Water Management Pond –
Sediment removal and contouring
slopes

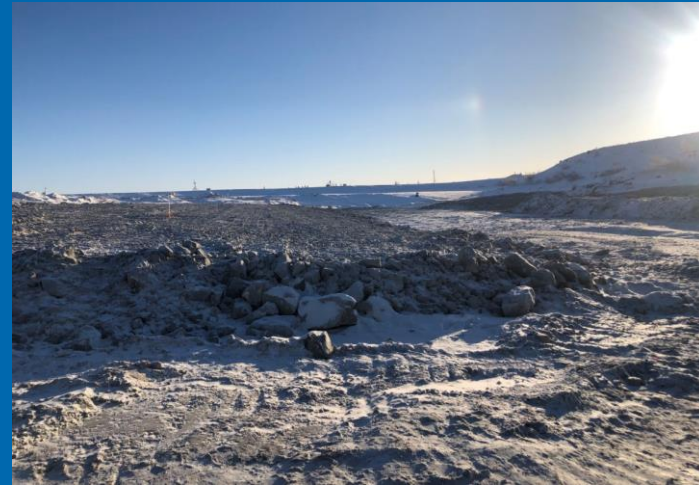
4 – WMP– Sediment removal and
contouring slopes

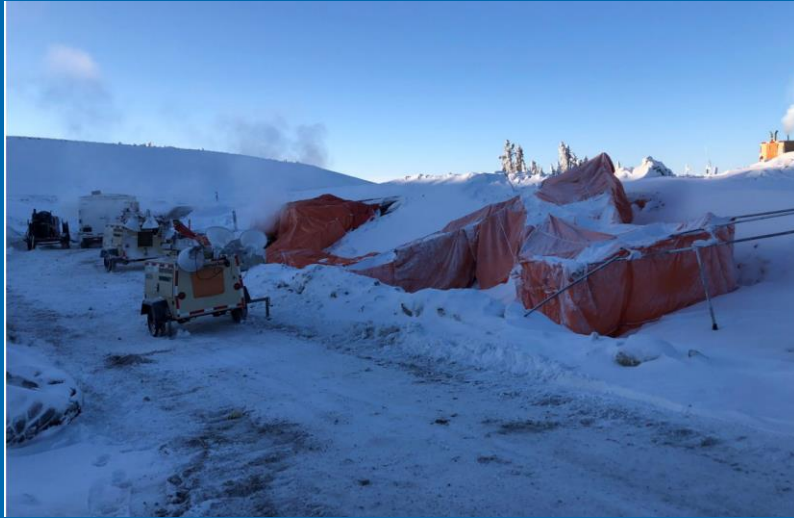
- Former SP4
 - Dental concrete continues to be poured using tarps and Herman Nelson heaters (Photo 5)
- Former SP1
 - Being in-filled
 - Finished blasting for connectivity to East Influent Storage Pond/Water Management Pond (Photo 6)
 - Blasting mats are placed as a safety measure to avoid projectiles (Photo 7)

5 – Former SP4 - Dental concrete pour

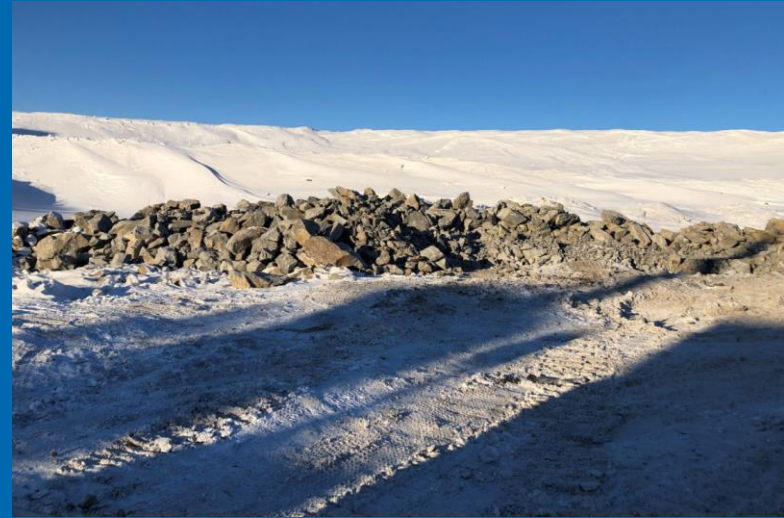
6 – Former SP 1 – Blasting has concluded

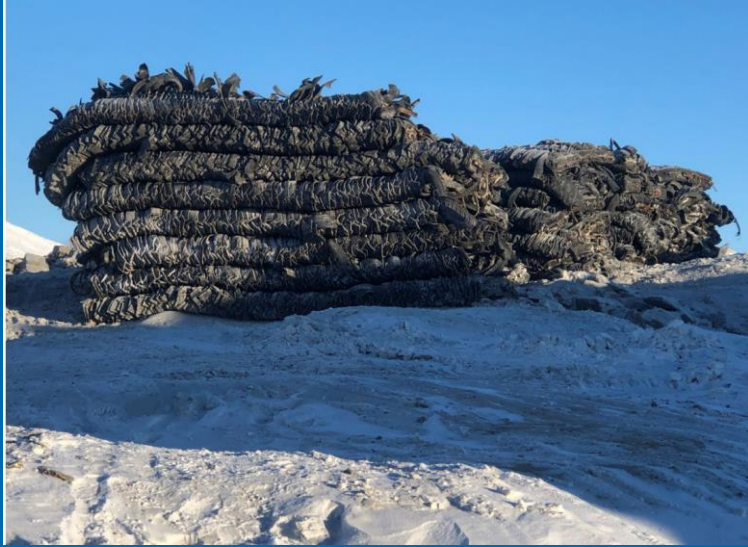
7 – Former SP 1 – Blasting mats

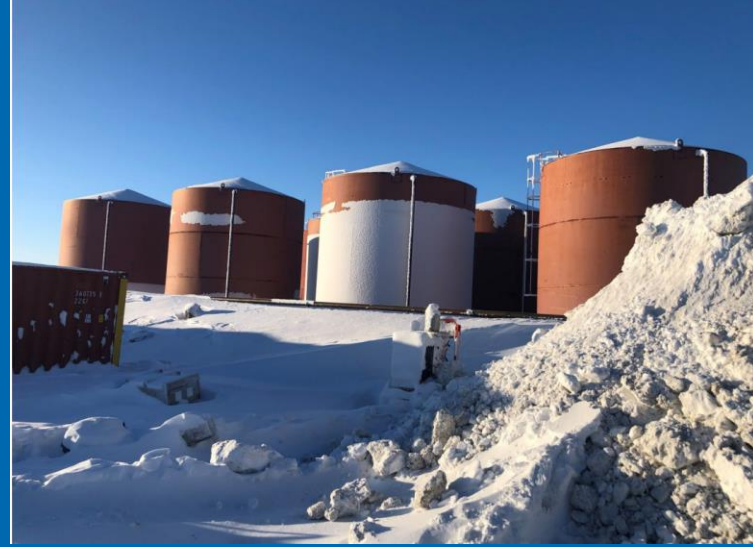
- There are 12 remaining fuel tanks of 330,000L (Photo 8)
- Of those 12, only 4 will remain in use
- There is a total of 1 million litres of fuel currently on site
- 3.5 million litres of fuel is expected via winter road
- There is a 500,000L tank that is solely dedicated to the powerhouse

8: Fuel Tank Farm 330,000L tanks only 4 will remain in use

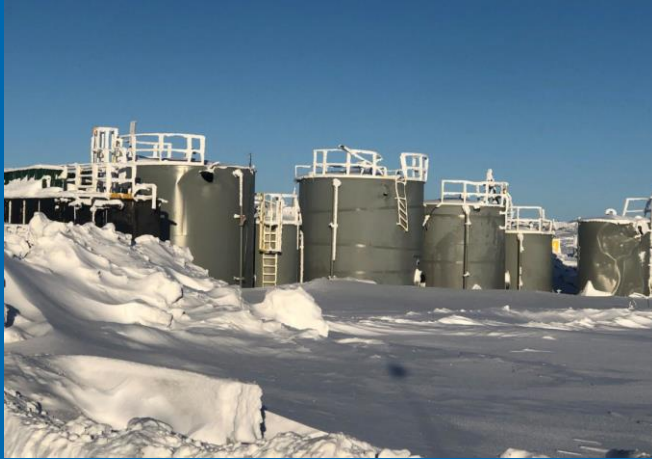
- There are several grey tanks yet to be demolished and buried (Photo 9)
- There are very few structures left to be demolished that are not necessary for current operations

9: Tanks to be demolished and buried

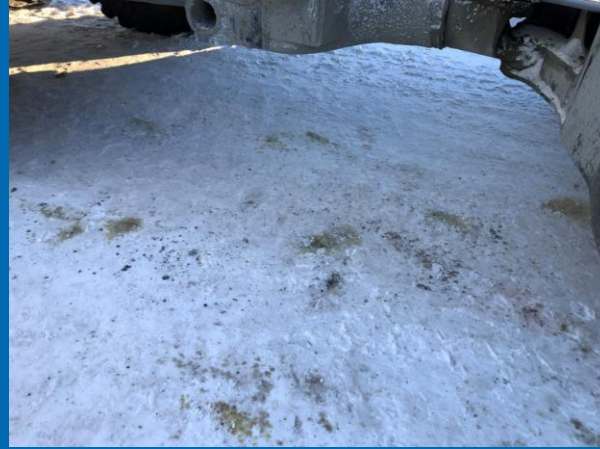
- This area is historically a storage yard for equipment
- It consists of a multitude of equipment that is currently being re-used, shipped out or disposed of on site
- Approximately 50% of the material will be buried at site
- There were several small patches of staining from various vehicles parked in this location (Photos 10&11)
- The spill pads being used to capture leakages must be changed out more frequently and be available for use when vehicles are idling short term, as well as long term (Photo 12)

10: Laydown 1 - Hydrocarbon staining #1

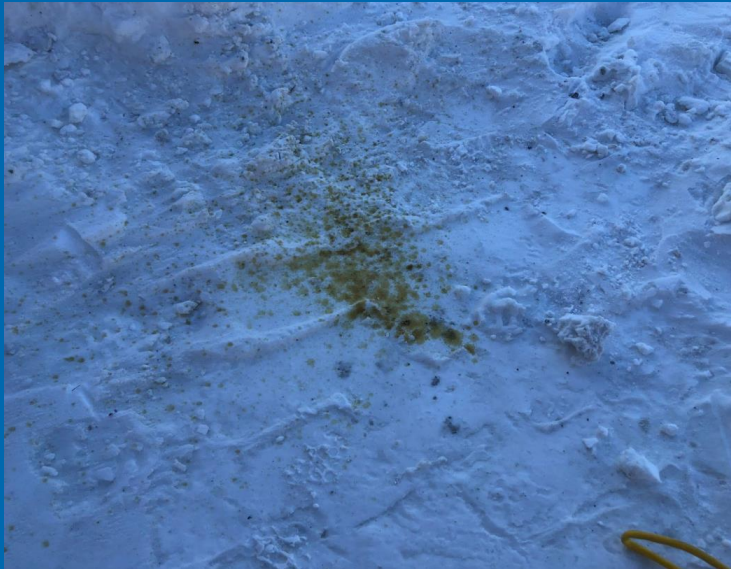
11: Laydown 1 - Hydrocarbon staining
#2

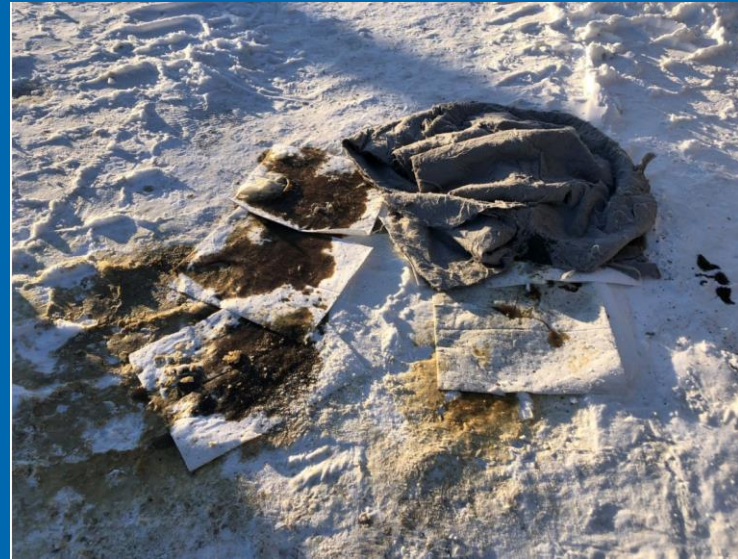
12: Laydown 1 – Absorbent pads
need to be changed out and used
more frequently

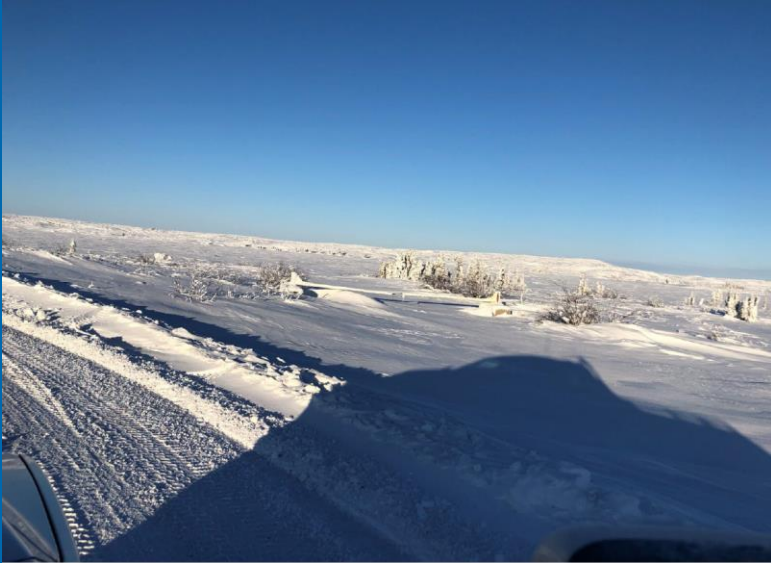
Profiling was to begin at the typical entry area to the mine site (Photo 1) while working back toward the Tibbitt to Contwoyto Winter Road

1. Access to Snap Lake from Spur Road

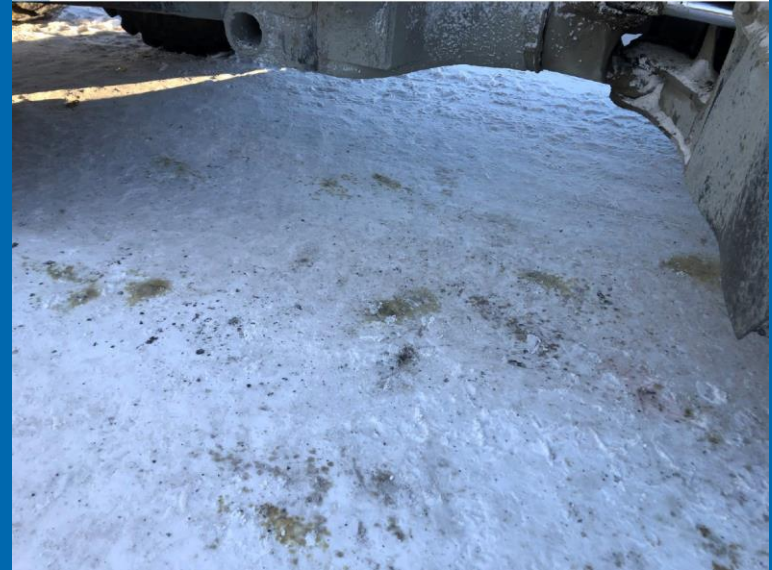
Various fluids were observed on the ground where vehicles are typically parked (Photos 2-4). It is common for spill pads to be stapled to boards and placed under vehicles to catch any leakage (Photo 5) but there needs to be more frequent placement and regular disposal of the pads for both short term and long term parked vehicles, as per condition 68 of the LUP

2. Hydrocarbon Staining in Parking Area of Laydown 1

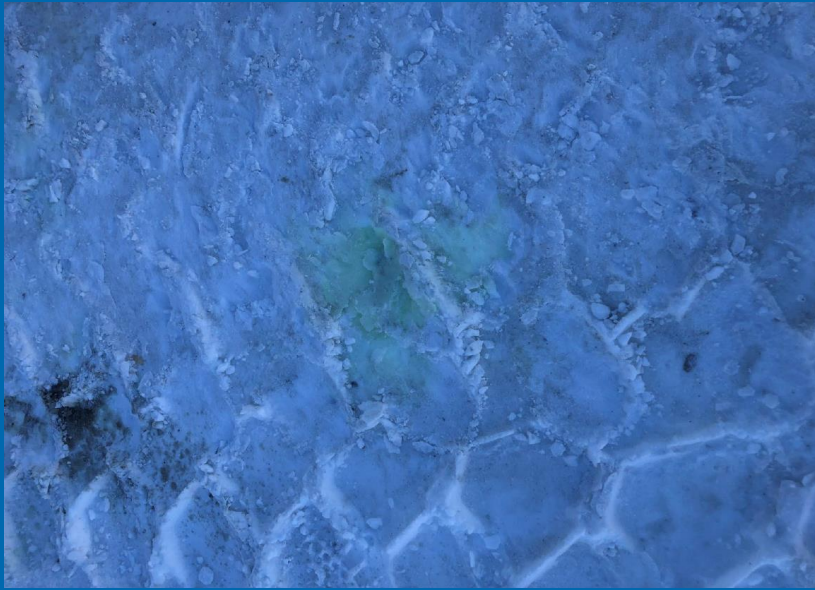
3. Hydrocarbon Staining in Parking Area of Laydown 1

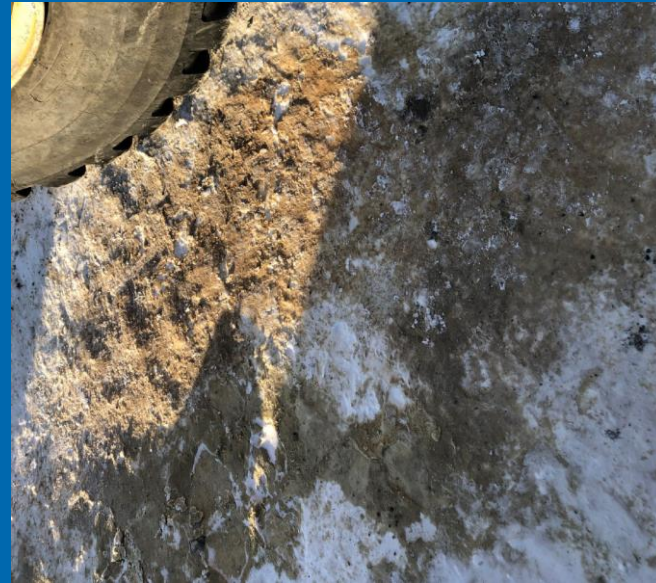
4. Hydrocarbon staining in the Parking Area of Laydown 1

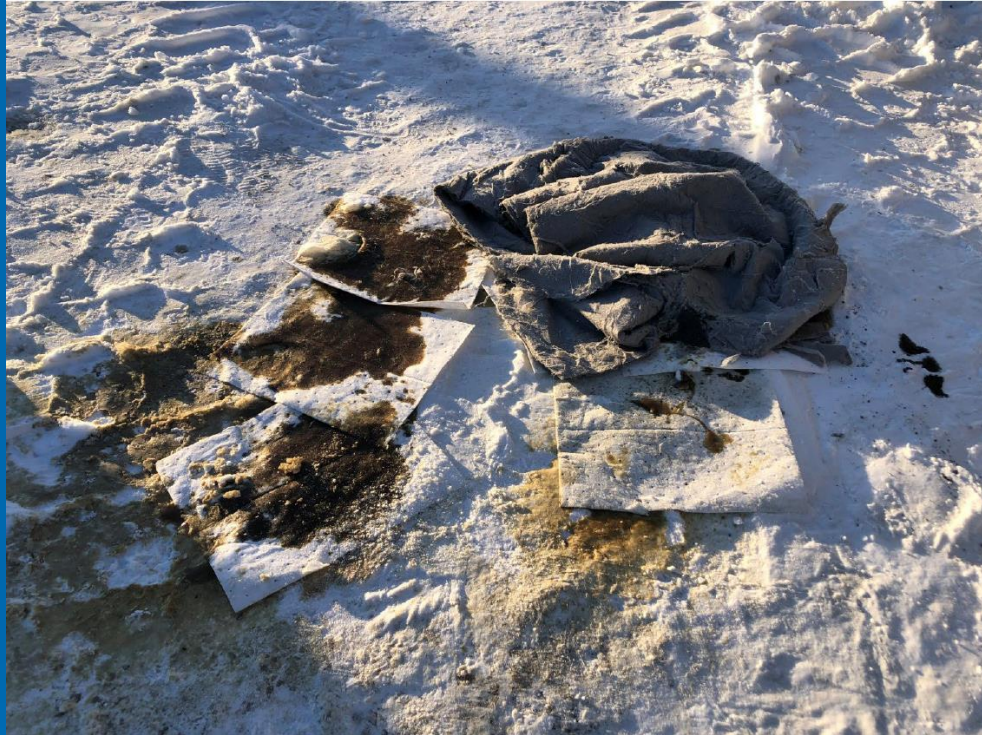
5. Spill Pads Must Be Used and Replaced More Frequently

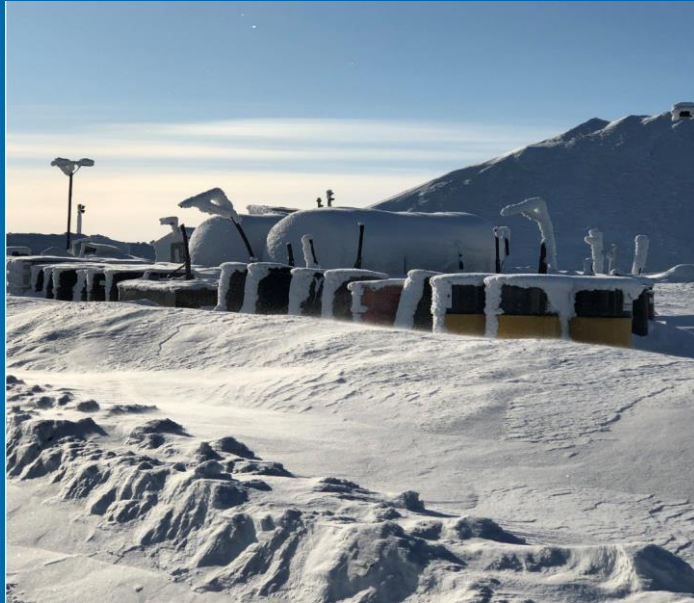
- No leaks or hydrocarbon staining were observed during inspection of the area
- All material will be removed via the winter road in March (Photo 1)

1 TWMA: Materials prepared for transport off site

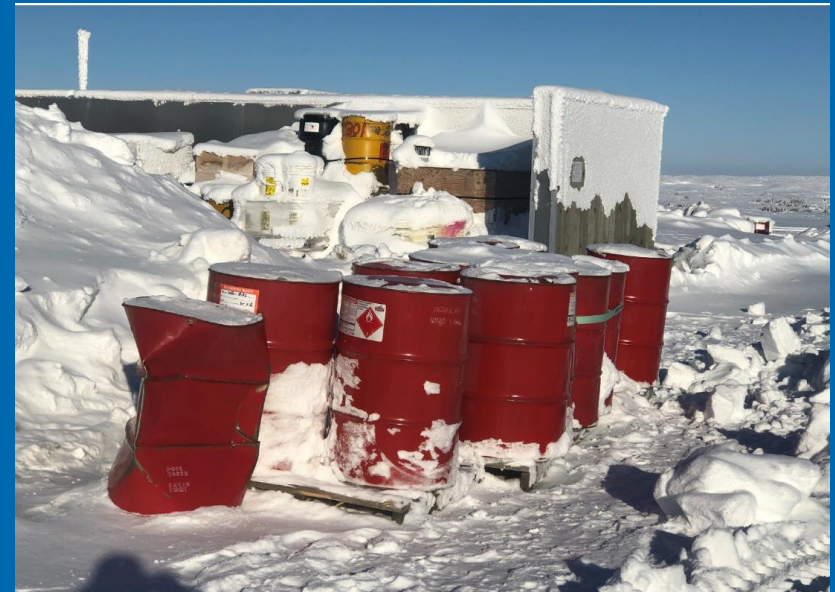
- All material stored in this area will be removed in March via the winter road (Photo 2-3)
- No issues noted during the inspection

2 TWMA: All materials stored in this location are awaiting removal via winter road

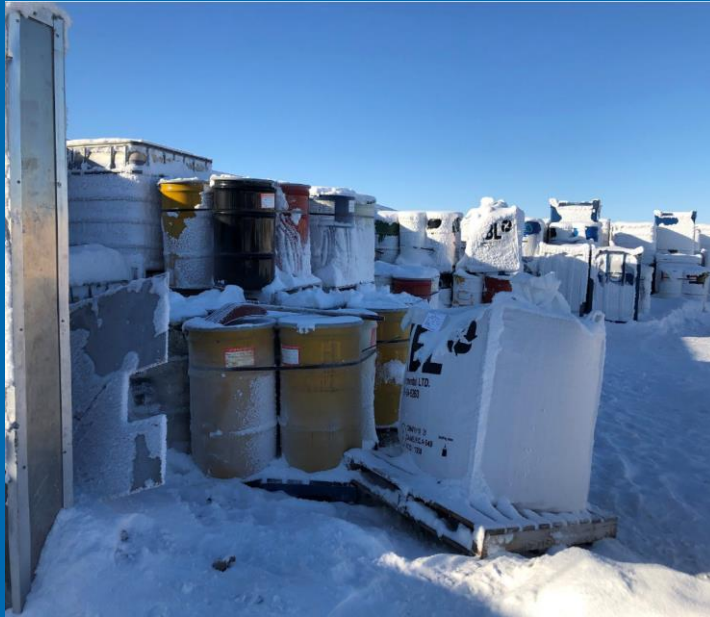
3. TWMA: All materials stored in this location are awaiting removal via winter road

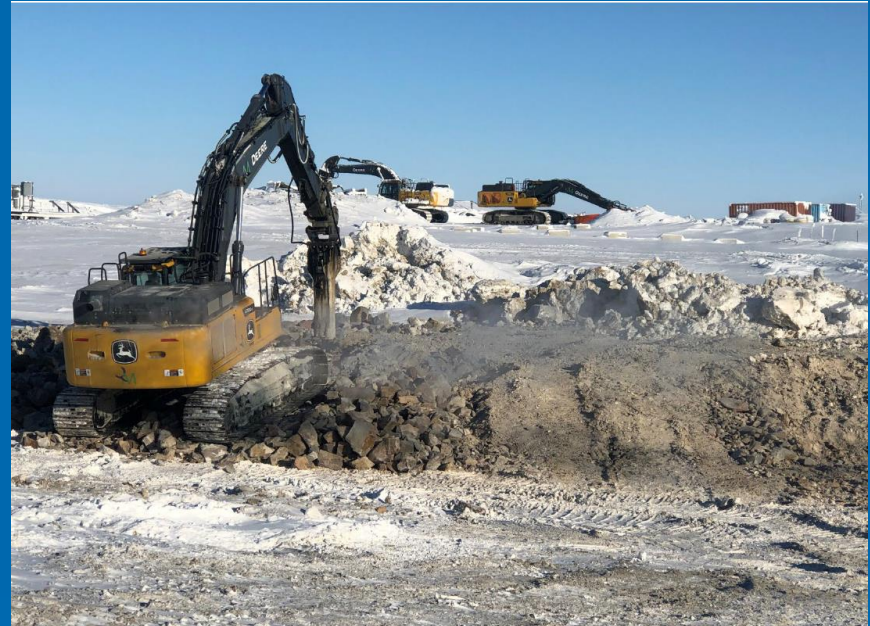
- The channel has been designed with a flat bottom and 7:1 sloping for the walls
- At the time of inspection outcrops of rock were being broken to ensure channel bottom and sloping were to design (Photo 4)
- Blasting is not needed, as the method being conducted is more efficient.

4. East Influent Storage Pond: Earthworks regarding sloping

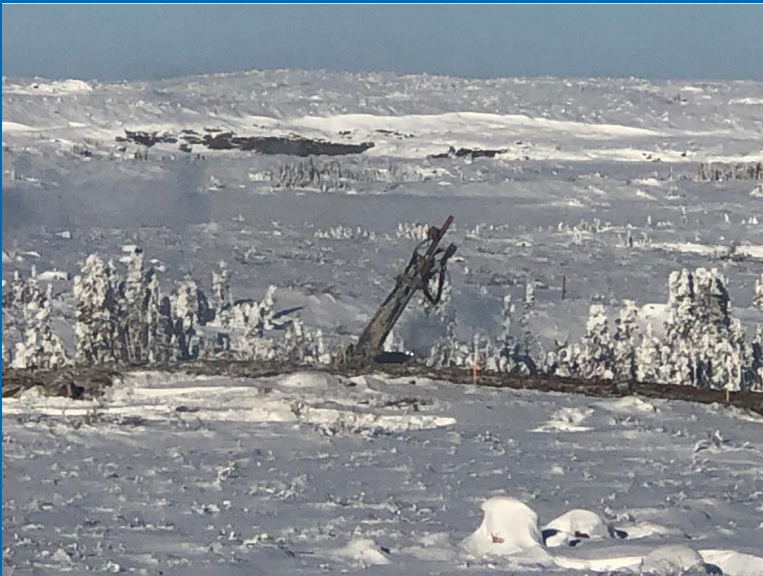
- Blasting is being conducted to slope area to design (Photo 5)

5. IL6 Ditch: Blasting occurring to slope to design

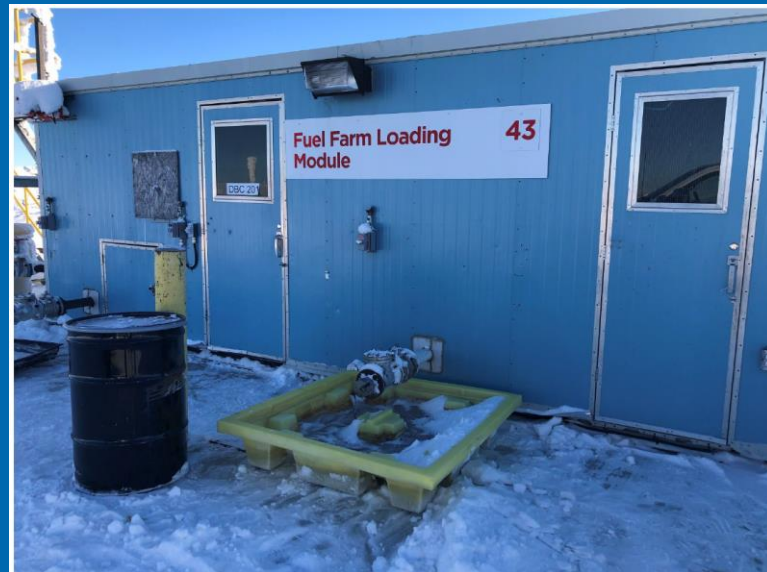
6. Module 43: Fuel transfer area

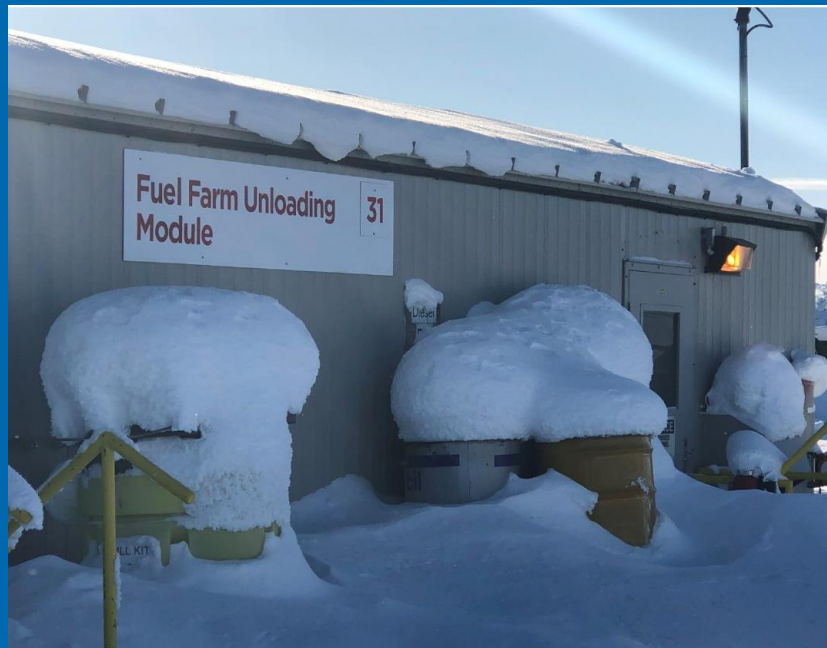
7. Module 31, Former fuel transfer area : Awaiting deconstruction and disposal

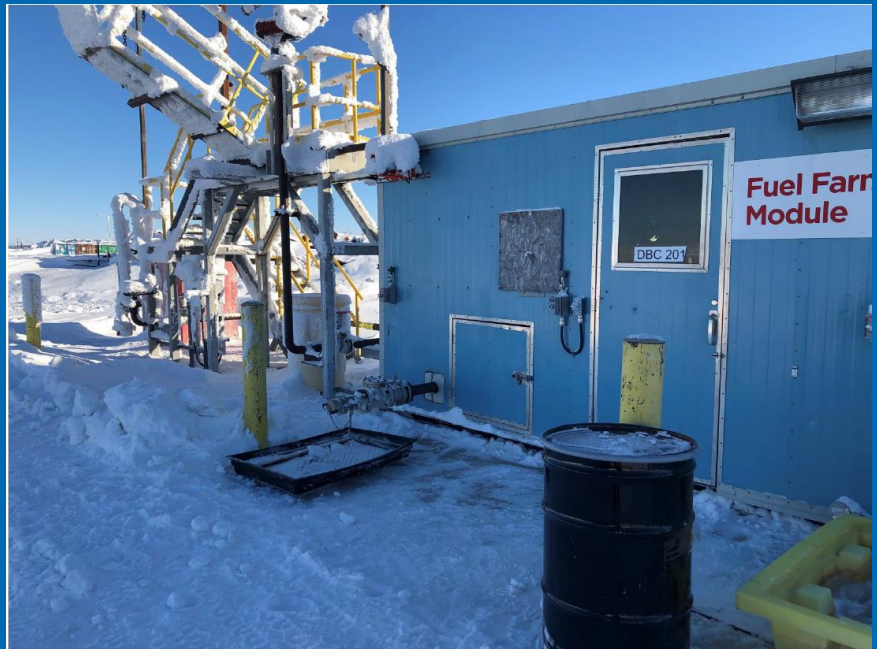
- The remainder of fuel tanks in the tank farm are 12 x 330,000L
- Of the 12 remaining tanks only 4 will remain in use.
- 3.5 million litres of fuel expected via winter road.
- On March 4, 2023 Nuna Logistics personnel provided notification that 200,000L of fuel had been delivered to site.
- Module 43 will be the only offloading location for fuel delivery during the winter road (Photo 6)
- Module 31 is not in use and is awaiting deconstruction and disposal (Photo 7)
- Spill kits and drip trays were present. Nuna personnel are to ensure spill kits are fully stocked in the event of a spill and that drip trays should be cleaned of snow and ice to ensure maximum capacity (Photo 8)

8. Fuel Transfer Module 43: Spill kits and drip trays

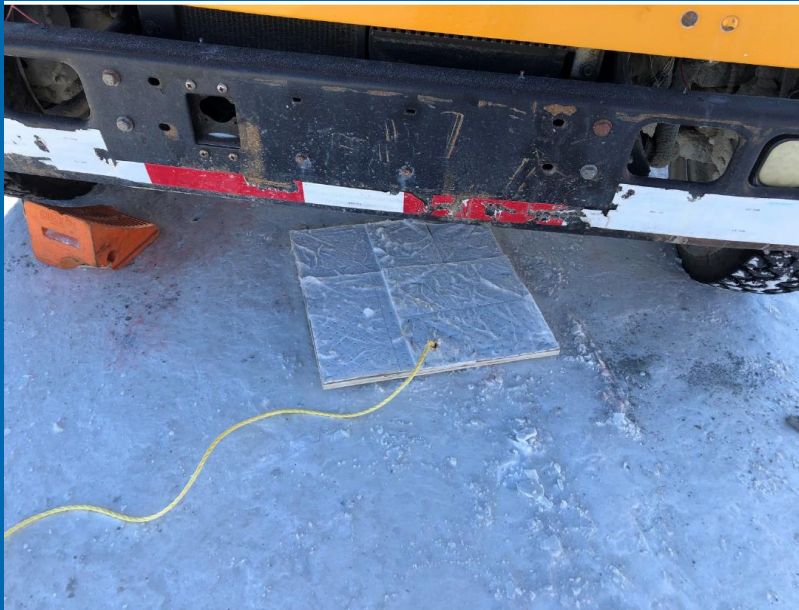
- Drip trays were placed under the parked vehicles in the logistics area, as per the request of the Inspector (Photo 9)
- There was no staining observed in the area
- Trays or boards with absorbents need to be placed under vehicles parked for longer than 2 hours
- Some of the material stored at the laydown was being prepared for transport off site. Material is being weighed before transport (Photo 10)

9. Laydown 1: Drip catchment implemented

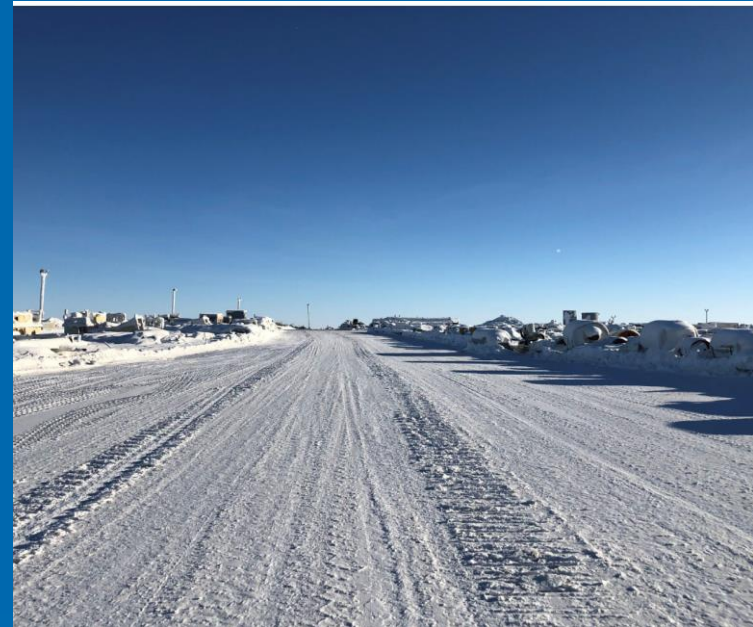
10. Laydown 1: Some material will be weighed before transport off site via winter road

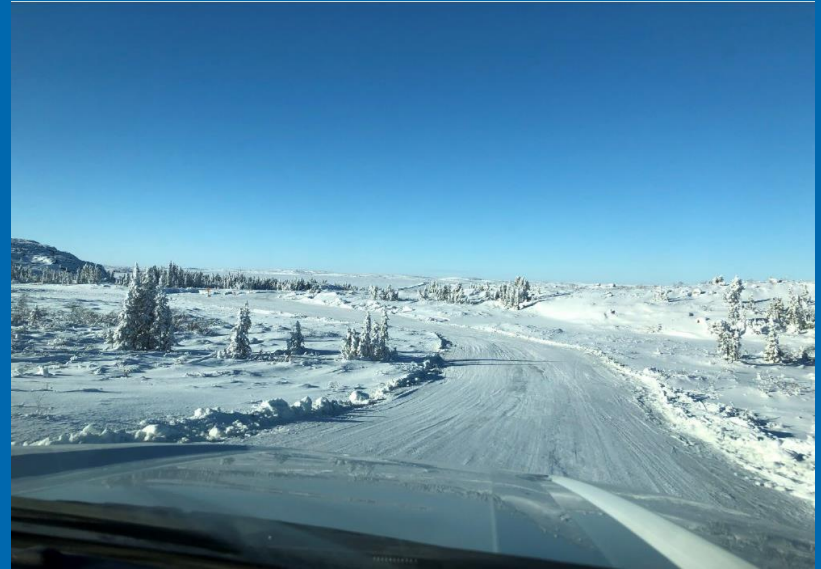
2. Snap Lake Spur Road. Excellent Conditions. Signage placement.

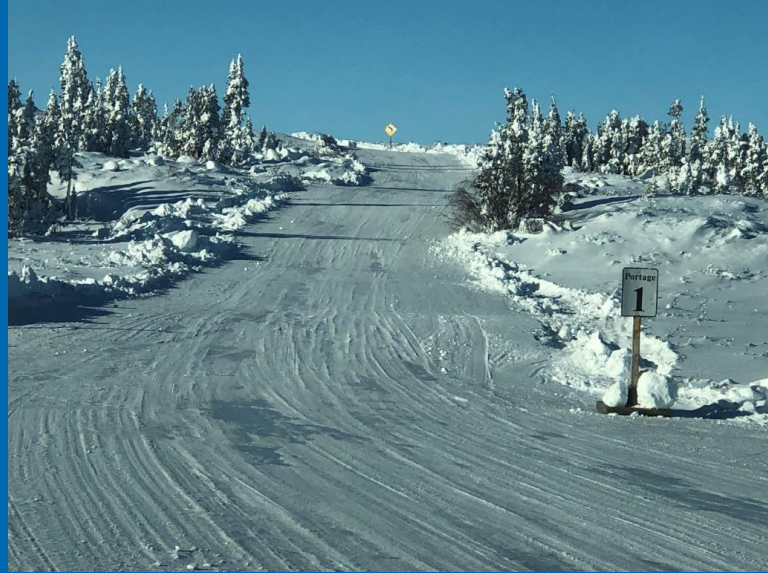
4. Spur Road. Portage 1. Steep incline

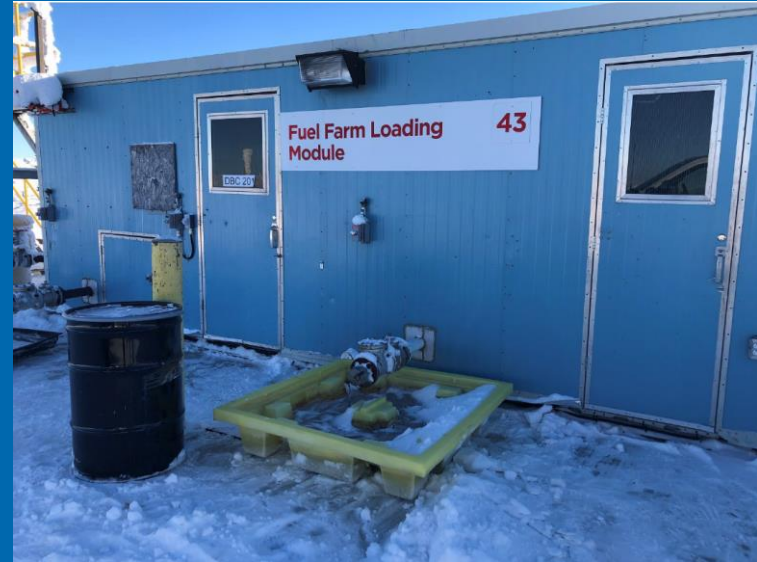
Fuel Farm Loading Module 43 will be used for the transfer of fuel to site from the winter road (Photo 8)

Snow has been cleared, spill kits are in place, and drip trays are present

8. Fuel transfer area for trucks coming off the winter road

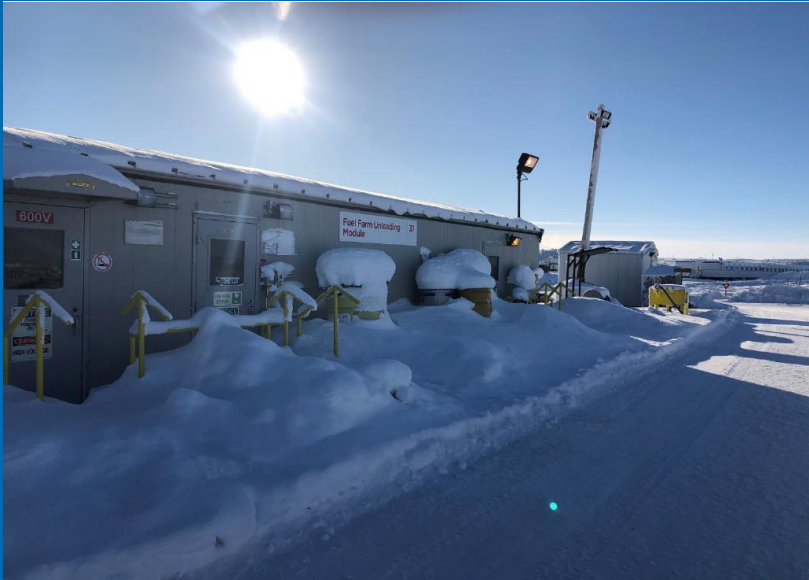
Fuel Farm Loading Module 31 is not in use and will be dismantled (Photo 9)

9. Former fuel transfer area. To be decommissioned
