March & April 2020
Environmental Update
May 14, 2020

1. Mine Update
2. SNP Reports
3. Inspection Reports
4. Update of the Water Licence and Land Use Permit Review Process for Snap Lake Mine Closure
5. Environmental Agreement Update
6. SLEMA's Activities

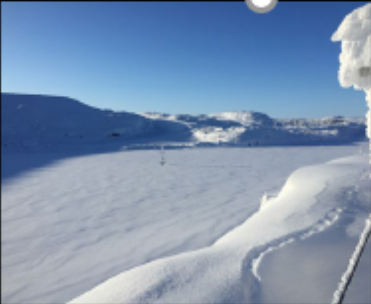
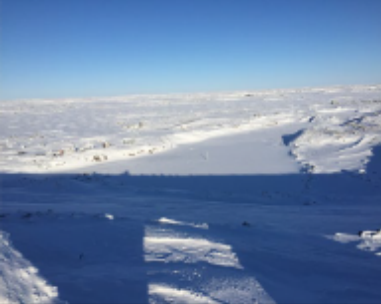
Not Available due to camera malfunction
Water Managemnet Pond

Water Control Structure	Photos			
	Week 1 (February 01 - 07)	Week 2 (February 08-14)	Week 3 (February 15-21)	Week 4 (February 22-29)
Perimeter Sump 5	Not Available due to camera malfunction

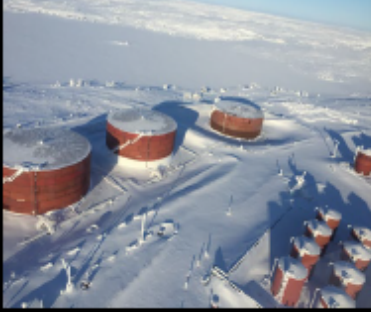
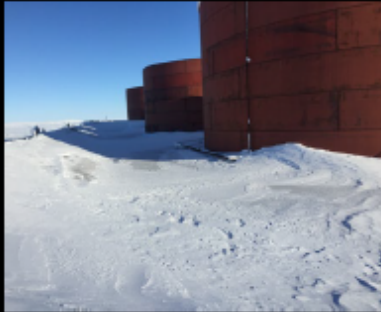
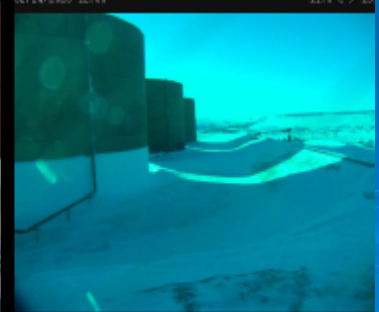
Fuel Tank	Not Available due to camera malfunction

PS1, PS2, PS3, PS4, PS5 and Fuel Tanak cameras are malfunctioning. At this time no definitive explanation for failure

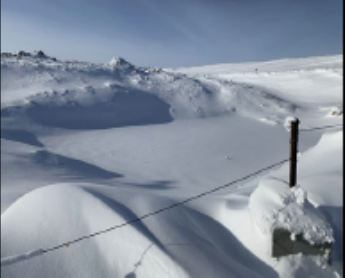
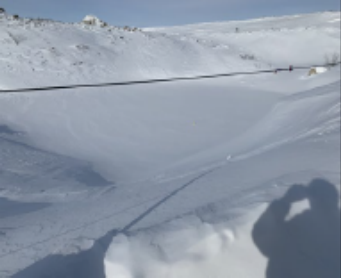
Water Control Structure	Photos			
	Week 1 (March 01 - 08)	Week 2 (March 09-15)	Week 3 (March 16 -22)	Week 4 (March 23-31)
Perimeter Sump 1

Not Available due to camera malfunction	Not Available due to camera malfunction

PS1 and PS5 cameras are malfunctioning. At this time no definitive explanation for failure

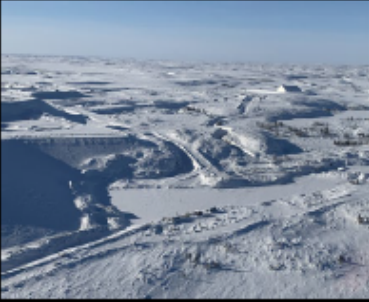
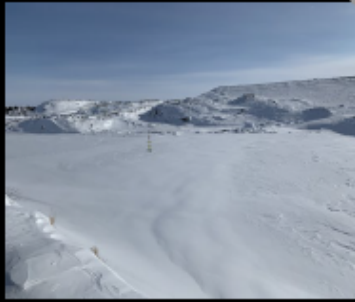
Water Control Structure	Photos			
	Week 1 (March 01 - 08)	Week 2 (March 09-15)	Week 3 (March 16 -22)	Week 4 (March 23-31)
Perimeter Sump 5

Not Available due to camera malfunction	Not Available due to camera malfunction
