June 2019 Environmental Update for SLEMA Board

July 04, 2019

3. Inspection Report

- An inspection of the Snap Lake Mine was conducted by Inspector Joe Heron on June 7, 2019;

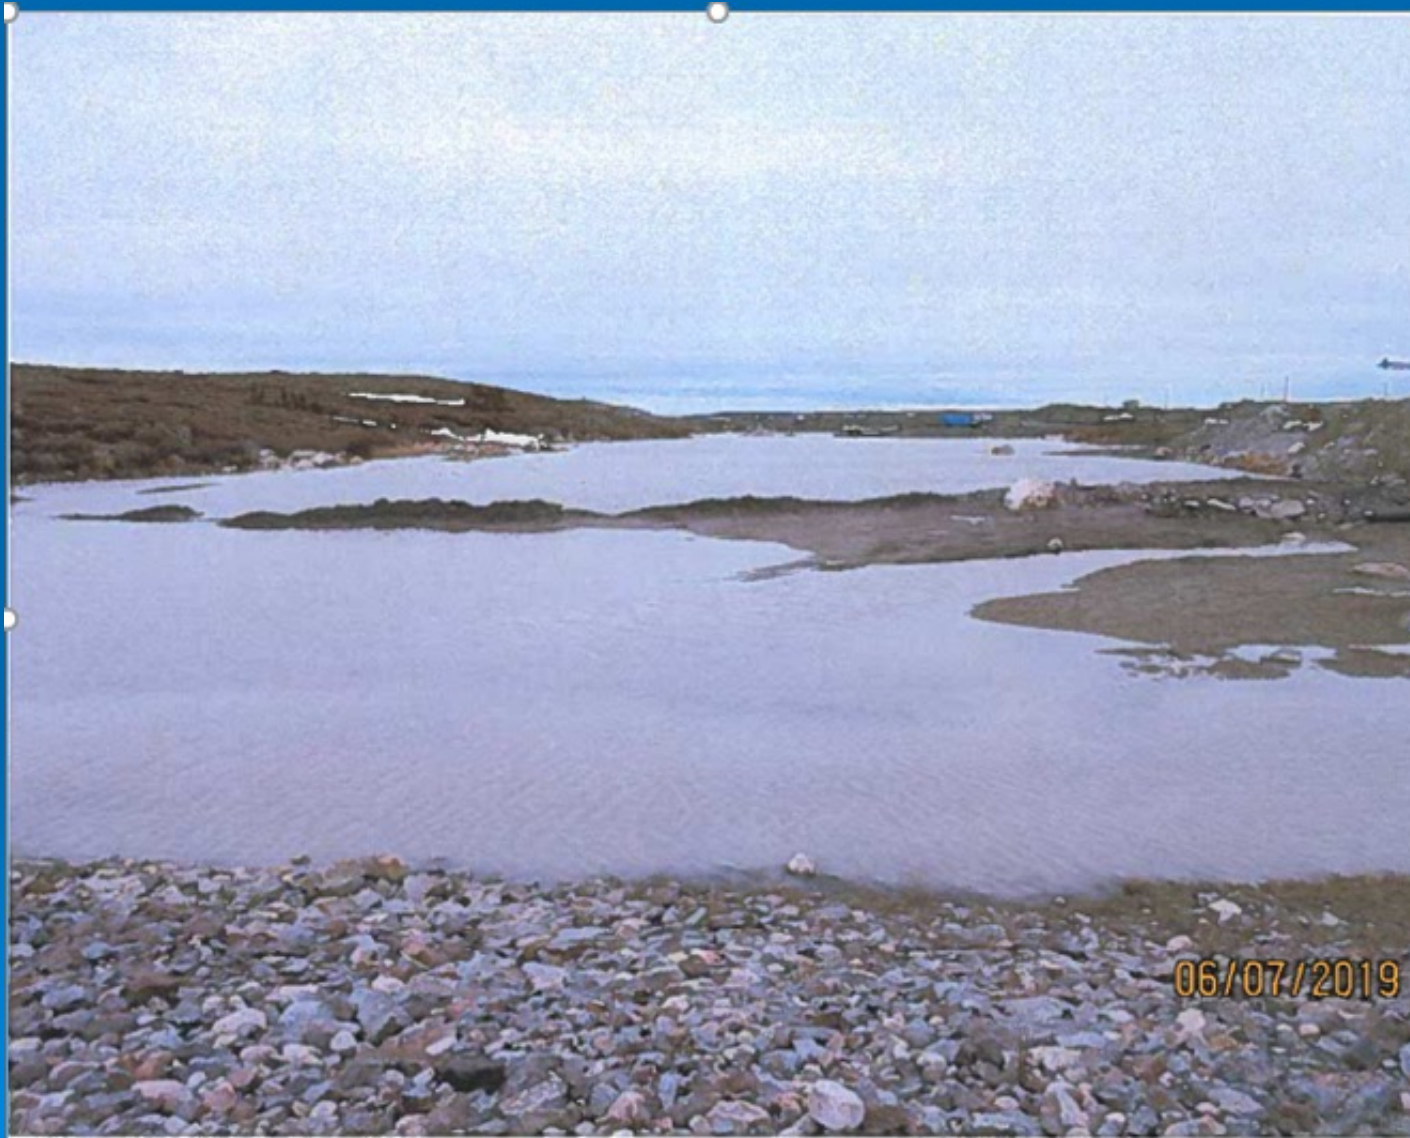
The WMP is the holding area for the mine wastewater;

Photo #1 Water Management Pond. No capacity issues were noted

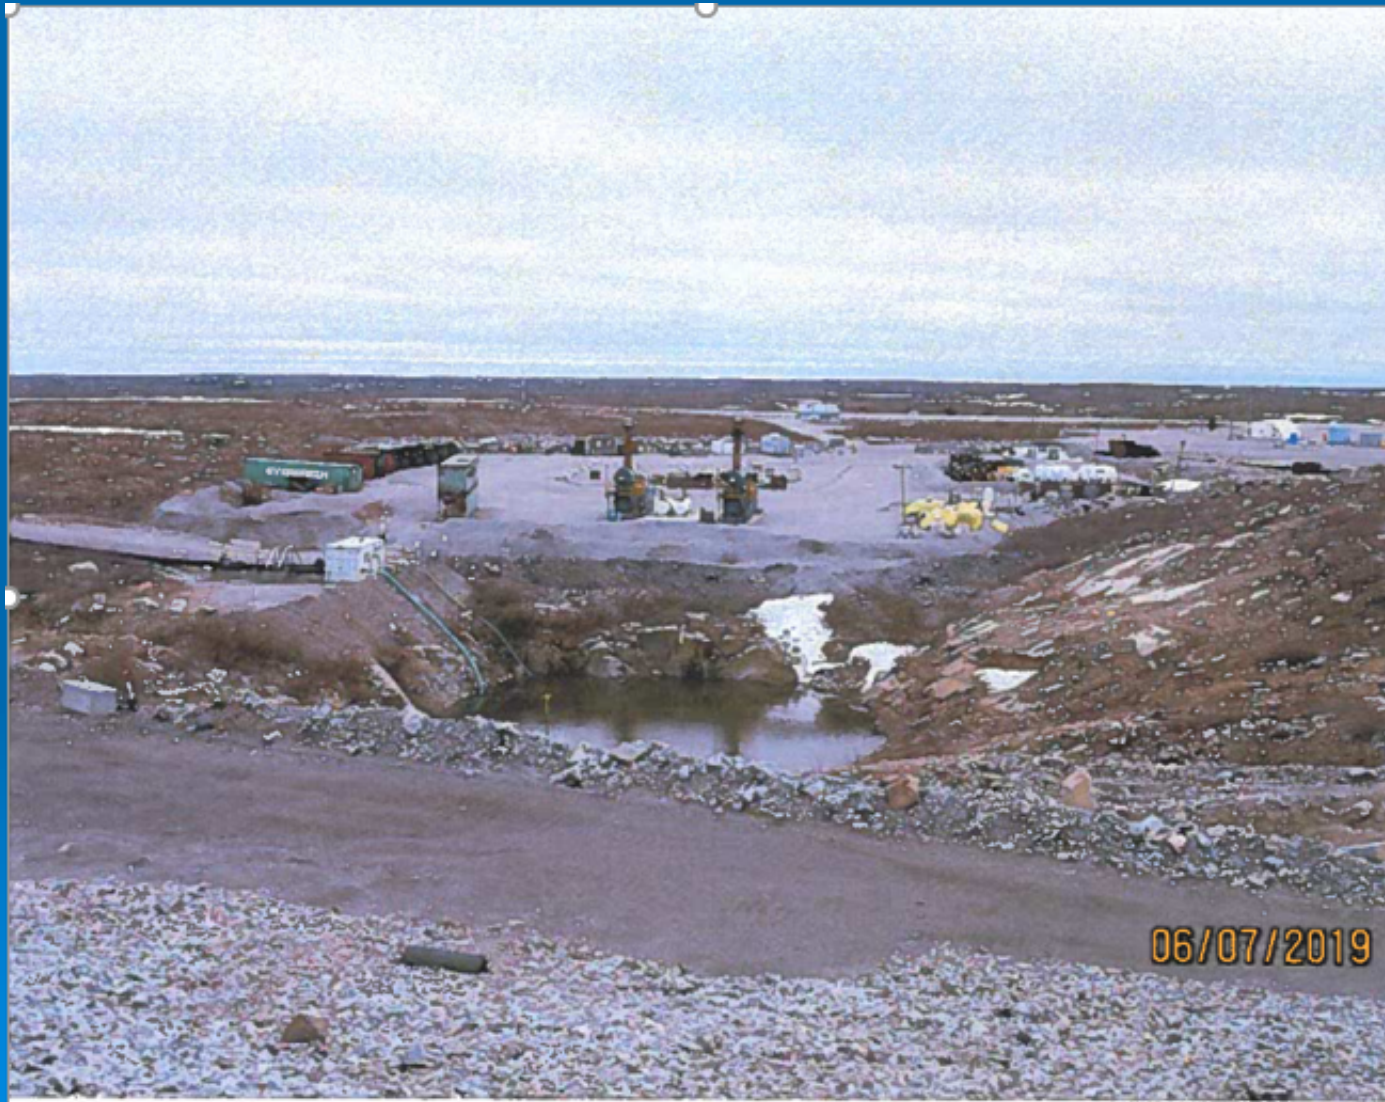
Waste that reports to the Waste Management Area was properly segregated, staged and labeled;

Photo #3 Waste Management Area with Sump #1

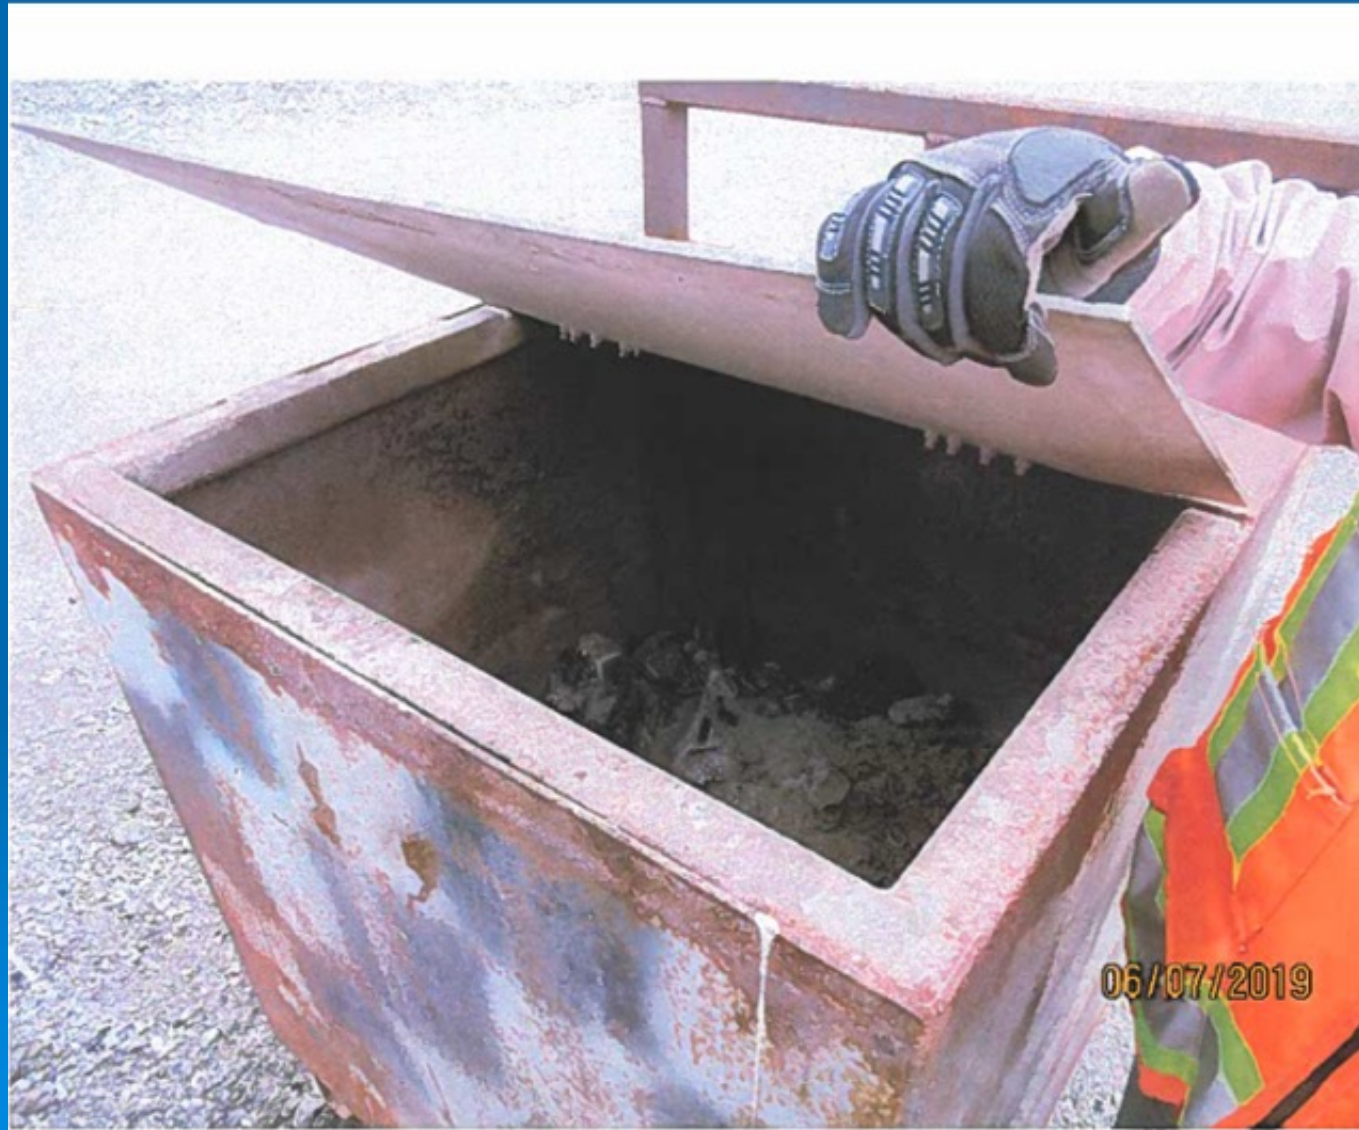
Incinerable waste is incinerated. Ashes are tested prior final disposal into the landfill. Ashes no suitable to go to the landfill are shipped offsite to an approved facility;

Photo #4 Containment with burned ashes

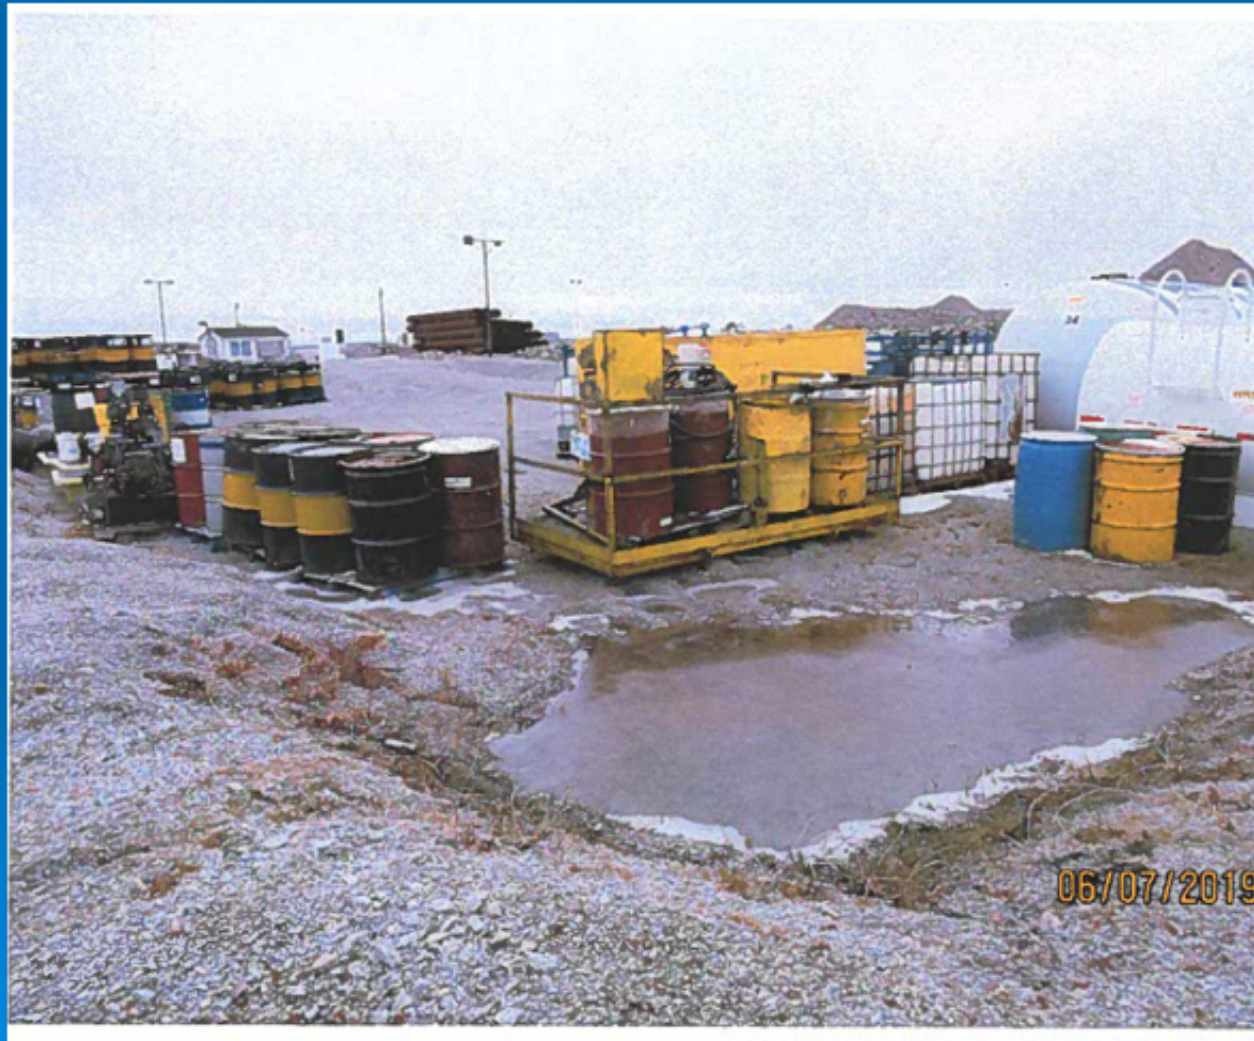
Photo #5 Other view of the Waste Management Area - WMA

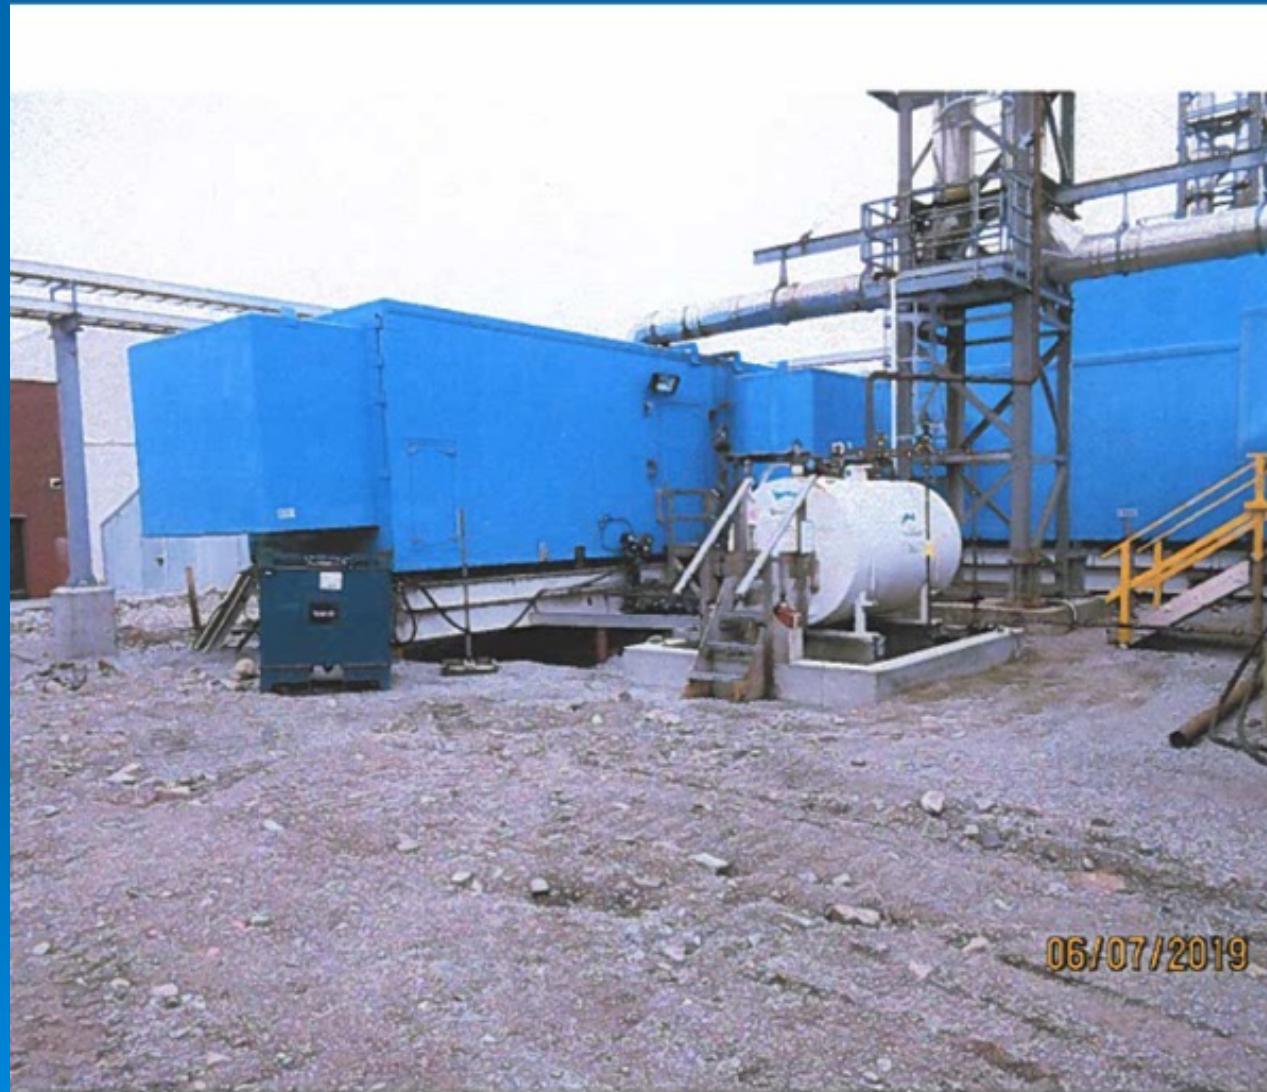
This spill occurred on December 7, 2017 at the auxiliary genset day tank #2;

The tank overtopped and $\sim 5 \text{ m}^3$ of diesel fuel spilled onto the soil impacting $\sim 8 \text{ m}^2$

Photo #6 Tank that overtopped in December 2017, Spill #17-044

Cleanup efforts include the pumping out and recovery of fuels within the containment berm, the removal and disposal of the impacted soil and the installation of two monitoring wells

The reminder clean up will be addressed during mine reclamation activities

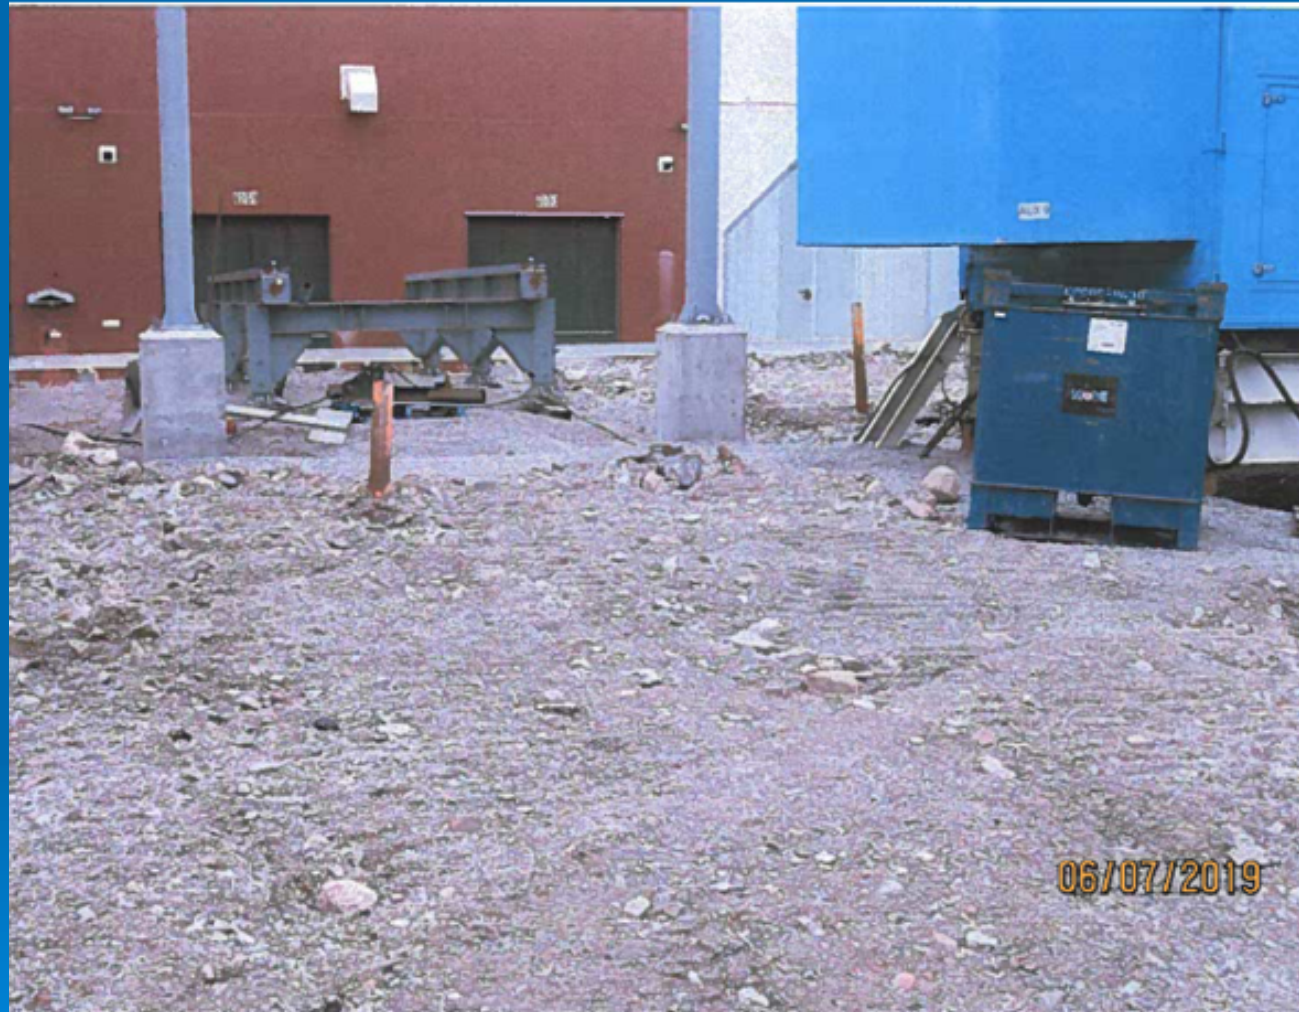
Photo #7 View of the monitoring wells installed at spill site in order to monitor if there was any impact on groundwater quality due to the spill

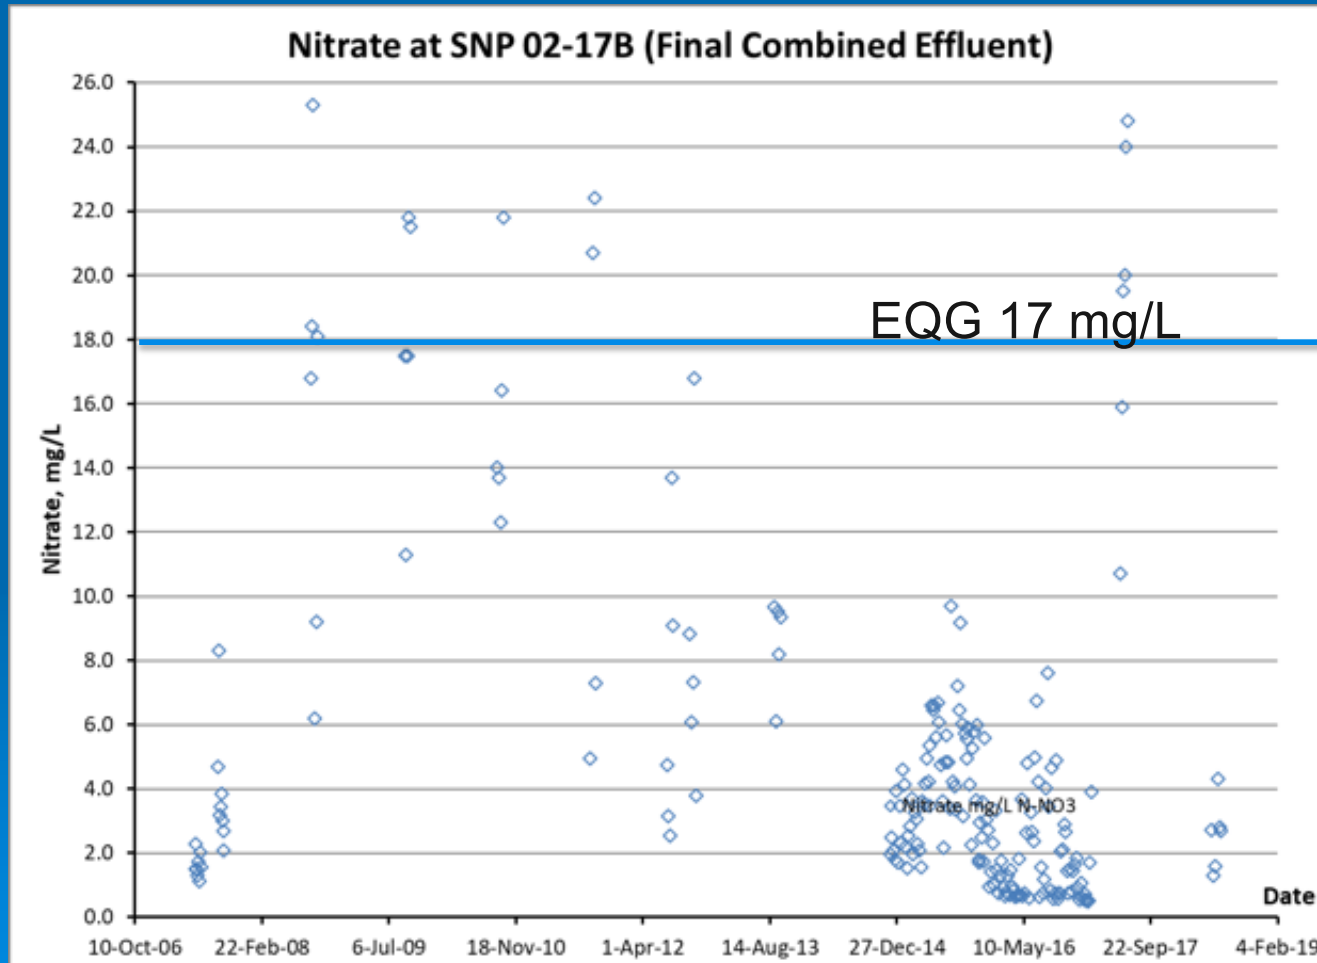
4) How much is nitrate concentration in the final effluent discharge at Snap Lake?
