September – October 2020 Environmental Update for SLEMA Board

November 5, 2020

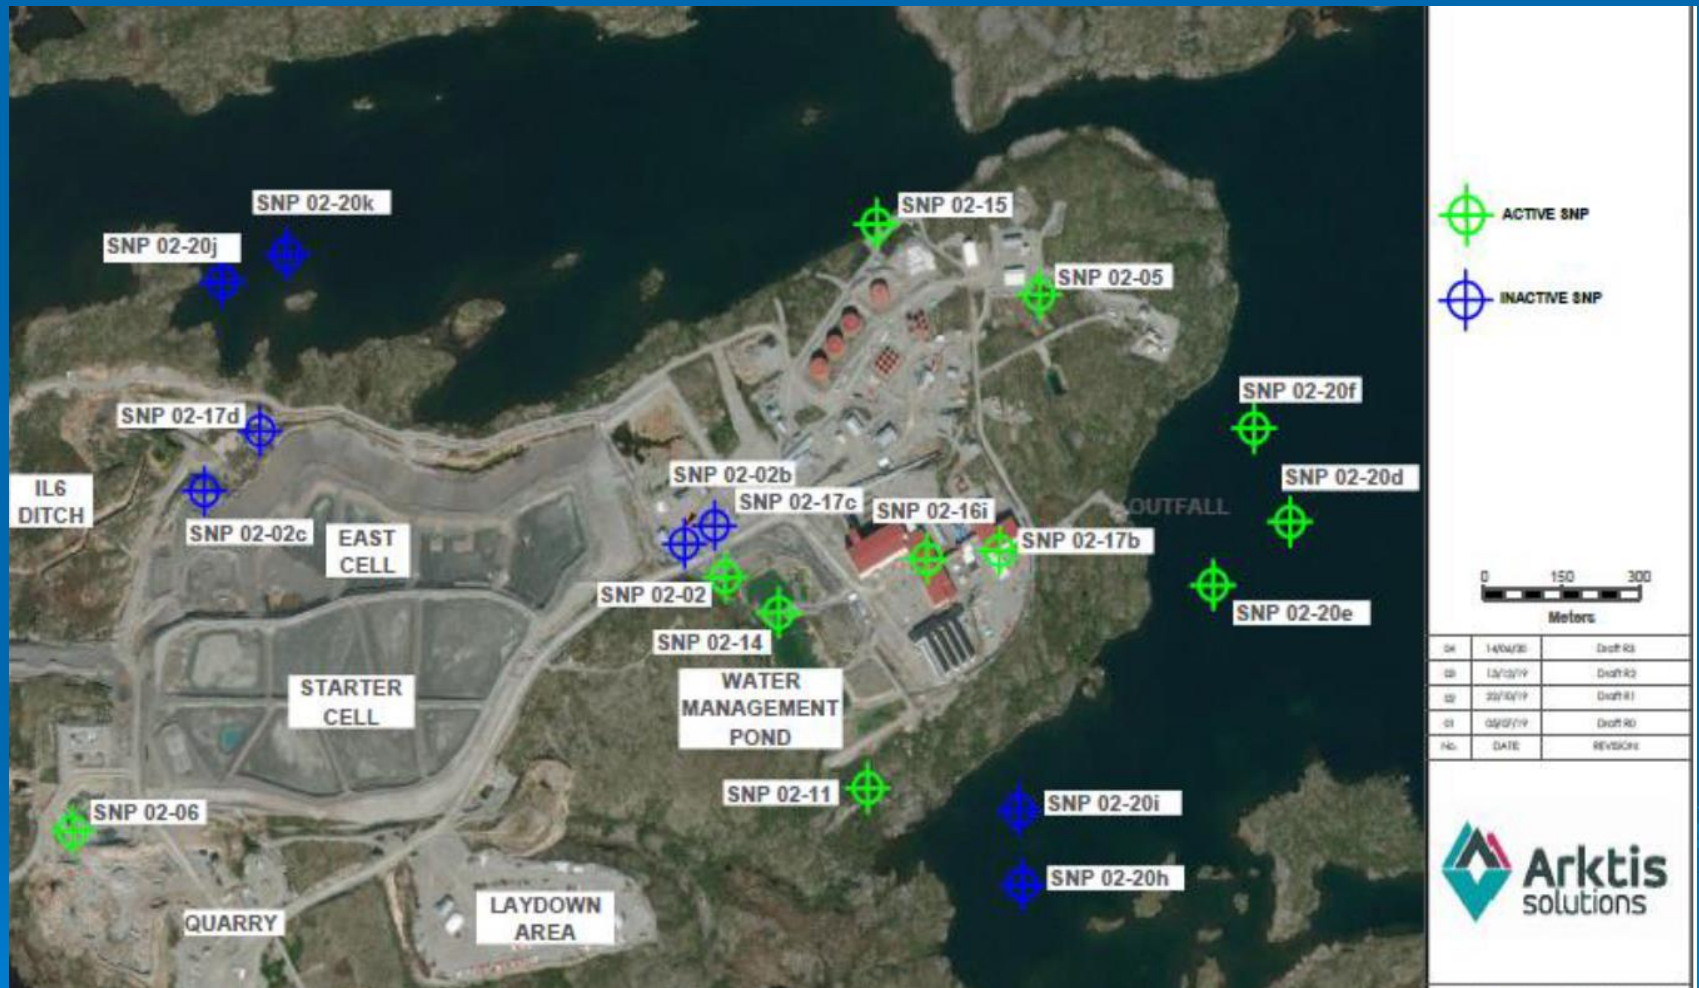
Fig 1: SNP Sampling Stations

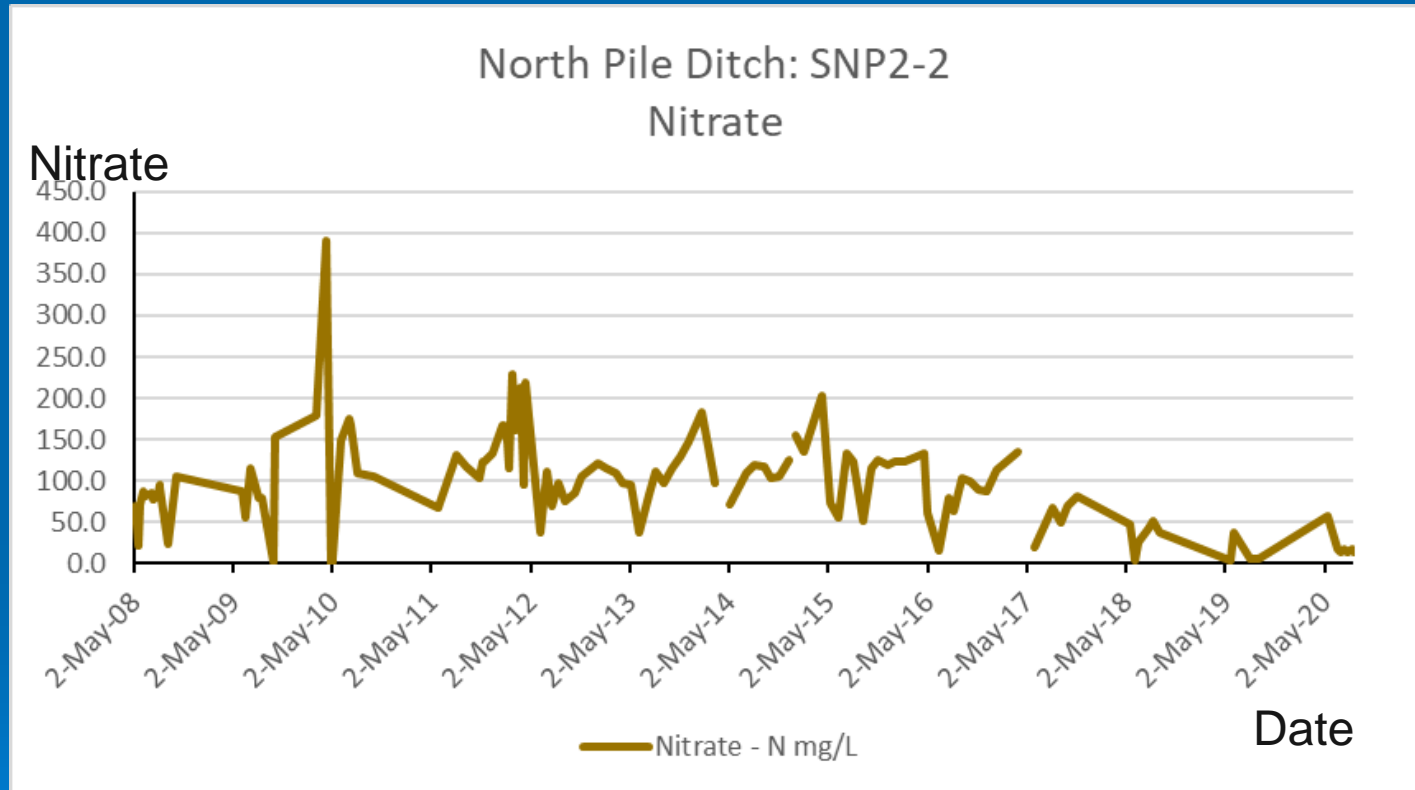
- Graph 2: Nitrate in North Pile Collection Ditch

Data 2008-2020 from SNP Reports

- Graph 2 displays nitrate values for water in North Pile Collection Ditch
- Graph 3 displays ammonium values for water in North Pile Collection Ditch
- Data show the evolution of nitrate & ammonium values from 2008 to 2020;
- Nitrate has been ruled out by the Board as the main contaminant of concern
- Effluent from the North Pile is the main source of nitrate & ammonium at the site, due mainly to the use of explosives

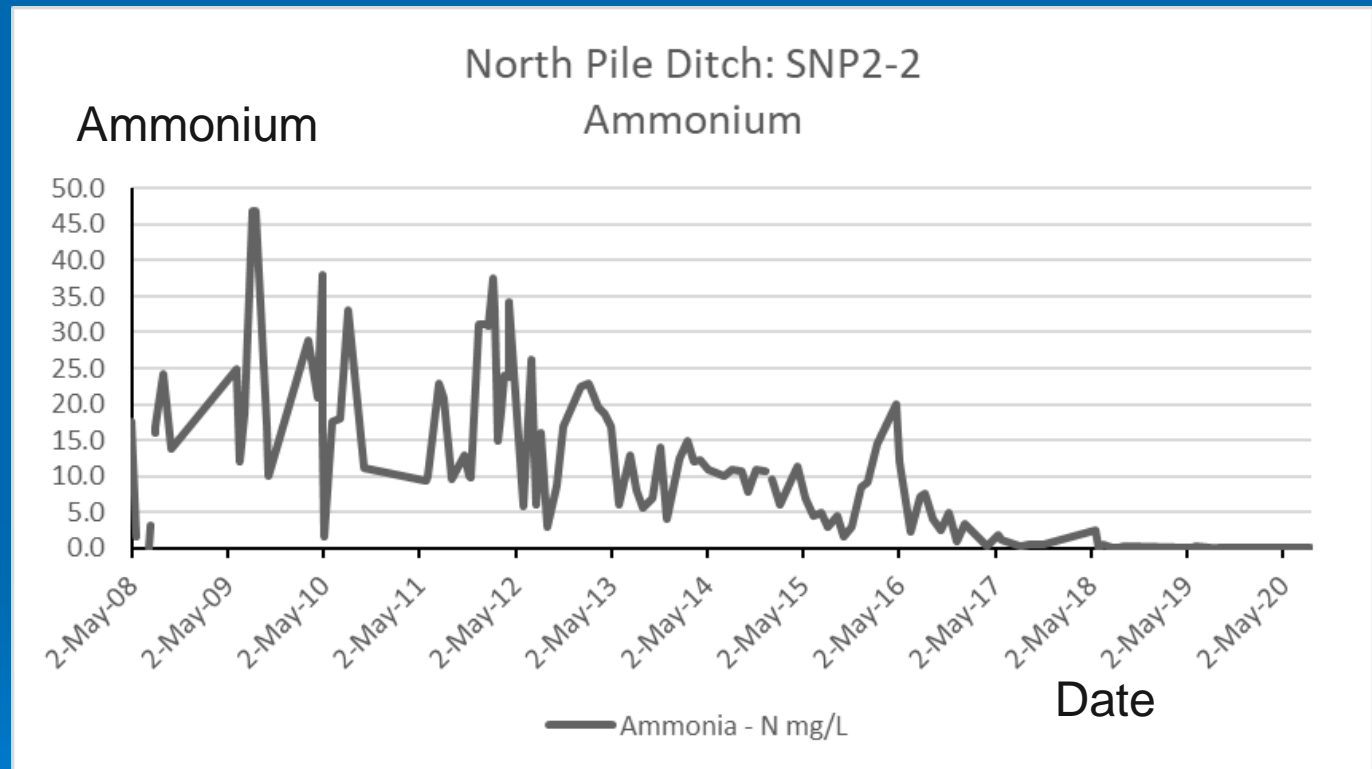
- Graph 3: Ammonium in North Pile Collection Ditch

Data 2008-2020 from SNP Reports

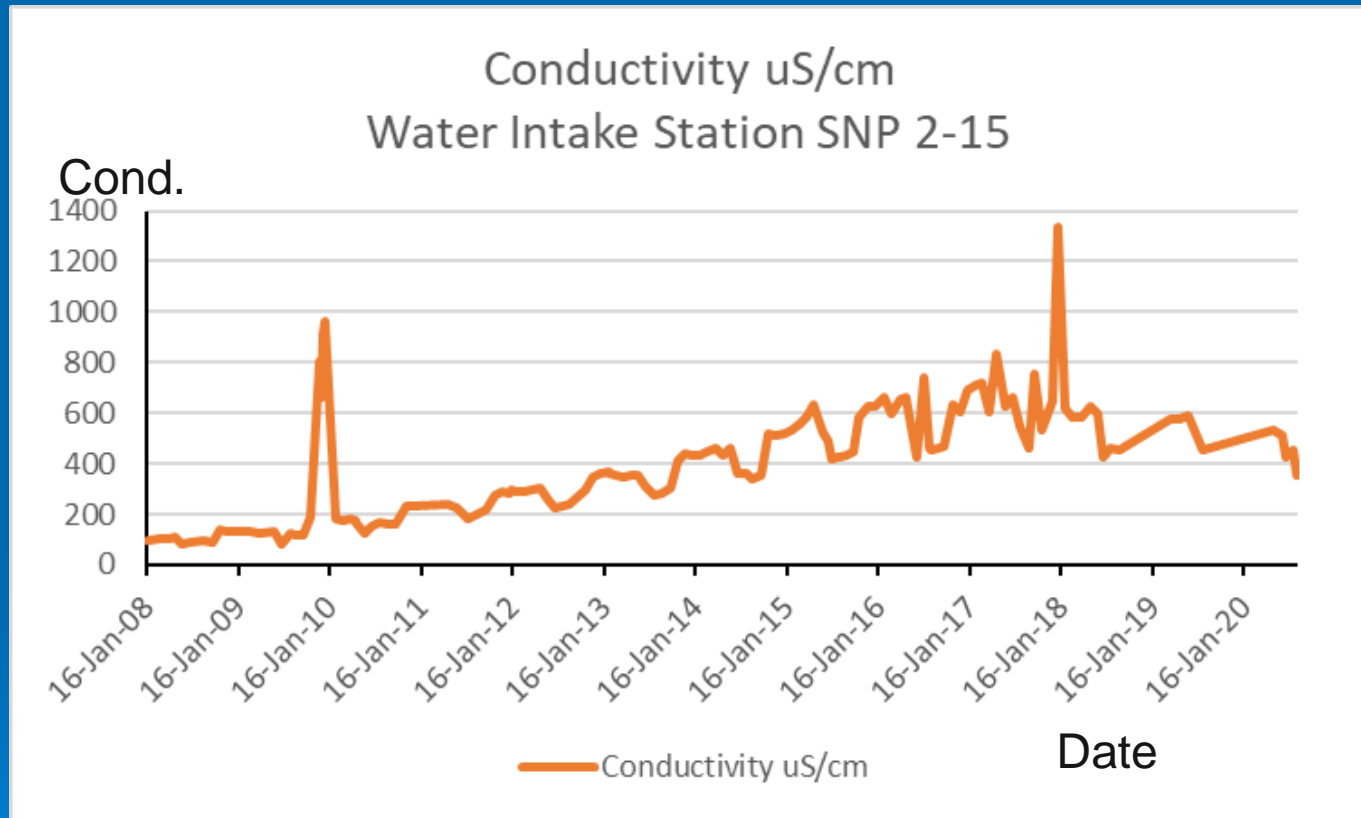
- Graph 4: Conductivity at Snap Lake Water Intake

Data 2008 to 2020 from SNP Reports

- Graph 4 displays Conductivity values for drinking water extracted at the Snap Lake Water Intake
 - Data shows the evolution of Conductivity values from 2008 to 2020;
 - Conductivity is related to any minerals, salts, metals dissolved in water. It comprises mainly inorganic salts that are dissolved in water;
 - High conductivity implies high salt content
