NOV - DEC 2022
Environmental Update
for SLEMA Board
January, 2023

November 2 Site Inspection

December 12 Site Inspection

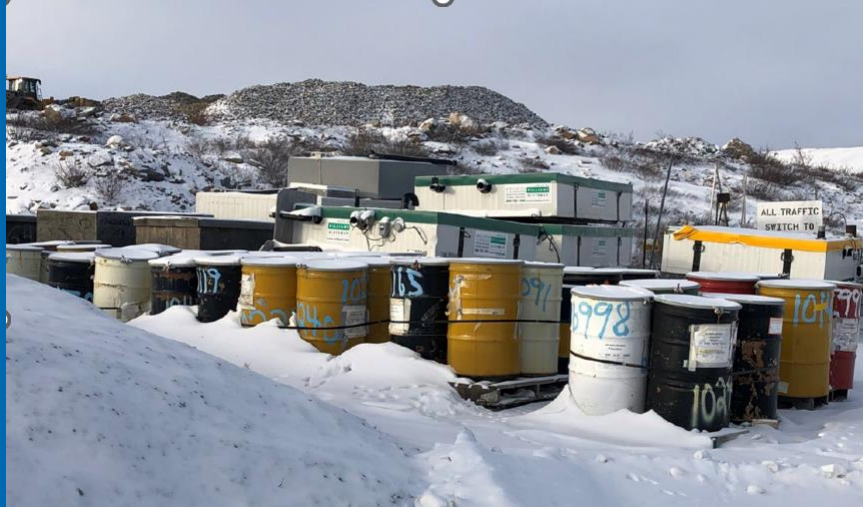
1. Waste Management Area – drums awaiting removal

- Waste Management Area
 - Much of the staged material has been removed from this location and placed in the temporary hazardous waste area for removal on the winter road
 - Material remaining is also earmarked for removal via winter road
 - Drums were well organized with proper labels, strapping and placed on pallets
 - No leaks or staining was observed during inspection of the area

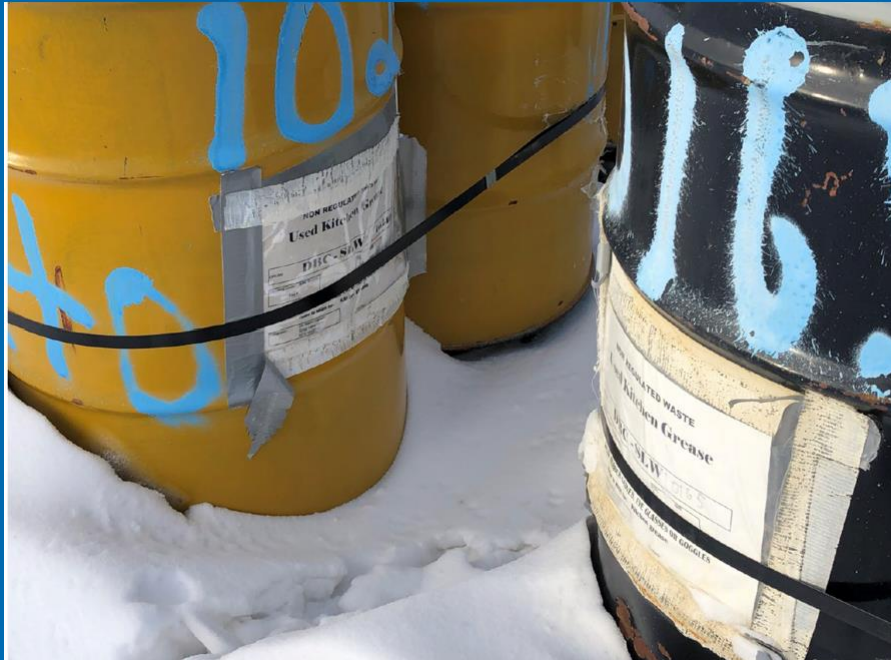
2. Waste Management Area – Drums properly labeled and strapped on pallets

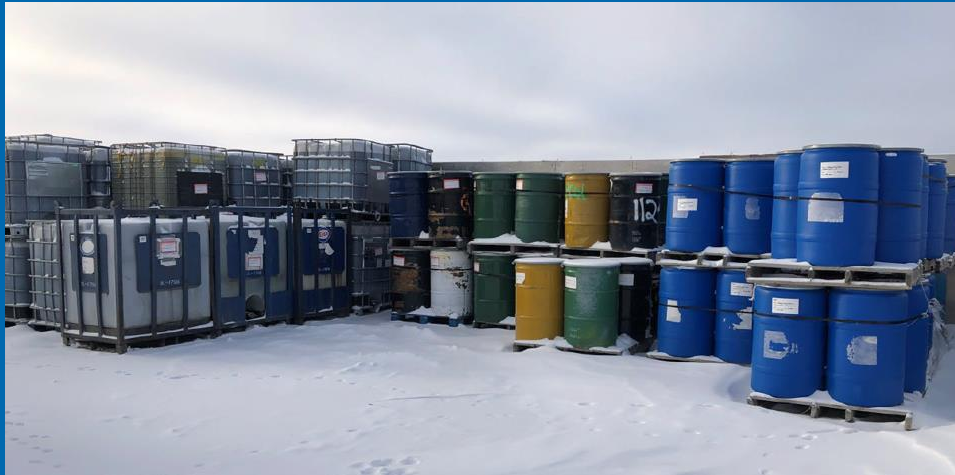
3. Temporary Hazardous Area – Drums are well staged and labelled

- Temporary Hazardous Waste Area
 - All material stored in this area will be removed
 - Totes and drums are well organized with proper labels present
 - No observable leakage or staining during inspection
- Crusher
 - The crusher was in operation
 - The crushed material will be used as erosion control, rip-rap, and bedding
 - The material originates through the construction of perimeter sumps and blasting on site, and is then crushed and redistributed where required

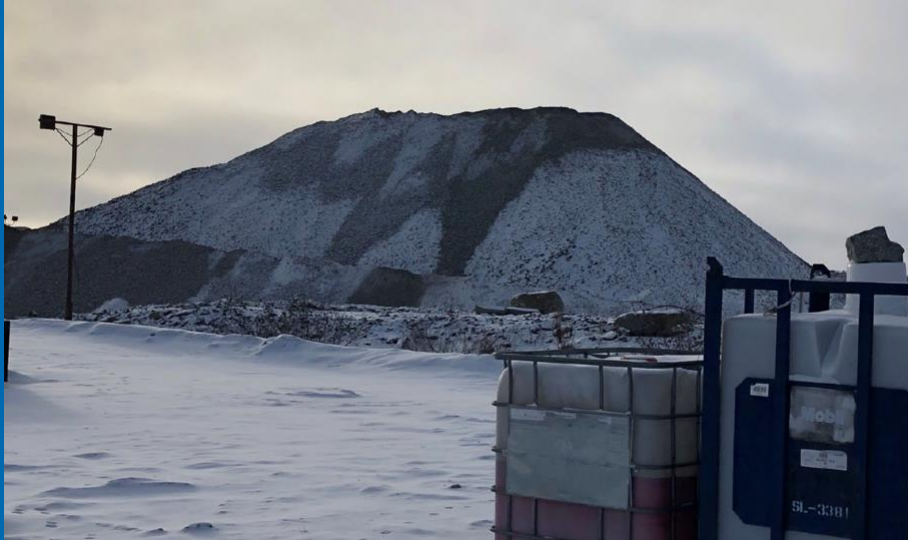
4. Crusher Area – Material is separated based on size and used for rip-rap, bedding and erosion control

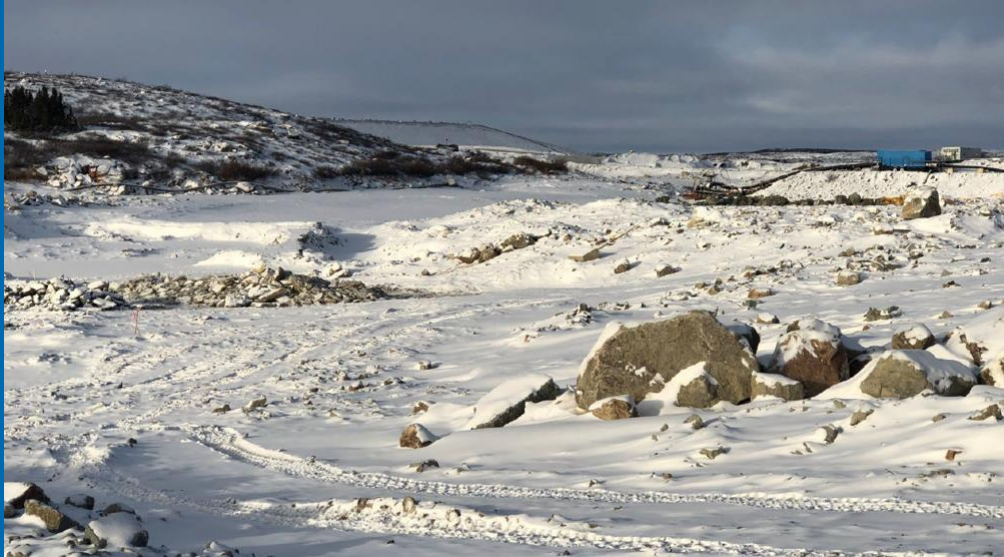
Water Management Pond – construction to remove sediments

- Water Management Pond
 - Construction at the WMP involved sediment removal as part of the redesign for the east Influence Storage Pond (ISP)
 - The former pumping infrastructure has also been disconnected
 - Water is no longer being pumped underground (see below authorizations), as flow has subsided due to weather conditions

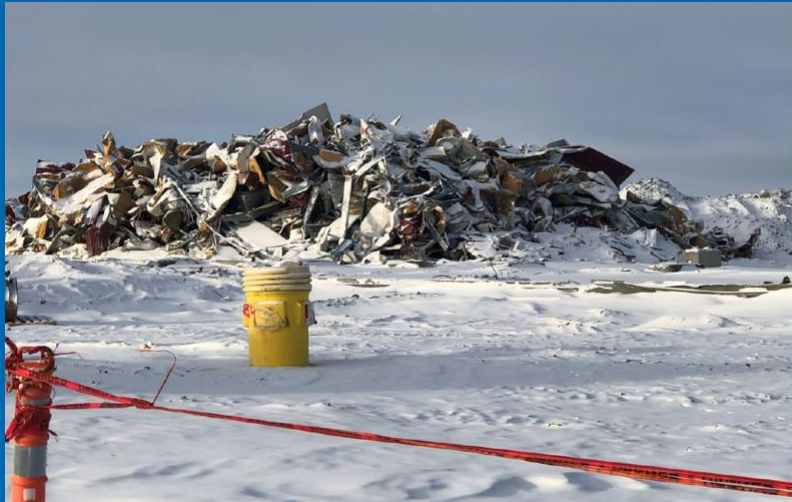
6. Cell 2 – Demolished material awaiting burial

- Perimeter Sumps/Cells- Cell 1
 - Cell 1 is a former landfill. Some material has been buried there
- Perimeter Sumps/Cells- Cell 2
 - Currently active and is where demolition material is buried. Several 600 mm lifts have already been completed
 - Before being buried in 600 mm lifts the process involves the building being handed over to QM(contractor) to be demolished
 - The demolition material is placed specifically into the designated cells which are then covered with coarse and grits and compacted

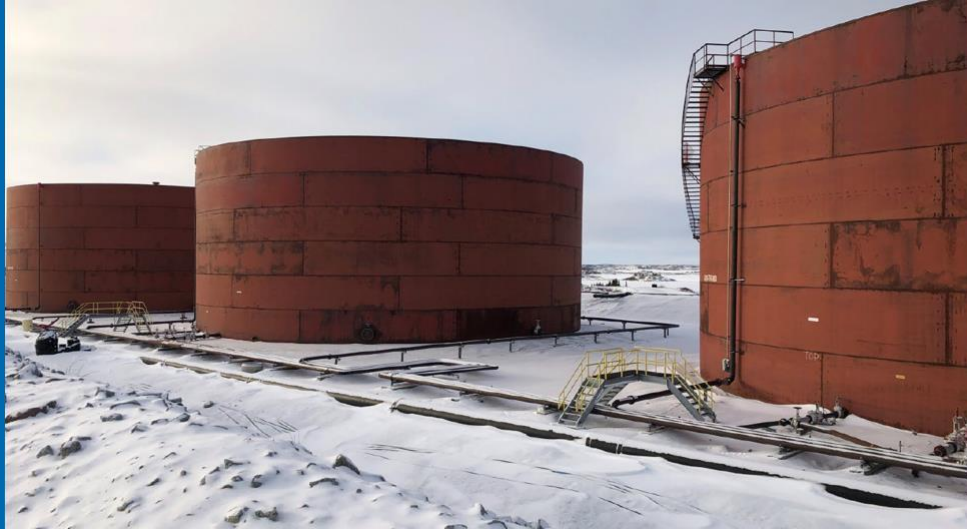
7. Fuel Tank Farm – 12 million litre tanks – awaiting demolition

- Winter Road
 - Snap Lake personnel are hoping to get an earlier start on winter road construction. Equipment has been staged for the build-out of the spur road.
- 12 Million Litre Tanks
 - The tanks have been pumped down but still have minimal fuel. The tanks are most likely to be demolished and buried on site.

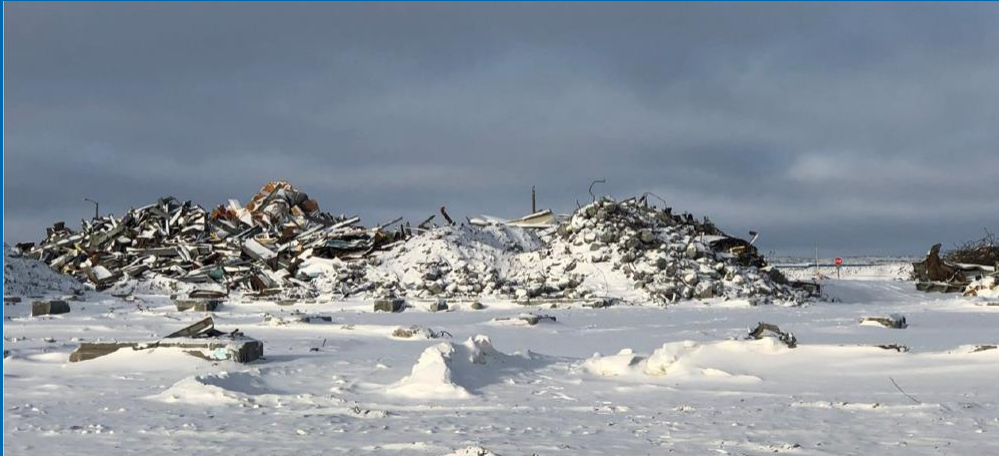
8. Process plant demolition

- Process Plant: it has been demolished and awaits disposal. There is potential to bring scrap material off site via winter road for re-use
- Main Complex: This includes offices, environmental lab, truck shop, mine dry, and ERT, which are totally demolished and awaiting disposal
- Powerhouse: It has been demolished and awaits disposal
- Batch Plant: Also known as “Big Top” has been demolished and has been disposed of on-site (Cell 2)

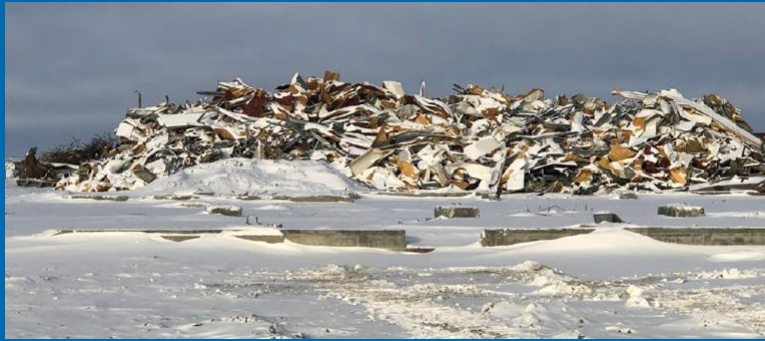
Main Complex demolition

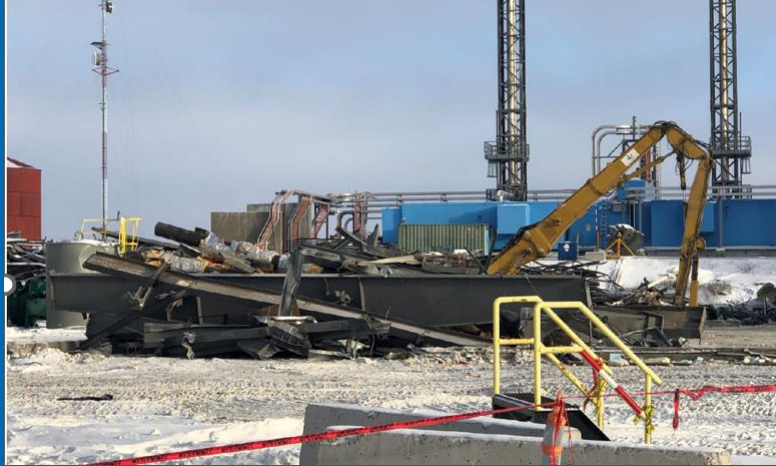
10. Powerhouse demolished and awaiting disposal

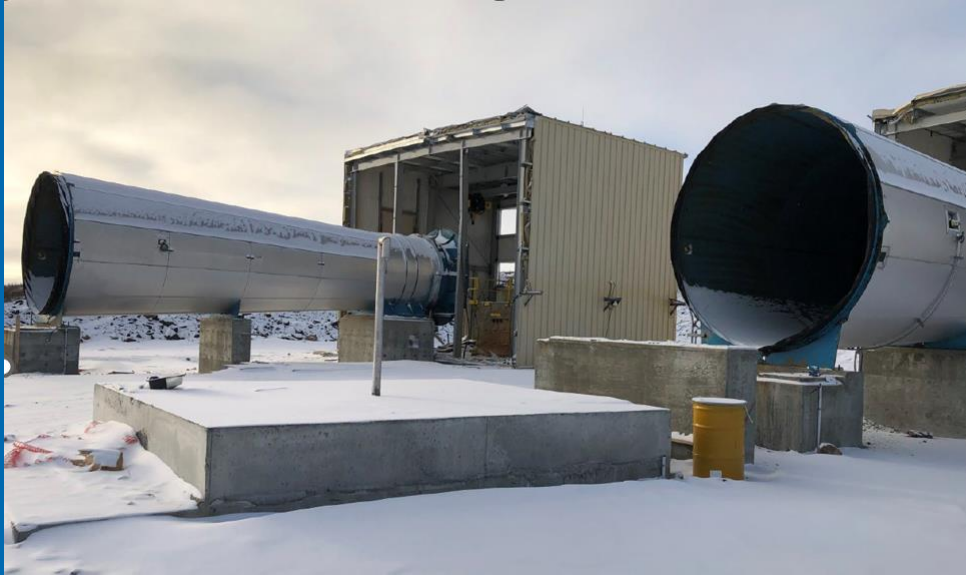
11. Fresh Air Raise. Lenmark to salvage components for secondary market

- Fresh Air Raise (FAR)
 - Components have been separated and are earmarked for removal via winter road upon which Lenmark will acquire the components for re-sale on the secondary market
 - Concrete caps have been poured to seal the underground

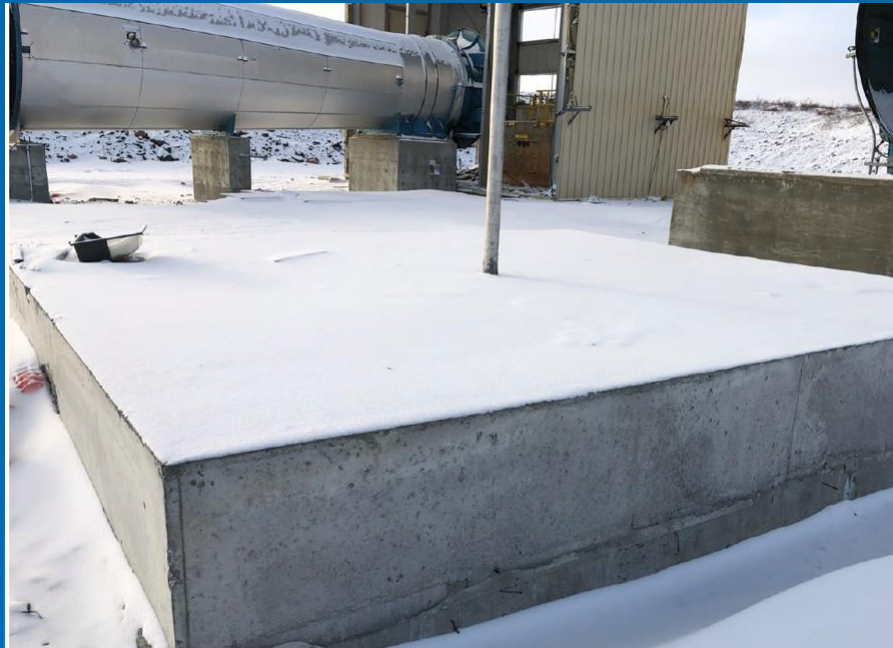
14. Fresh Air Raise – Underground has been capped with concrete

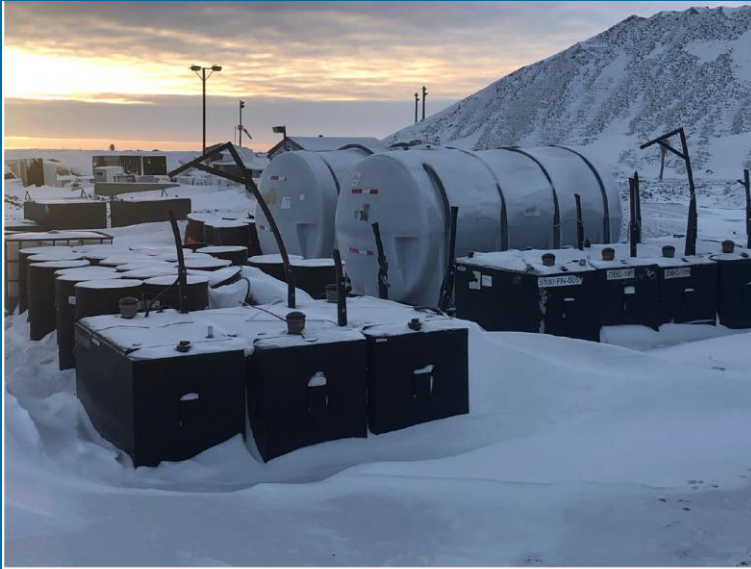
Photo 1 – Waste Management Area – Totes and tanks awaiting removal via winter road.

- Much of the staged material has been removed from this location and placed in the temporary hazardous waste area for removal on the winter road
- Material remaining is also earmarked for removal via winter road (Pic 1)
- Drums were well organized with proper labels, strapping and placed on pallets (Pic 2)
- No leaks or staining were observed during inspection of the area
- Incineration occurs on an as-needed basis (Pic 3)
- Crushed material is now being stored in the area and will later be used for erosion control, rip-rap, and bedding (Pic 4).

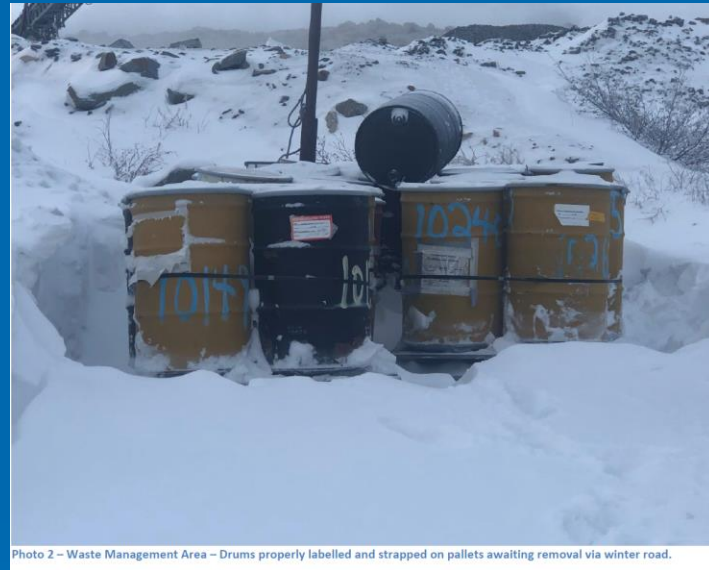
Photo 2 – Waste Management Area – Drums properly labelled and strapped on pallets awaiting removal via winter road.

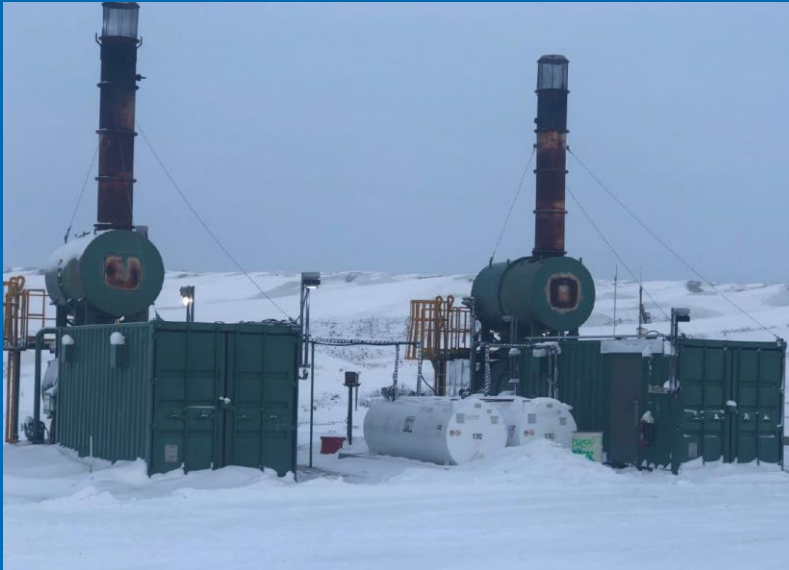
3. Incinerators - Waste Management Area

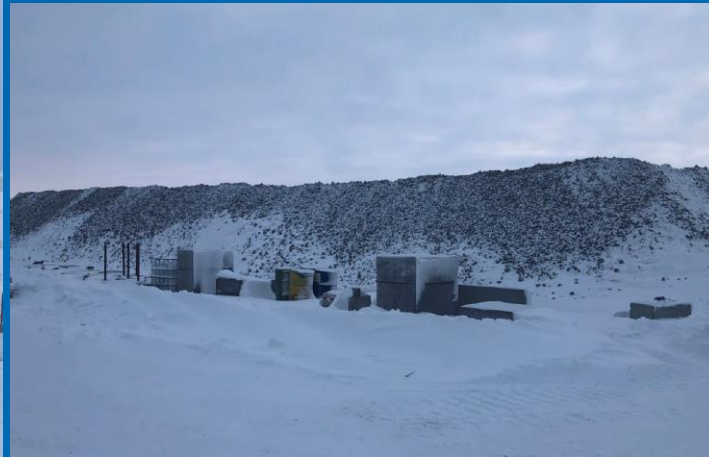
4. Waste Management Area
– Stockpiled crush

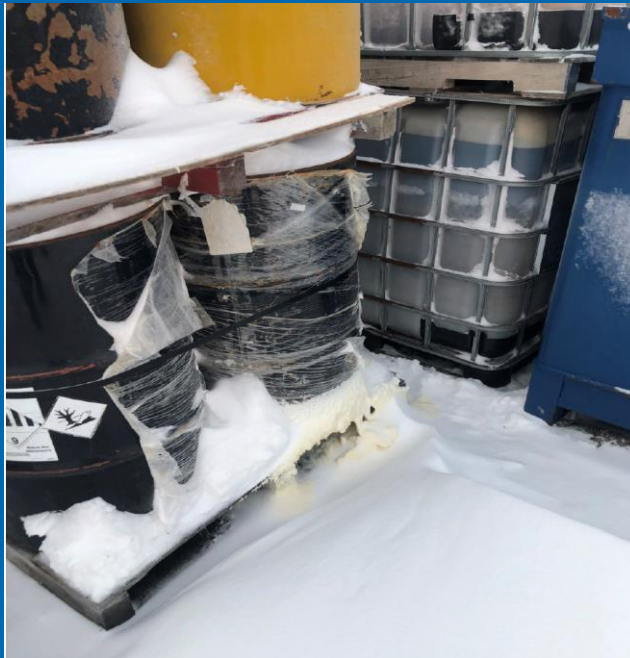
- All material stored in this area will be removed by the winter road
- Totes and drums are well organized with proper labels
- One drum was observed as having some staining in the surrounding snow. This drum was removed, and the area was cleaned during the inspection (Pic 5).

5. Temporary Hazardous Waste Area – Leakage from drum.

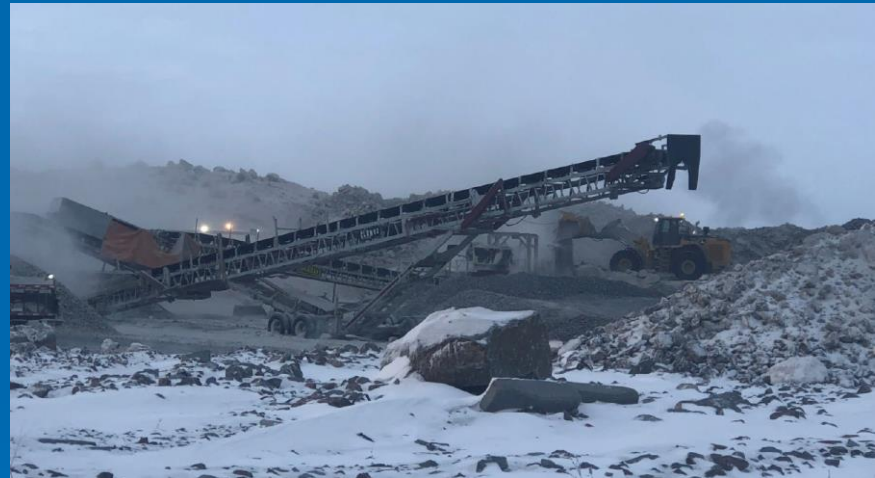
6. Crusher Area

- The different sizes of crushed material will be used as erosion control, rip-rap, and bedding during the closure and reclamation process (Pic 6)

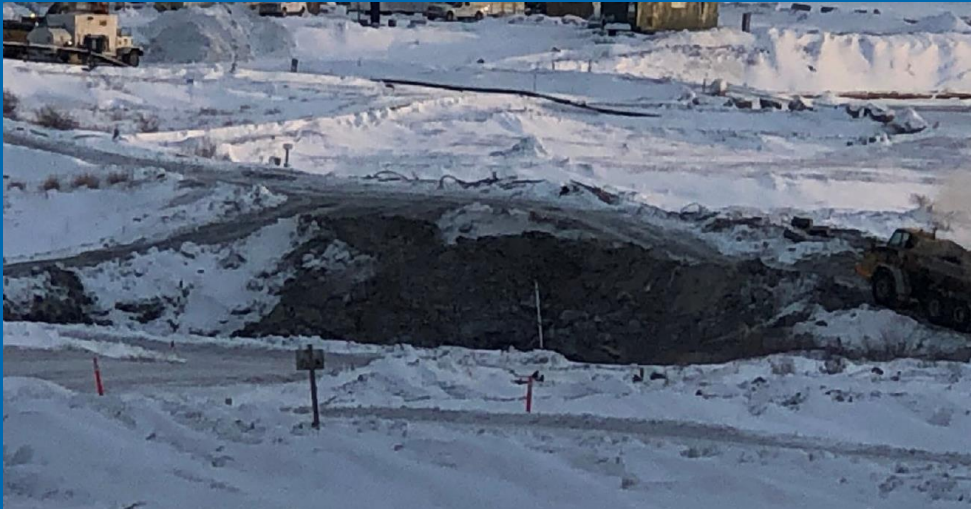
- Construction at the WMP (Pic 7) involved sediment removal as part of the redesign for the east Influence Storage Pond (ISP)
- Material is being separated into sediment and organics piles
- Earthworks involving reshaping for sloping and channel construction for flow will occur going forward, followed by erosion protection.

7. Water Management Pond – Construction to remove sediment

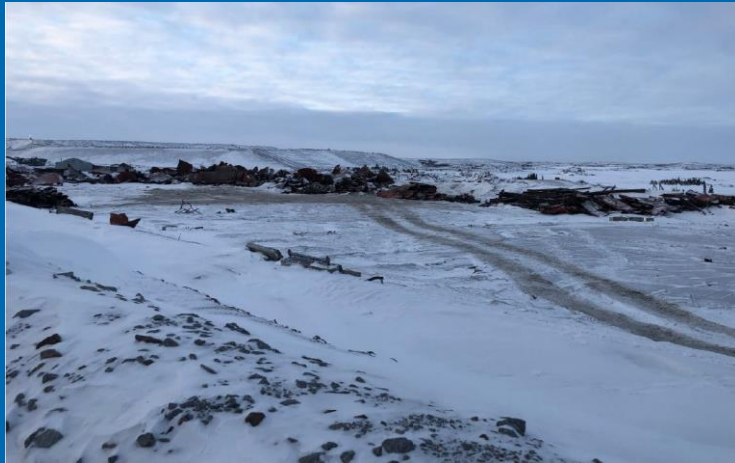
- The 3 tanks have been demolished and await disposal (Pic 8)

8. Fuel Tank Farm – 12 million litre tanks - Demolished material awaiting burial

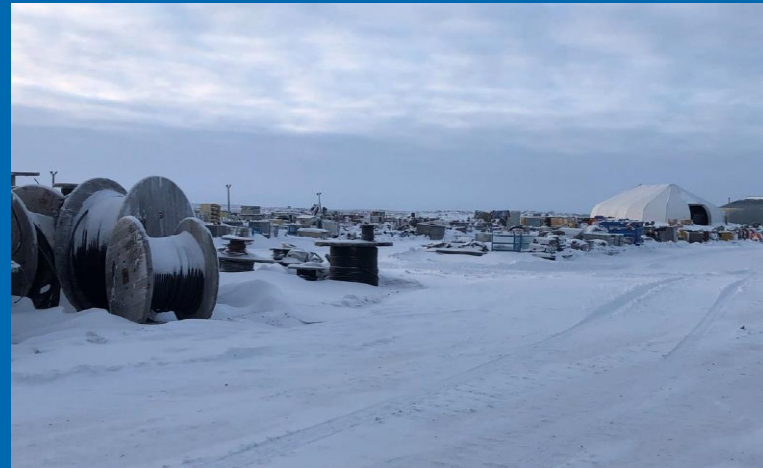
- This area is historically a storage yard for equipment. It consists of a multitude of equipment that is currently being re-used, shipped out or disposed of on site
- Approximately 50 % of the material will be buried at site (Pic 9)
- One of the 6 snow dump locations will be within this area

9. Laydown 1 – Storage yard.
