MAR – APR 2024 Snap Lake Mine Closure & Reclamation Activities Summary

MAY 2024

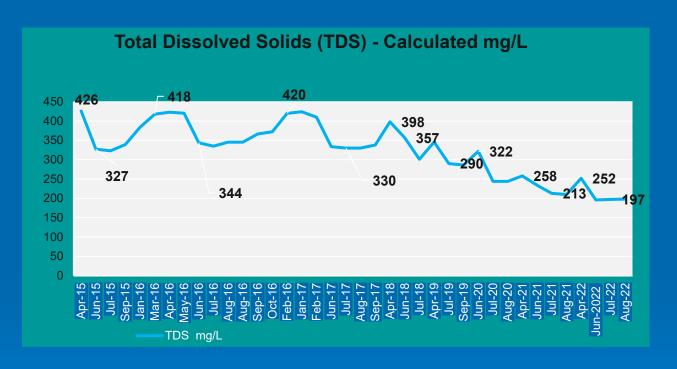
TDS RESULTS AT SNP 2-20d

SNP2-20d	Apr-15	Apr-22
TDS mg/L	426	252

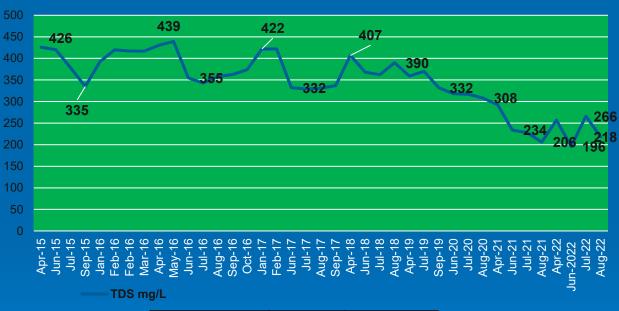
TDS RESULTS AT SNP 2-20e

Total Dissolved Solids - Calculated (TDS) mg/L

SNP2-20e	Apr-15	Apr-22
TDS mg/L	426	257

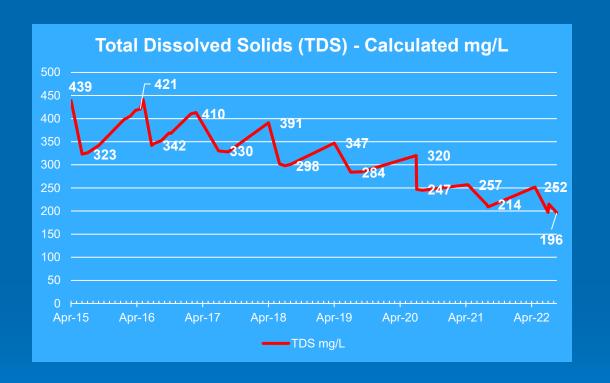
TDS RESULTS AT SNP 2-20f

SNP2-20f	Apr-15	Apr-22
TDS mg/L	439	252
